Court Henri

Llangathen

Recorded Geoff Ward, 18/ 12/ 2014.

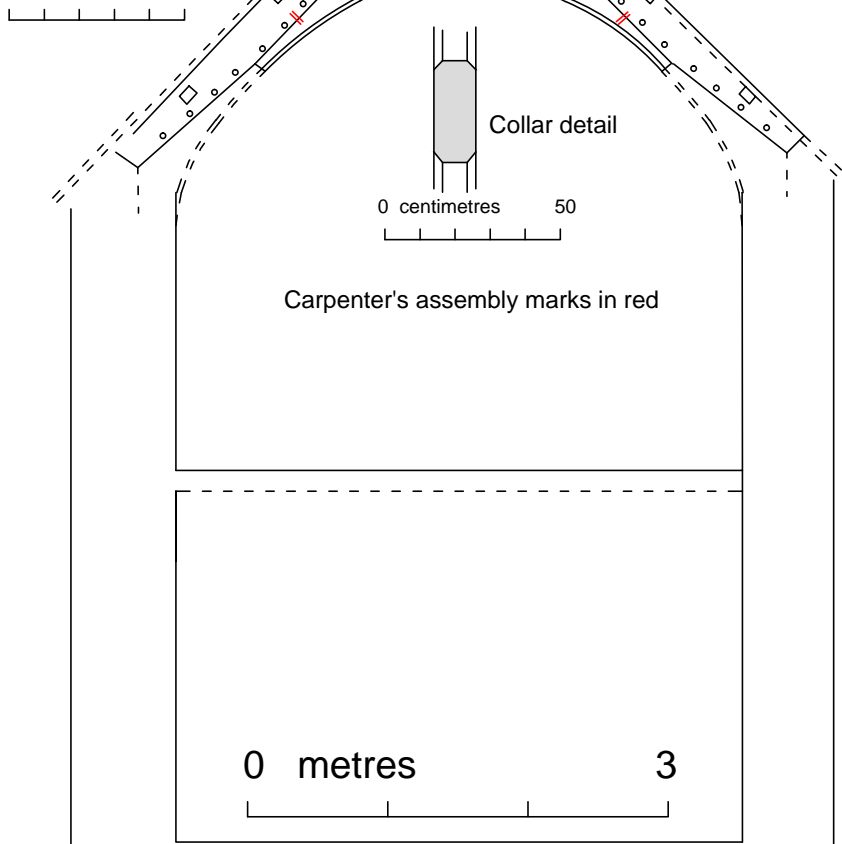
Threaded purlin joint at truss

Collar detail

Carpenter's assembly marks in red

Cross-section of chapel roof

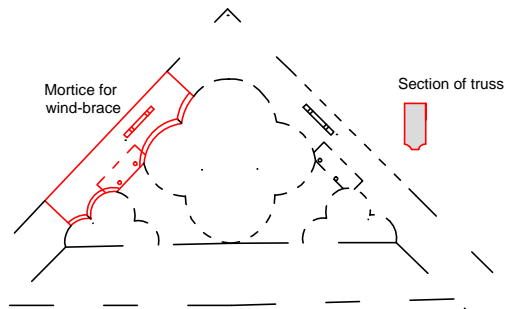
Mortise for wind-brace

Section of truss

Hall roof truss reconstruction from re-used lintel (shown in red)

Hall roof truss

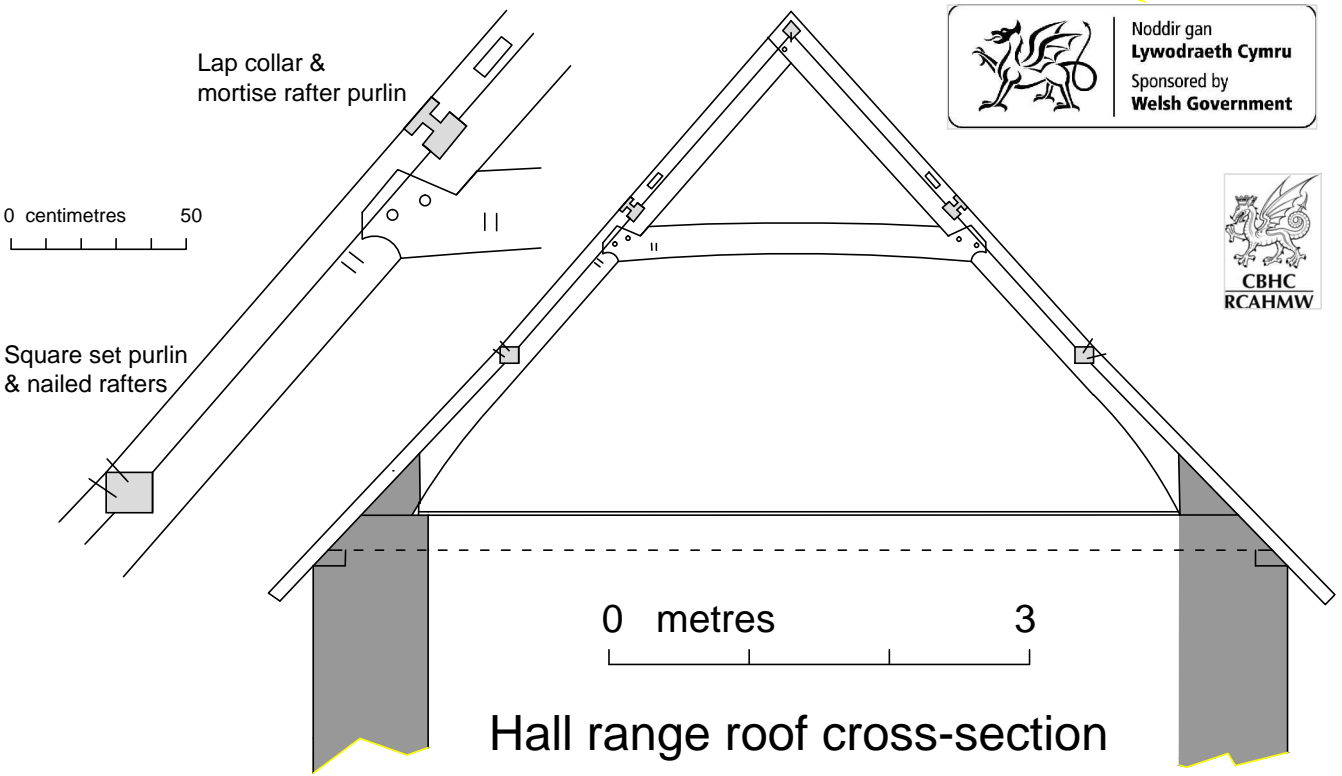
Lap collar & mortise rafter purlin

Square set purlin & nailed rafters

Hall range roof cross-section
