HERITAGE IMPACT STATEMENT

FORMER PROVISIONS MARKET, CARMARTHEN
STREET, LLANDEILO

PEMBROKE DESIGN LTD

JULY 2019

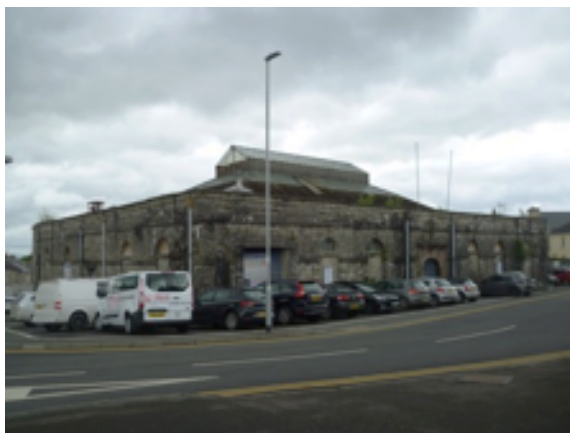
Market exterior: Asphalt flat roof with solar reflective coating over concrete slabs and steel beams. The roof is punctured by glazed metal lanterns with fibre cement cladding, a variety of flues and two red clay chimney pots. The central area has a hipped pitched roof with corrugated and flat fibre cement sheets and glass panels within metal framework. Lead lined outlets fall into cast iron hoppers draining into UPVC downpipes. UPVC soil and vent pipes and waste hoppers are located on the north east elevation only. Walls are built of exposed coursed squared stonework laid to banded diminishing courses with recessed panels, stone string and impost courses. The north east elevation is less formal with odd traces of limewash amongst the random rubble stonework with flush concrete bands mimicking the string course with red sandstone quoins at the corners and around openings. There are several different types of pointing but the majority has been undertaken in cement raised ribbon style. The main entrance along the south west elevation has a red sandstone moulded door surround with keystone arch and depressed spandrels. Above is a recessed niche with stone carved letter block. The side entrance to the north west elevation has lugged stone surround with flat arched head. Arched openings are finished with stone voussoir with concrete lintels to large flat heads and concrete window cills throughout. The parapet is finished with concrete copings. A built up opening to the north west elevation has a brick arch. Painted metal fixed and opening casement windows and fitted with plain and textured single glazing, some with arched heads. External doors are all painted timber with the large ones folding into leaf's with framed ledged and braced boarded panels. Timber doors along the north east elevation of similar construction are smaller. Doors to the south west and north west elevations are flat panels decorated with raised timber beading with arch and narrow panels. There is a painted iron gate to the south west elevation lined with plywood internally. A Victorian post box is built into the south west elevation.

Figure 7 above: Market viewed from north west

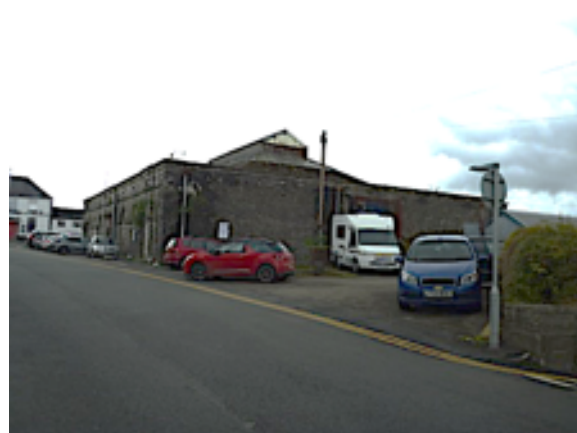
Figure 8 above: Market viewed from south west

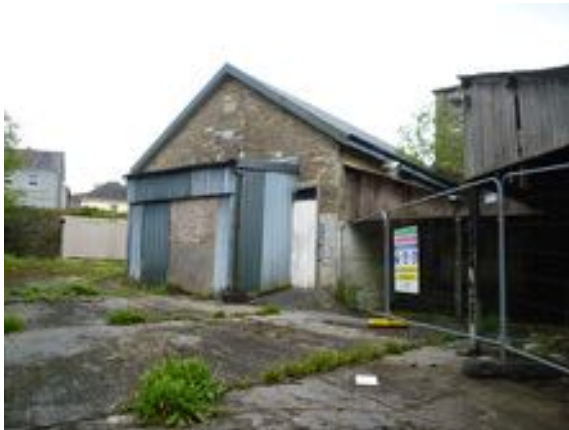
Slaughter house exterior: Powder coated metal sheet pitched roof covering with angled ridges and verge overcloak's. Painted timber fascia and UVC rainwater goods. Partly modified timber roof structure with king posts, timber purlins and steel beams added for hoists. Exposed random rubble stonework and painted render walls. Stone voussoir to round arched heads and stone cills to windows. Traces of limewash and paint over stone. Carved stone date plaque. Powder coated corrugated steel store room. Painted timber windows with plastic panes, mesh and iron bars. Painted timber framed, ledged and braced doors.

Figure 9 above: Slaughter house viewed from north east

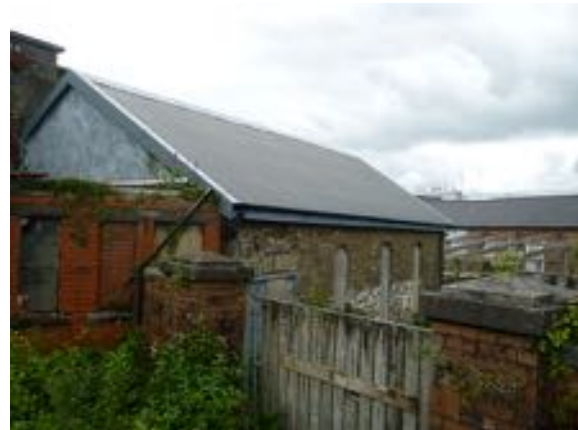
Figure 10 above: Slaughter house viewed from south west

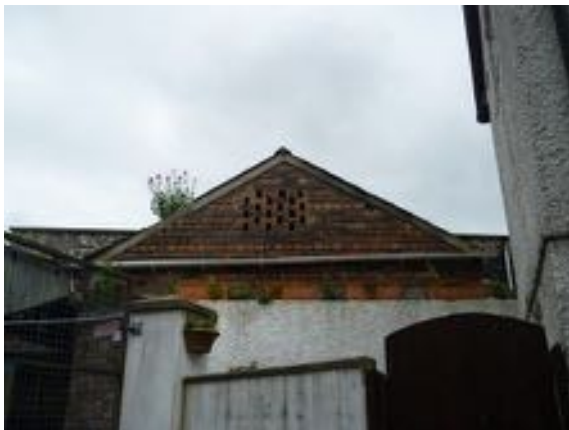
Figure 11 above: Store shed viewed from north east

Store shed exterior: Pitched roof covered with natural Welsh slate and artificial slate. Mix of interlocking through coloured blue/back clay tiles and glazed terracotta butt jointed ridge tiles. Rendered barge, painted timber fascia with UPVC and painted cast iron rainwater goods. Partly modified timber roof structure with king posts and steel beams added for hoists. Exposed random rubble stonework to walls with painted and fair faced brickwork, painted render. Missing bricks for ventilation to gables with concrete lintels above openings. Painted timber framed, ledged and braced doors.

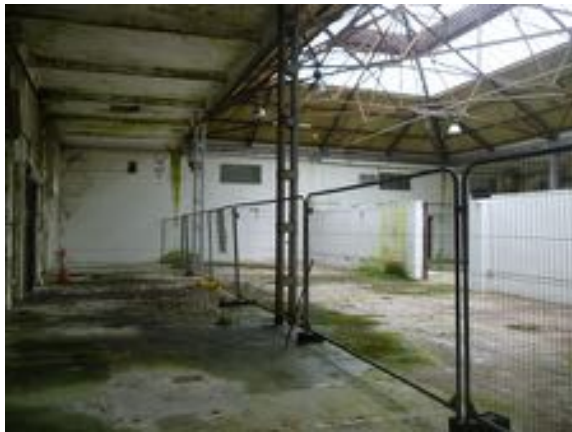
Market interior at upper ground and mezzanine levels: Largely modernised with painted and unpainted plastered walls, some drylined with plasterboard and plywood. Traces of limewash under some finishes. Painted steel columns and posts with unfinished iron fink type trusses. Plywood, timber board and painted concrete ceilings with exposed steel beams. Exposed underside of corrugated fibre cement roof sheeting. Exposed concrete floors and timber board mezzanine timber floors served by timber stairs. Partitions are a mix of solid painted, plastered brick and concrete block, timber stud with hardboard linings. Tiled fireplaces to north wall. Early C20th painted panelled and boarded timber doors with textured glass panels. Textured glass fanlights within metal frames. Large boiler with stainless steel flue to east corner. Disused glazed lanterns infilled with timber boarding. Roller shutter galvanized door behind gate to south west elevation.

Figure 13 above: Market interior main space viewed towards north west corner

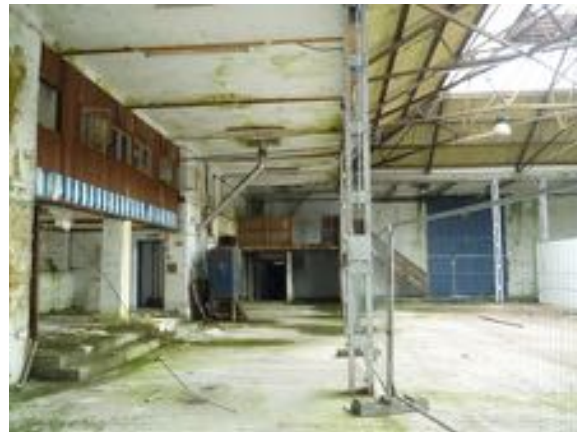
Figure 14 above: Market interior main space viewed towards south east corner

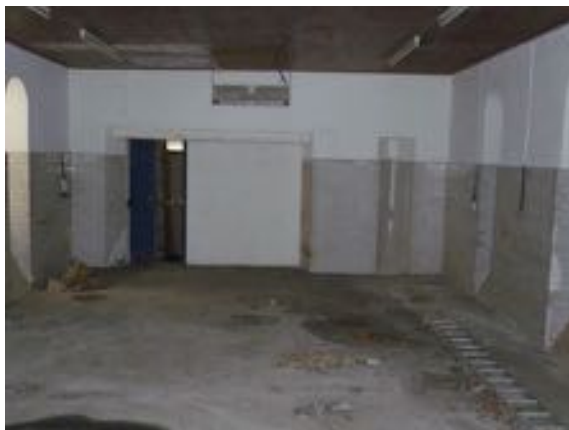
Slaughter house interior: Varnished plywood ceiling and exposed underside to corrugated metal roof covering. Painted plaster walls and white ceramic tiles to mid wall height including window reveals. Exposed concrete floor with ramps.

Figure 19 above: Slaughter house interior east end

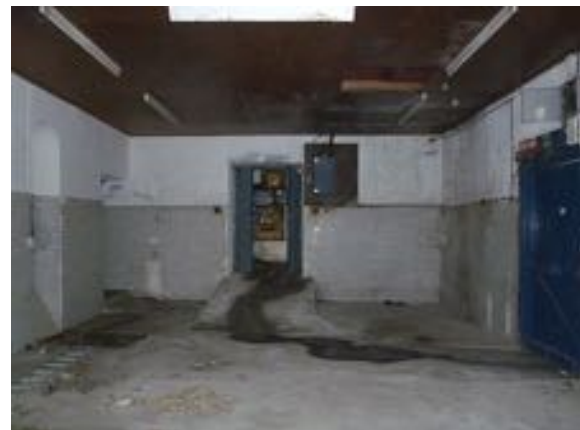
Figure 20 above: Slaughter house interior west end

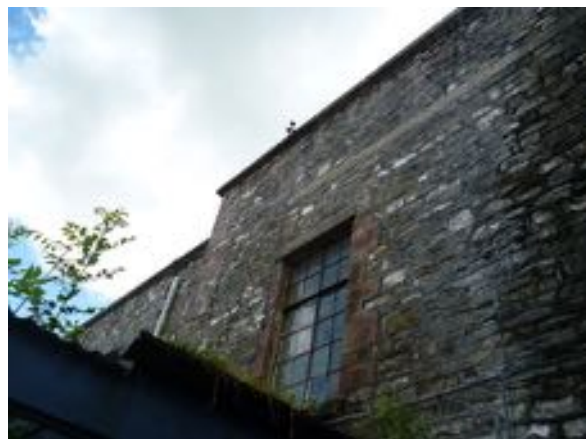
Stonework to the rear north east elevation of the market is much poorer than the rest of the building with random rubble and string course continued in concrete, suggesting this area was perhaps raised in the C20th. Isolated sections of red sandstone have been incorporated along upper level, supplemented with red sandstone quoins lining window reveals which are clearly later C20th origin with concrete cills and lintels. Many of the stones at upper level appear to have been recycled too with traces of lime wash. Red sandstone was used to pick out the entrance door to the south east elevation with moulded stone architrave with keystone arch and depressed spandrels and suspect this is a later addition too.

Figure 26 above: Stonework to north east elevation

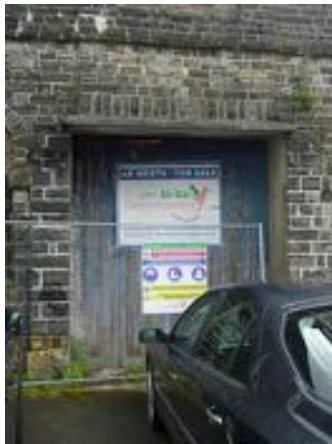
The design to the main façade along New Road and Carmarthen Road is markedly different with squared rubble laid to diminishing courses set with impost band connecting half round stone arches to blind recesses. The parapet also has a projecting stone string course with sunken rectangular panels. This has probably not changed much since the original construction. C20th work appears to be the addition of a raised parapet with opening up of some of the blind panels with small arched windows and perhaps later, the creation of large rectangular openings given the concrete lintels above.

Figure 27 opposite: door to south west elevation

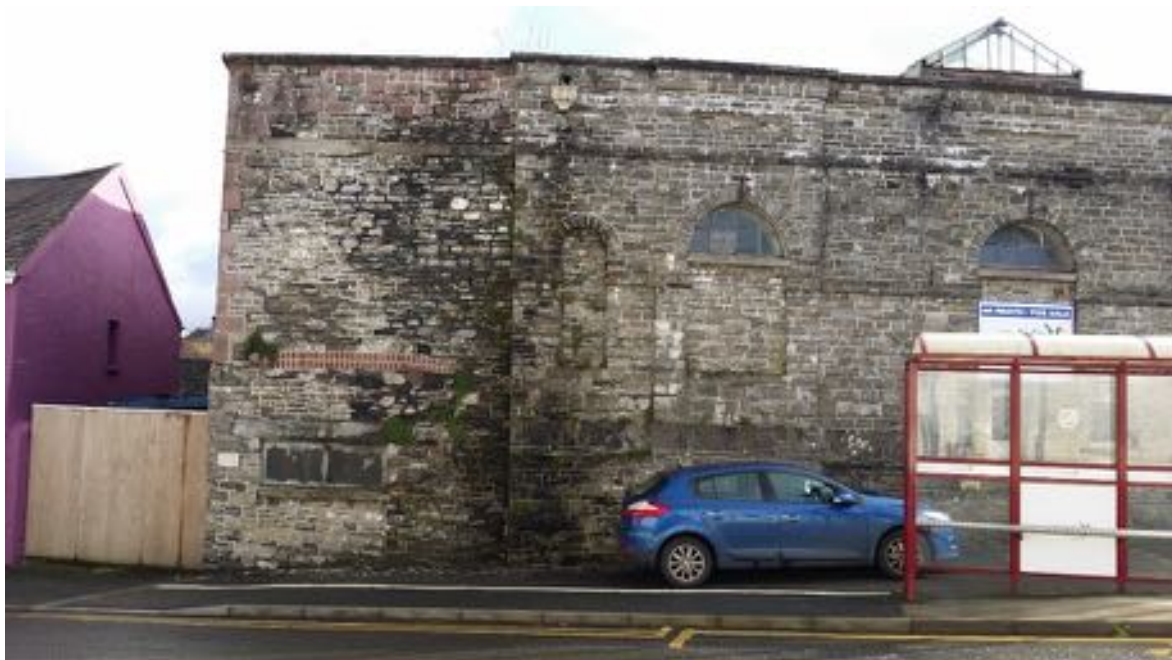
Figure 28 above: Contrasting market stonework along north west elevation highlighting different periods of construction and style

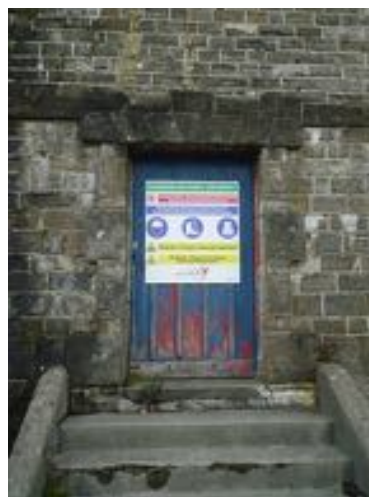
Most of the external doors date from the late C20th but there are a couple on the market which are likely to be earlier. Although the door to the south west elevation boarded over now, they share the same design and detailing as the exposed door on the north west elevation. Planted beads create long panels with an arched head and internally the door is lined with diagonal boarding. The south west door no longer serves the market due to the additional of a small room in the southern corner which is only accessible from the external door. The Victorian post box in the south west elevation appears to be a later insertion rather than part of the original design.

Figure 31 above: Door to north west elevation of market

Fragments of the southern door to the market south west elevation may remain behind the boarding which will allow a like for like replacement. The door detail has been recorded in earlier photographs however and a matching door on the north west elevation will allow for a faithful replacement.

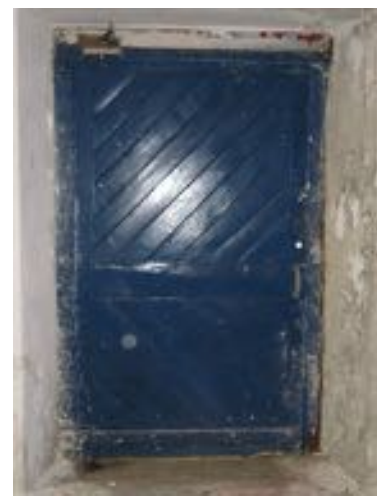
Figure 32 above: Door to north west elevation of market viewed internally with diagonal boarding

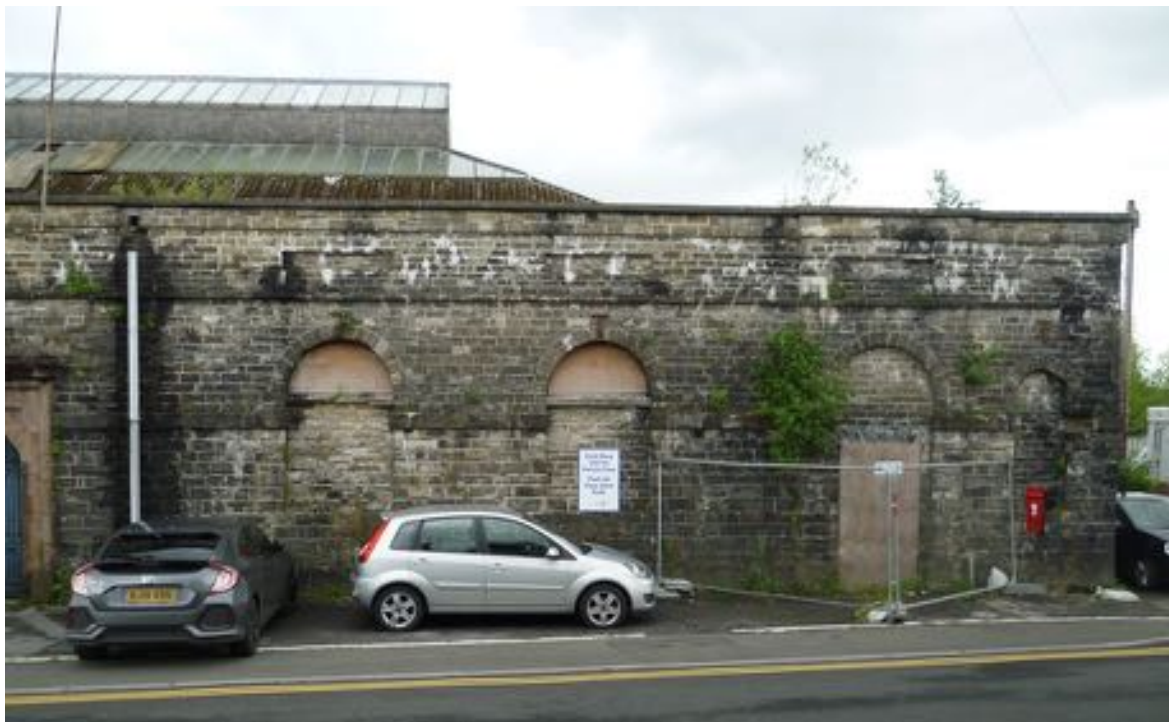
Figure 33 above: Southern end of south west elevation

Stone repairs to the southern end of the south west elevation have been identified in the condition report but essentially entail the replacement of 2no. missing stones. This work can be undertaken on a like for like basis and is necessary to prevent further loss of masonry and minimise risk of further deterioration such as vegetation growth, risk of frost and salt contamination from saturation of exposed core masonry. Work is confined to a local area and will be undertaken using traditional materials such as lime mortar with stone salvaged and reused from the works. Works comply with Cadw Conservation Principles due to understanding the impact of the repair, minimal intervention, sustaining heritage values and use of tried and tested materials.

The proposed stone repairs are confined to a small local area. Matching stone will become available from the opening up of the blind windows so the repair work will be discreet. The repair will prevent further loss of stone and deterioration and help conserve the striking masonry to this building. Using lime mortar, the repair will be undertaken like for like with traditional materials with proven durability. As the stones have already been lost, there will be little disturbance to fabric other than raking out mortar locally with negligible impact upon evidential values. The work will have beneficial impact upon significance by reinstating lost detail.

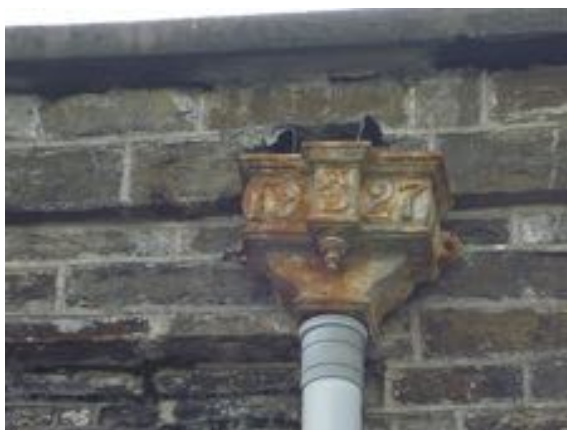
All wall tops throughout appear to have been rebuilt with C20th concrete copings laid onto damp proof course. The flat roof is likely to have been introduced in the early C20th and some of the cast iron hopper heads are dated 1927. The different types of hopper does suggest slightly different periods of construction however. There does not appear to be any evidence of former downpipe fixings other than the 1927 ones. This supports the idea that the earlier roofs were perhaps a shallow lean-to draining into the courtyards.

Figure 34 above: Hopper to market north west elevation

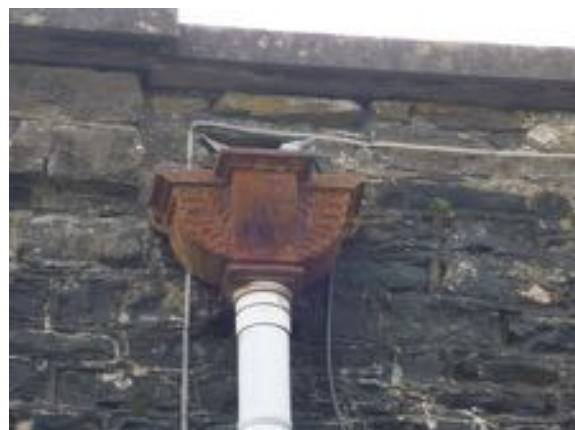
Figure 35 above: Hopper to market south east elevation

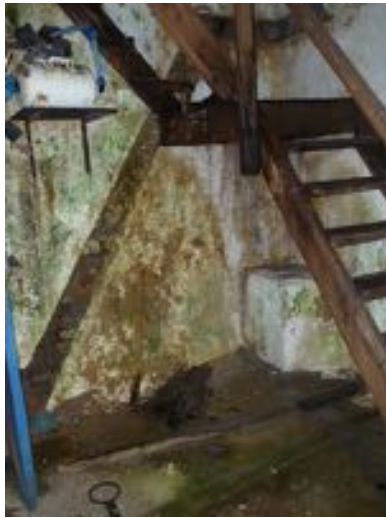
A stone plaque on the south west elevation is not dated but works were reported to have taken place in 1923. The pitched glazed roof structure is also C20th and suspect some elements e.g. lanterns, windows and corrugated fibre cladding may have been replaced in the 1950-60's. Numerous different types of plain and textured glass are fitted to the windows, although many are no doubt past repairs. Doors were also probably replaced when internal alterations were made in the 1980's with mezzanine levels and further subdivisions introduced. There is evidence of an older staircase to the north west corner which served a mezzanine level. The hoist to the south east elevation and sirens above the north western parapet provide evidence of former use as a foundry and fire station.

Figure 36 opposite: old staircase to north west corner of market

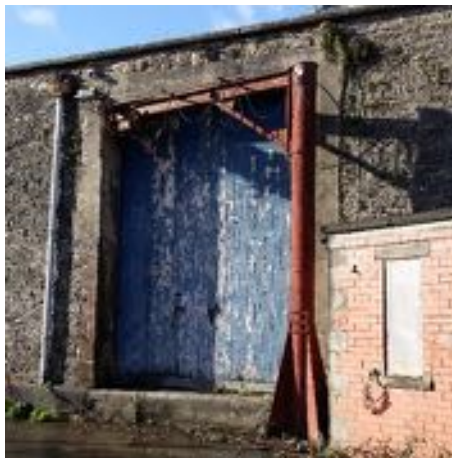
Figure 37 above: Hoist from iron foundry - – source Pembroke Design Ltd

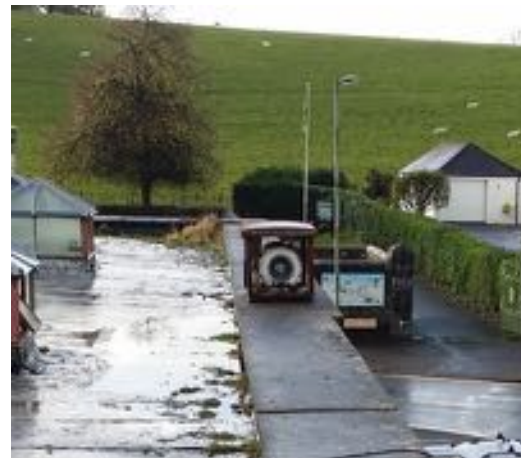
Figure 38 above: Sirens from fire brigade - – source Pembroke Design Ltd

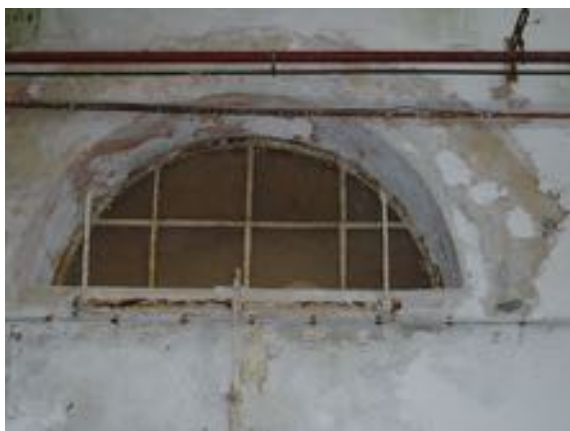
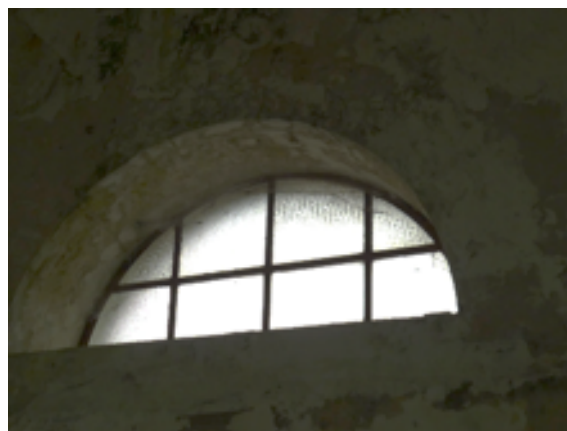
Figure 39 (left) and Figure 40 (right) above: typical arched metal window inserted into north west and south west elevations

Large door openings to the south east and north west elevations were inserted later. A brick arch inserted in the north west elevation has been partially infilled and fitted with modern timber window. Whilst the current arched metal windows are clearly C20th, there is speculation as whether the blind arch recesses were fully glazed originally. There is evidence of alteration around the current windows with making good. Fully blind recesses would have worked better with the original layout as shallow structures laid out around the two courtyards did not need the natural light from Carmarthen Street or New Road. The stone used in the recesses is consistent with the building too, although could have come from demolition of the early central wing. The south west and parts of the north west elevation are laid out in diminishing courses but masonry below the windows is laid to equal coursing. This may have been part of the original design however and internally, there is no suggestion of infill. The making good around the windows with strips of render and exposed brick to the arched reveals would probably not have been necessary if simply removing infill too.

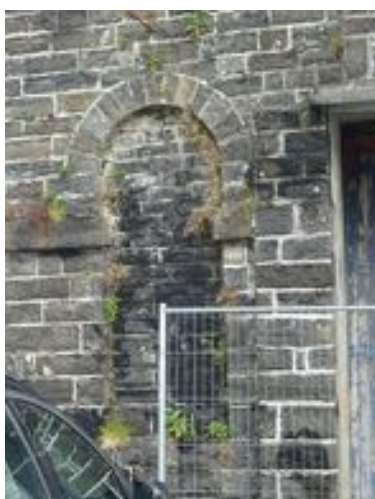
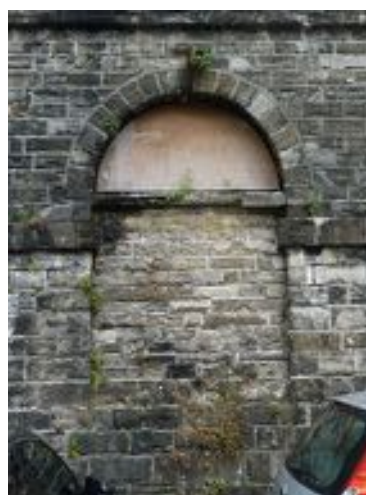
Figure 41 (left) and Figure 42 (right) above: Example of retained smaller blind panels and larger panels with windows inserted

14. Opening of blind openings along market north west and south west elevations
	15. Replacement of door to market south east elevation with new glazed design

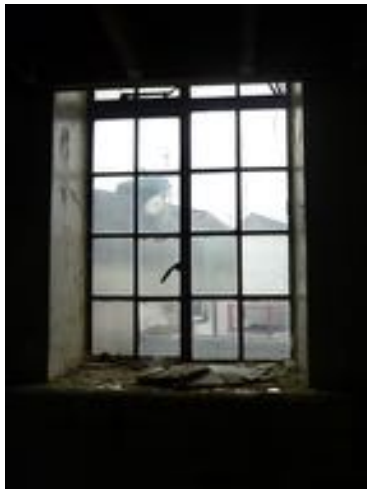
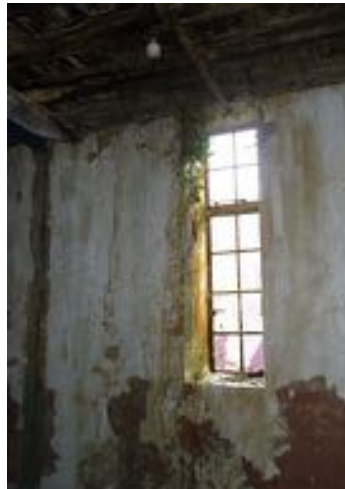
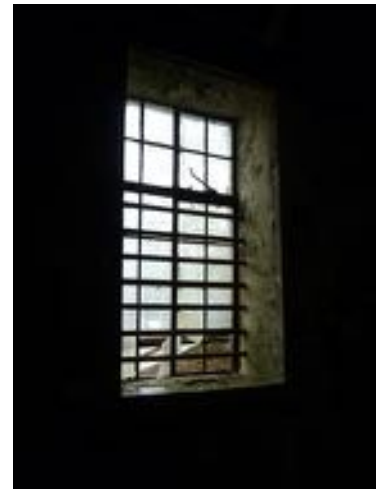
Figure 43, (left) Figure 44 (centre) and Figure 45 (right) above: typical rectangular metal windows inserted into the upper ground floor level of the north east elevation

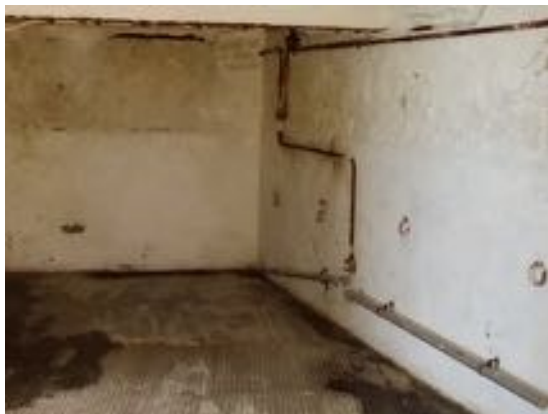
Within the eastern store room, there are also old tethering rings built into the wall which would have been used to tie up animals. The buildings at low level also exhibit larger areas of lime wash which was important for cleanliness.

Figure 46 left: Above tethering rings – source Pembroke Design Ltd

Figure 76 above: Area of proposed new staircase to south east corner in market upper ground floor level with door opening to be built up. See also Figure 46 showing area on lower ground floor

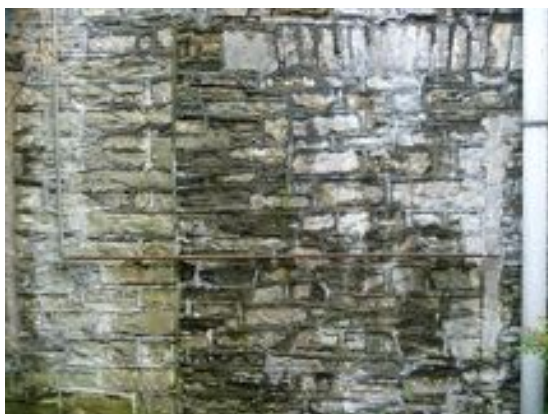
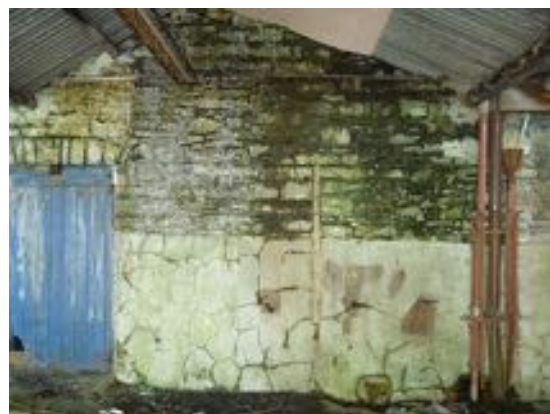
The lower ground levels of the market north east elevation have number of splayed vents, window and door openings that have been fully been built up. These suggest that the area was used to house livestock, possible prior to slaughter.

Figure 47 (left) and Figure 48 (right) above: old openings to north east wall at lower ground level – source Pembroke Design Ltd

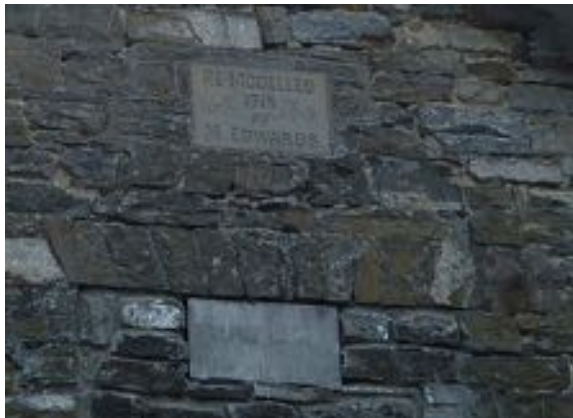
Figure 49 above: Stone plaques to former slaughter house – source Pembroke Design Ltd

The former slaughterhouse was also modified in the C20th with stone block dated 1914 located on the gable. A window opening was modified to create the east doorway but both west and north doorways are later additions with steel lintels and brick heads. A small window to the eastern gable of the former slaughterhouse has been built up and there is a blank stone which may have been intended for scribing. Traces of window joinery remain behind the slaughter house boarding with iron bars within timber frame. The interior has been partially tiled and again is thought to hail from the early C20th. The roof structure has been altered with king post trusses cut and modern treated timbers and steel beams inserted.

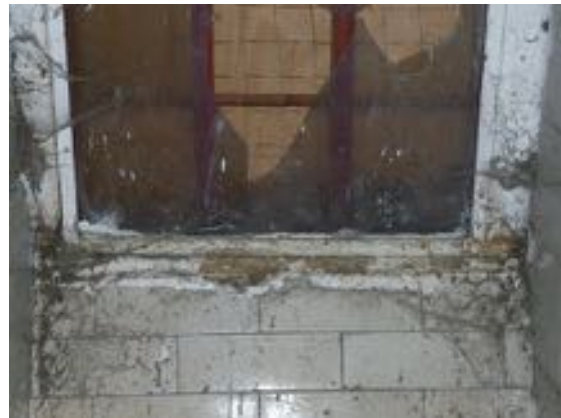
Figure 50 above: Window/tiling remains to former slaughterhouse – source Pembroke Design Ltd

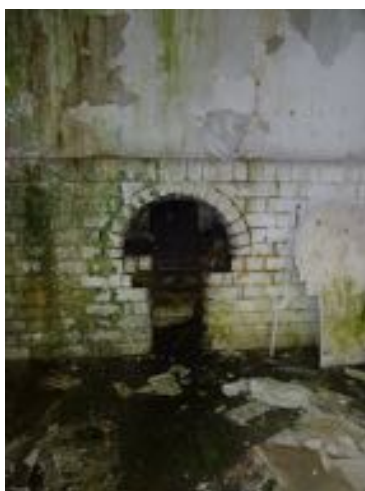
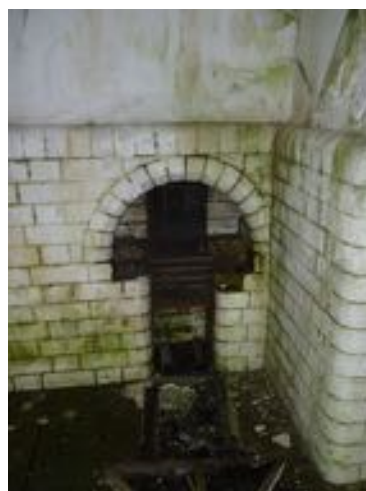
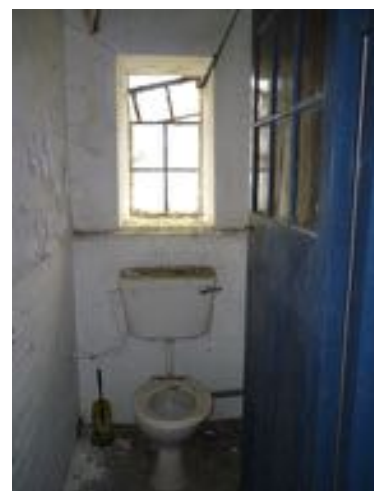
Figure 51 (left), Figure 52 (center) and Figure 53 (right) above: Market glazed bricks found in the central area of the north east wall only

Internally, all buildings have been altered and modernised. Early C20th glazed bricks exists to a couple of fireplaces within the market together with bullnose course within a couple of toilets. A few doors from this period but otherwise, only the basic fabric provides any early evidential information.

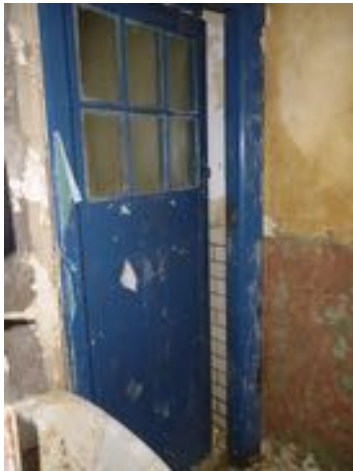
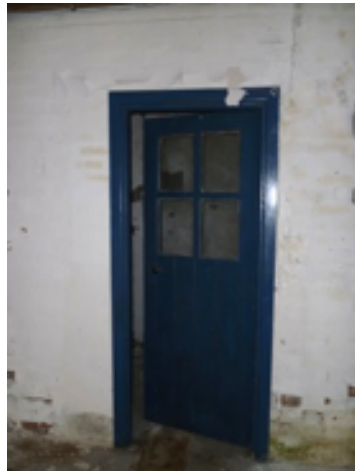
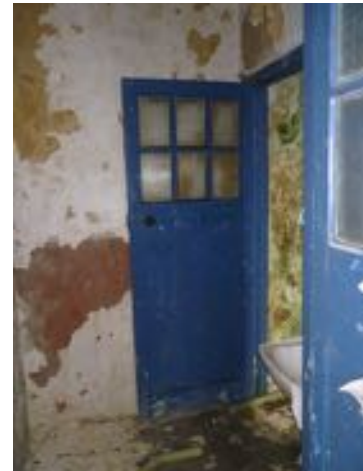
Figure 54 (left), Figure 55 (center) and Figure 56 (right) above: Market internal doors from 1920- 1950's

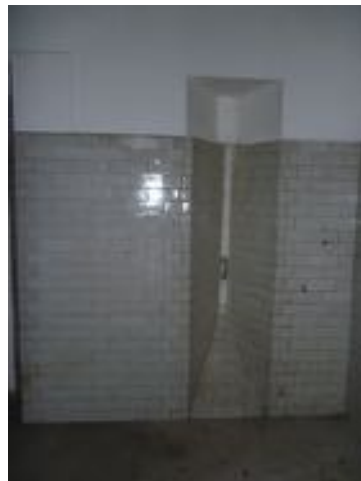
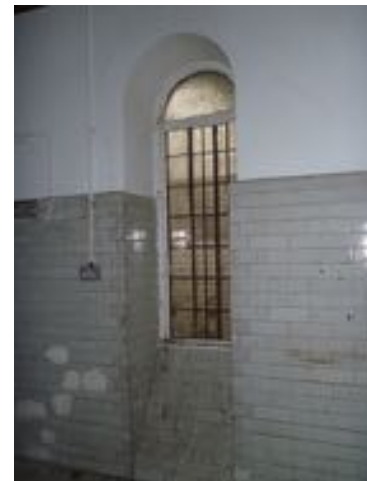
Figure 57 (left) and Figure 58 (right) opposite: Slaughter house tiling from the early C20th

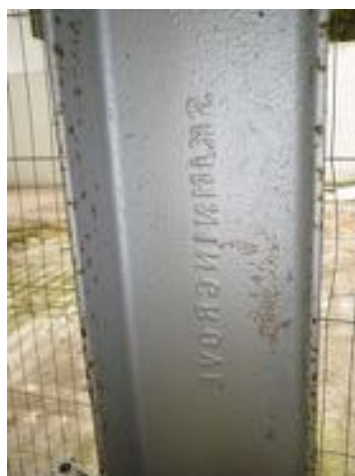
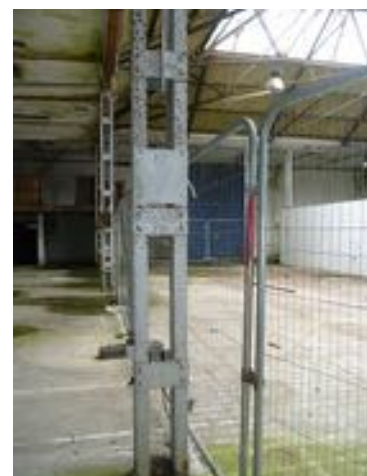
Steel columns supporting the marketglazed roof are fabricated in sections with the foundry mark of 'Skinningrove' and are likely to be pre-1950's. The same mark was found on other steelwork in the former slaughter house from a later date however. This steelworks was formed in 1880 in North Yorkshire initially producing pig iron then steel and specialised in long products. The flat roof has been punctured by various vents and flues with some openings built up and other lanterns appearing to be from different dates.

Figure 59 (left) and Figure 60 (right) opposite: columns supporting market roof

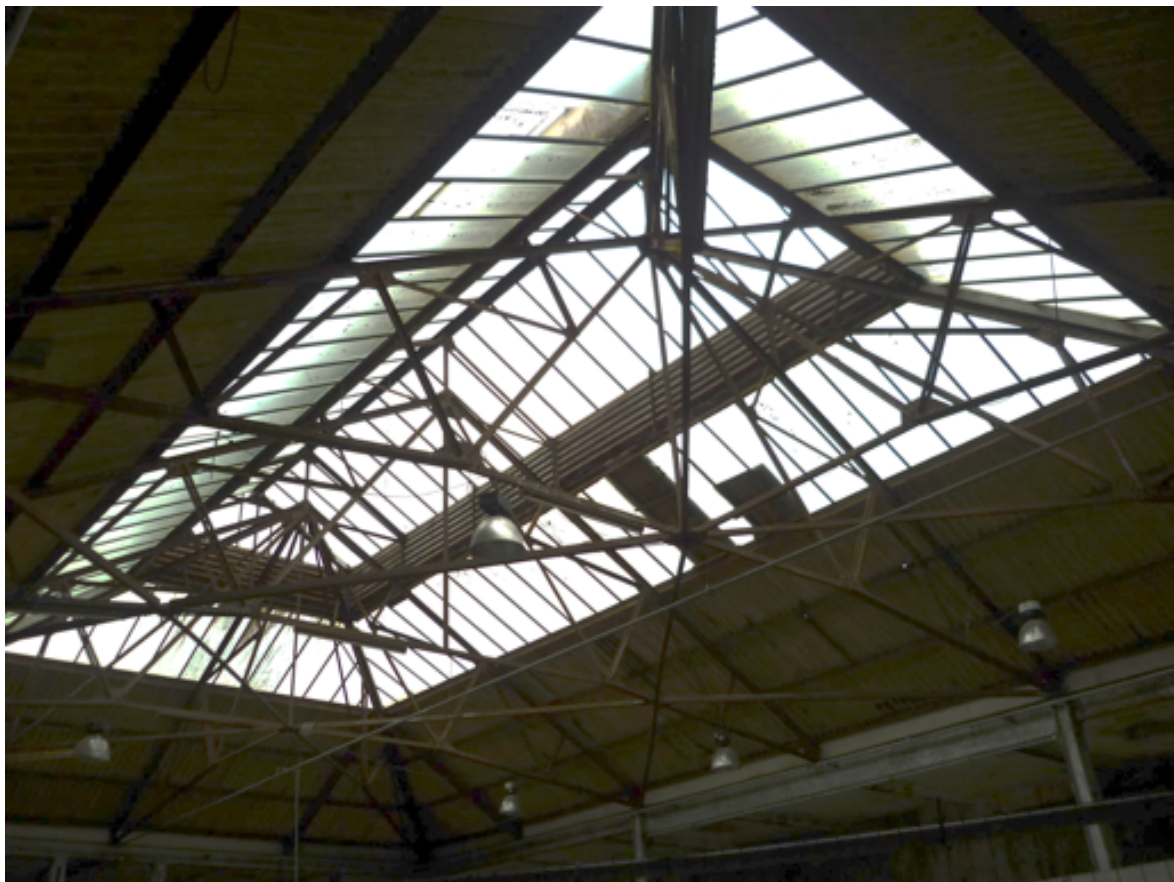
Figure 61 above: Glazed roof above market with early C20 steel trusses and uneven thickness glass panes

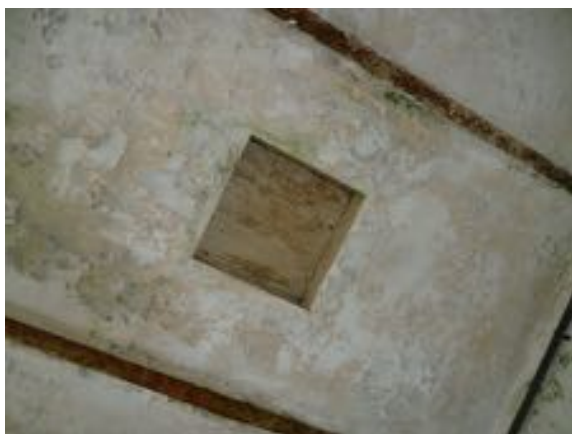
Figure 62 above: Boarded aperture to market flat roof

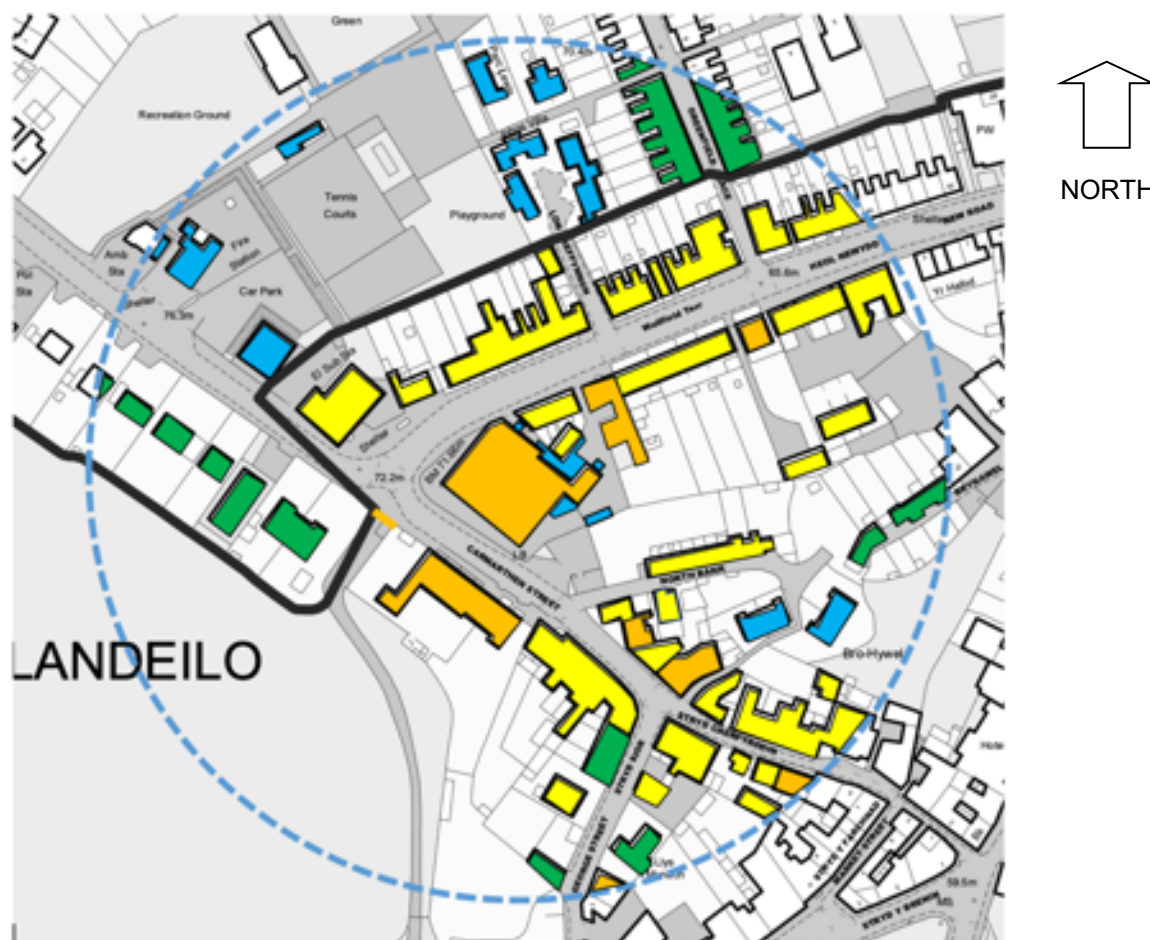
Figure 72 above: Significance of buildings within 150 meters of the market

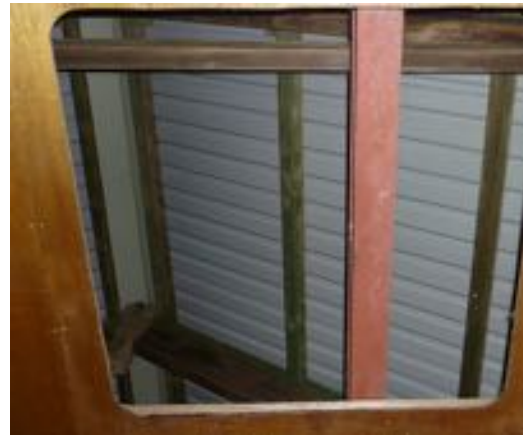
The corrugated metal roof is a later replacement and its prominence in the conservation area is particularly evident due to eye level position opposite the open space of car park. New steel beams and timber purlins have also been inserted but the C19th trusses remain. The top of the king post was notched for a ridge board with the roof most likely slated originally given the surrounding building finishes. Reinstatement of this traditional finish is therefore considered appropriate. The work complies with Cadw Conservation Principles in that it will enhance the setting without any further loss of historical detail with the current roof clearly a modern replacement.

Figure 74 above: View to underside of former slaughter house roof.

Although no old photographs of the former slaughter house have been found, the current corrugated metal roof is clearly a modern replacement with alterations to the roof structure. Given the singular use of slate in nearby roofs of similar period, we can be fairly confident that the former slaughter house roof was slated. The reinstatement of a slate finish will encourage the use of traditional building skills with more durability. It is also a more sympathetic material to the Conservation Area, particularly the visible prominence of the roof in the streetscape. The corrugated metal roof was raised above the C19th king post trusses on new purlins and therefore new purlins and rafters can be fitted slightly lower in their original position.

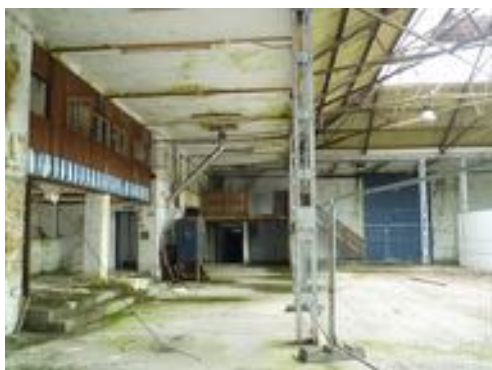
Figure 77 above: market upper ground floor interior looking towards south east corner.

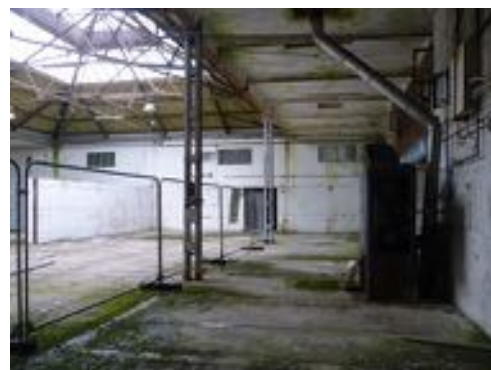
Figure 78 above: market upper ground floor interior looking towards north east corner

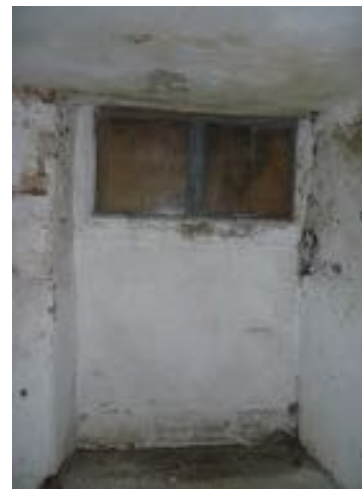
Figure 85 above: Window to be replaced in lieu of re-opening door – source Pembroke Design Ltd

Proposed door opening to market north east elevation at lower ground level omitted with new window fitted to original opening (12). Vision panel added to replacement door on market north east elevation at lower ground level (13)

Consented office accommodation on the lower ground floor level of the market is retained but the small kitchenette and toilet is relocated to allow for the new staircase in the southern end. There is no longer a need for an external door at the southern end of the north east elevation and therefore the existing window opening can be retained with widow replaced. Consented changing room spaces at the northern end of the market lower ground level are being changed to a plant room with no new partitions required so the single space reverts back to its current layout. Minor alterations are made to partitions around small kitchenette and toilet in the central area with vision panel added to the external door but the adjacent refuse area and new staircase remains as consented. No changes are proposed to store shed or former slaughter house which remain in office as use as consented. The vision panel is being inserted into a new replacement door with no further loss of original fabric. Whilst the vision panel improves connectivity between internal and external spaces it will only be local with other solid doors being retained to match original character.

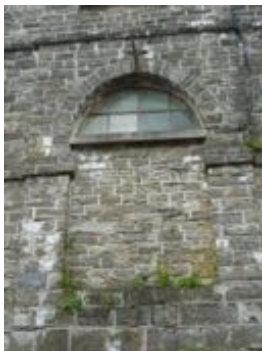
Figure 88 above: Blind opening far west end on north west elevation

Much discussion has taken place over the opening up of the blind recesses along the north west and south west elevations of the market. The building is very introverted and not particularly inviting or welcoming. The consented scheme did not propose such an alteration however as it was felt that this was not conducive to the market layout although a couple of openings to the café were consented. Offices require good natural light and ventilation however and opening up further openings would provide a practical use as well as make the building more attractive.

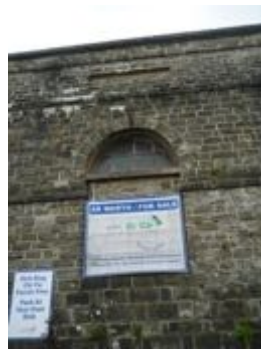
Figure 89 above: Blind opening west of central doorway on north west elevation

This work could be considered as a progression from the alterations already undertaken with small semicircular metal windows fitted in the C20th. Continued use of steel windows would therefore provide an honest to the historic fabric. The impact of the openings could be reversed later with the use of shutters or by building the openings back up again. The coursed stonework around these openings need not change so the original design is not otherwise affected. See elevations also on Figure 83, Figure 84, Figure 86, Figure 87, Figure 94, Figure 95, Figure 97 and Figure 98.

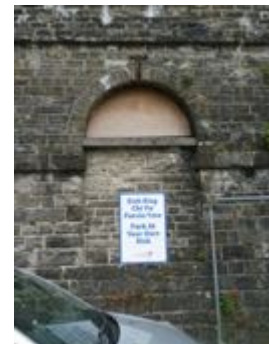
Figure 93 above: Blind opening far south end on south west elevation

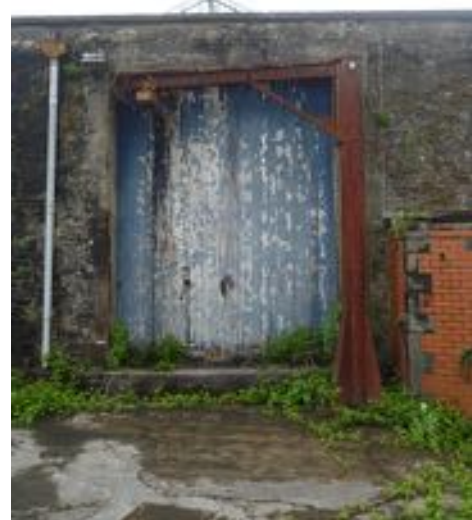
Figure 96 above: Solid door to be replaced with glazed door on market south east elevation with hoist retained

The proposed further subdivision of the main market space limits direct access to the central area and calls for a new entrance to create additional flexibility to allow this part of the building to be used independent of the offices. The large opening along the market south east elevation is probably a late C20th inserted for foundry use with external hoist located at the opening. Consented plans show the door to this opening being replaced like for like with a solid timber folding/sliding door but this does not particularly highlight it as another principle entrance. A glazed door would make it more attractive and create a visual connection for people approaching the building. It would also serve to make the interior space more welcoming with external aspect. The industrial feeling can be recreated by the use of glazing bars with horizontal emphasis and large glass panes. Retention of the external hoist and original proportions of the opening also helps minimise impact upon heritage values.

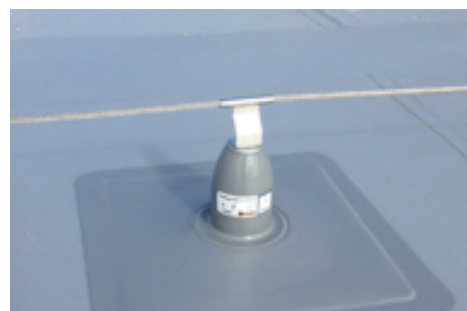
Figure 100 above: example of anchor point and cable within single ply roof finish

Cherry picker access is limited particularly due to neighbouring buildings, height and topography. The fitting of walkways and guard rails would be visible apparent with handrails 900mm above the roof and a roof and a fall arrest system is therefore being proposed as the least invasive solution. This will entail new anchor points incorporated in the new roof over the market hall connected with heavy duty cable. The anchors and cable will be located close to the roof surface and be in a similar colour to the roof covering. Fittings are also small scale and will also be set back from the edge of the roof to minimise visual impact. See Figure 104.

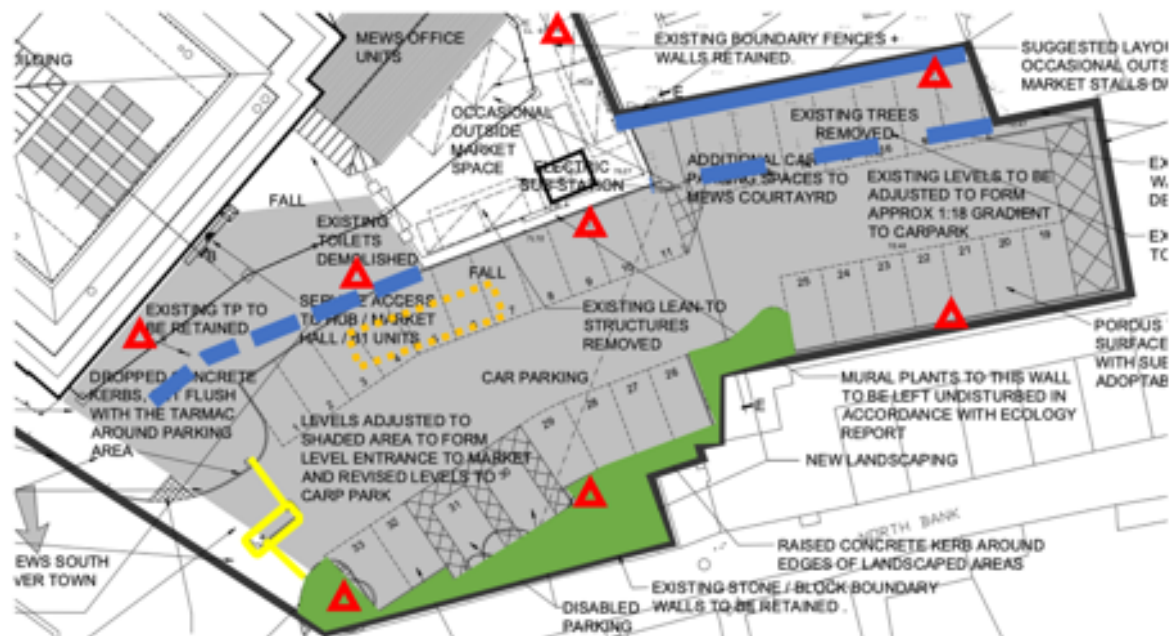
Figure 103 above: Car parking area – source Pembroke Design Ltd. New retaining wall with gateway indicated in solid blue line with walls for demolition dotted. New soft landscaping in green, below ground rainwater harvesting tank dotted in orange rectangle, external lighting in red triangles and vehicular control barrier in yellow with drop kerbs at entrance.

Modest lighting proposals will be introduced to highlight the entrances and parking areas using local fittings with a traditional lantern design mounted on 4m high independent poles. Although there is some street lighting along New Road and Carmarthen Street, the rear of the market building and car parking area in particular is dark. Visitor's and occupants therefore need some illumination for security and health and safety purposes given the building will be occupied outside daylight hours. The proposed lamps are based upon late Victorian design and will be more aesthetically pleasing within the setting of the listed building and conservation area. Any potential impact upon ecology has been reduced by selecting fittings with hood to control light distribution, reduced wattage and controls with night time sensors and timers. See Figure 103 and Figure 104.

development. Revised proposals therefore include the addition of vehicle control barriers to the car park entrance with reconfiguration of the car parking spaces and lowering of ground levels slightly to maximise manoeuvrability. To compensate for slight loss in the number of parking spaces, the car park will be extended in the north east corner. This will be achieved by breaking through a section of stone wall that divides the land from Salutation Inn. A new stone retaining wall will be built with timber fence above.
