A: Wall-top Capping - stone slabs

B: Wall Capping - mortar works (wall-tops and masonry tears)

1 Elevation 1.4.20 (West face)
214 1:50

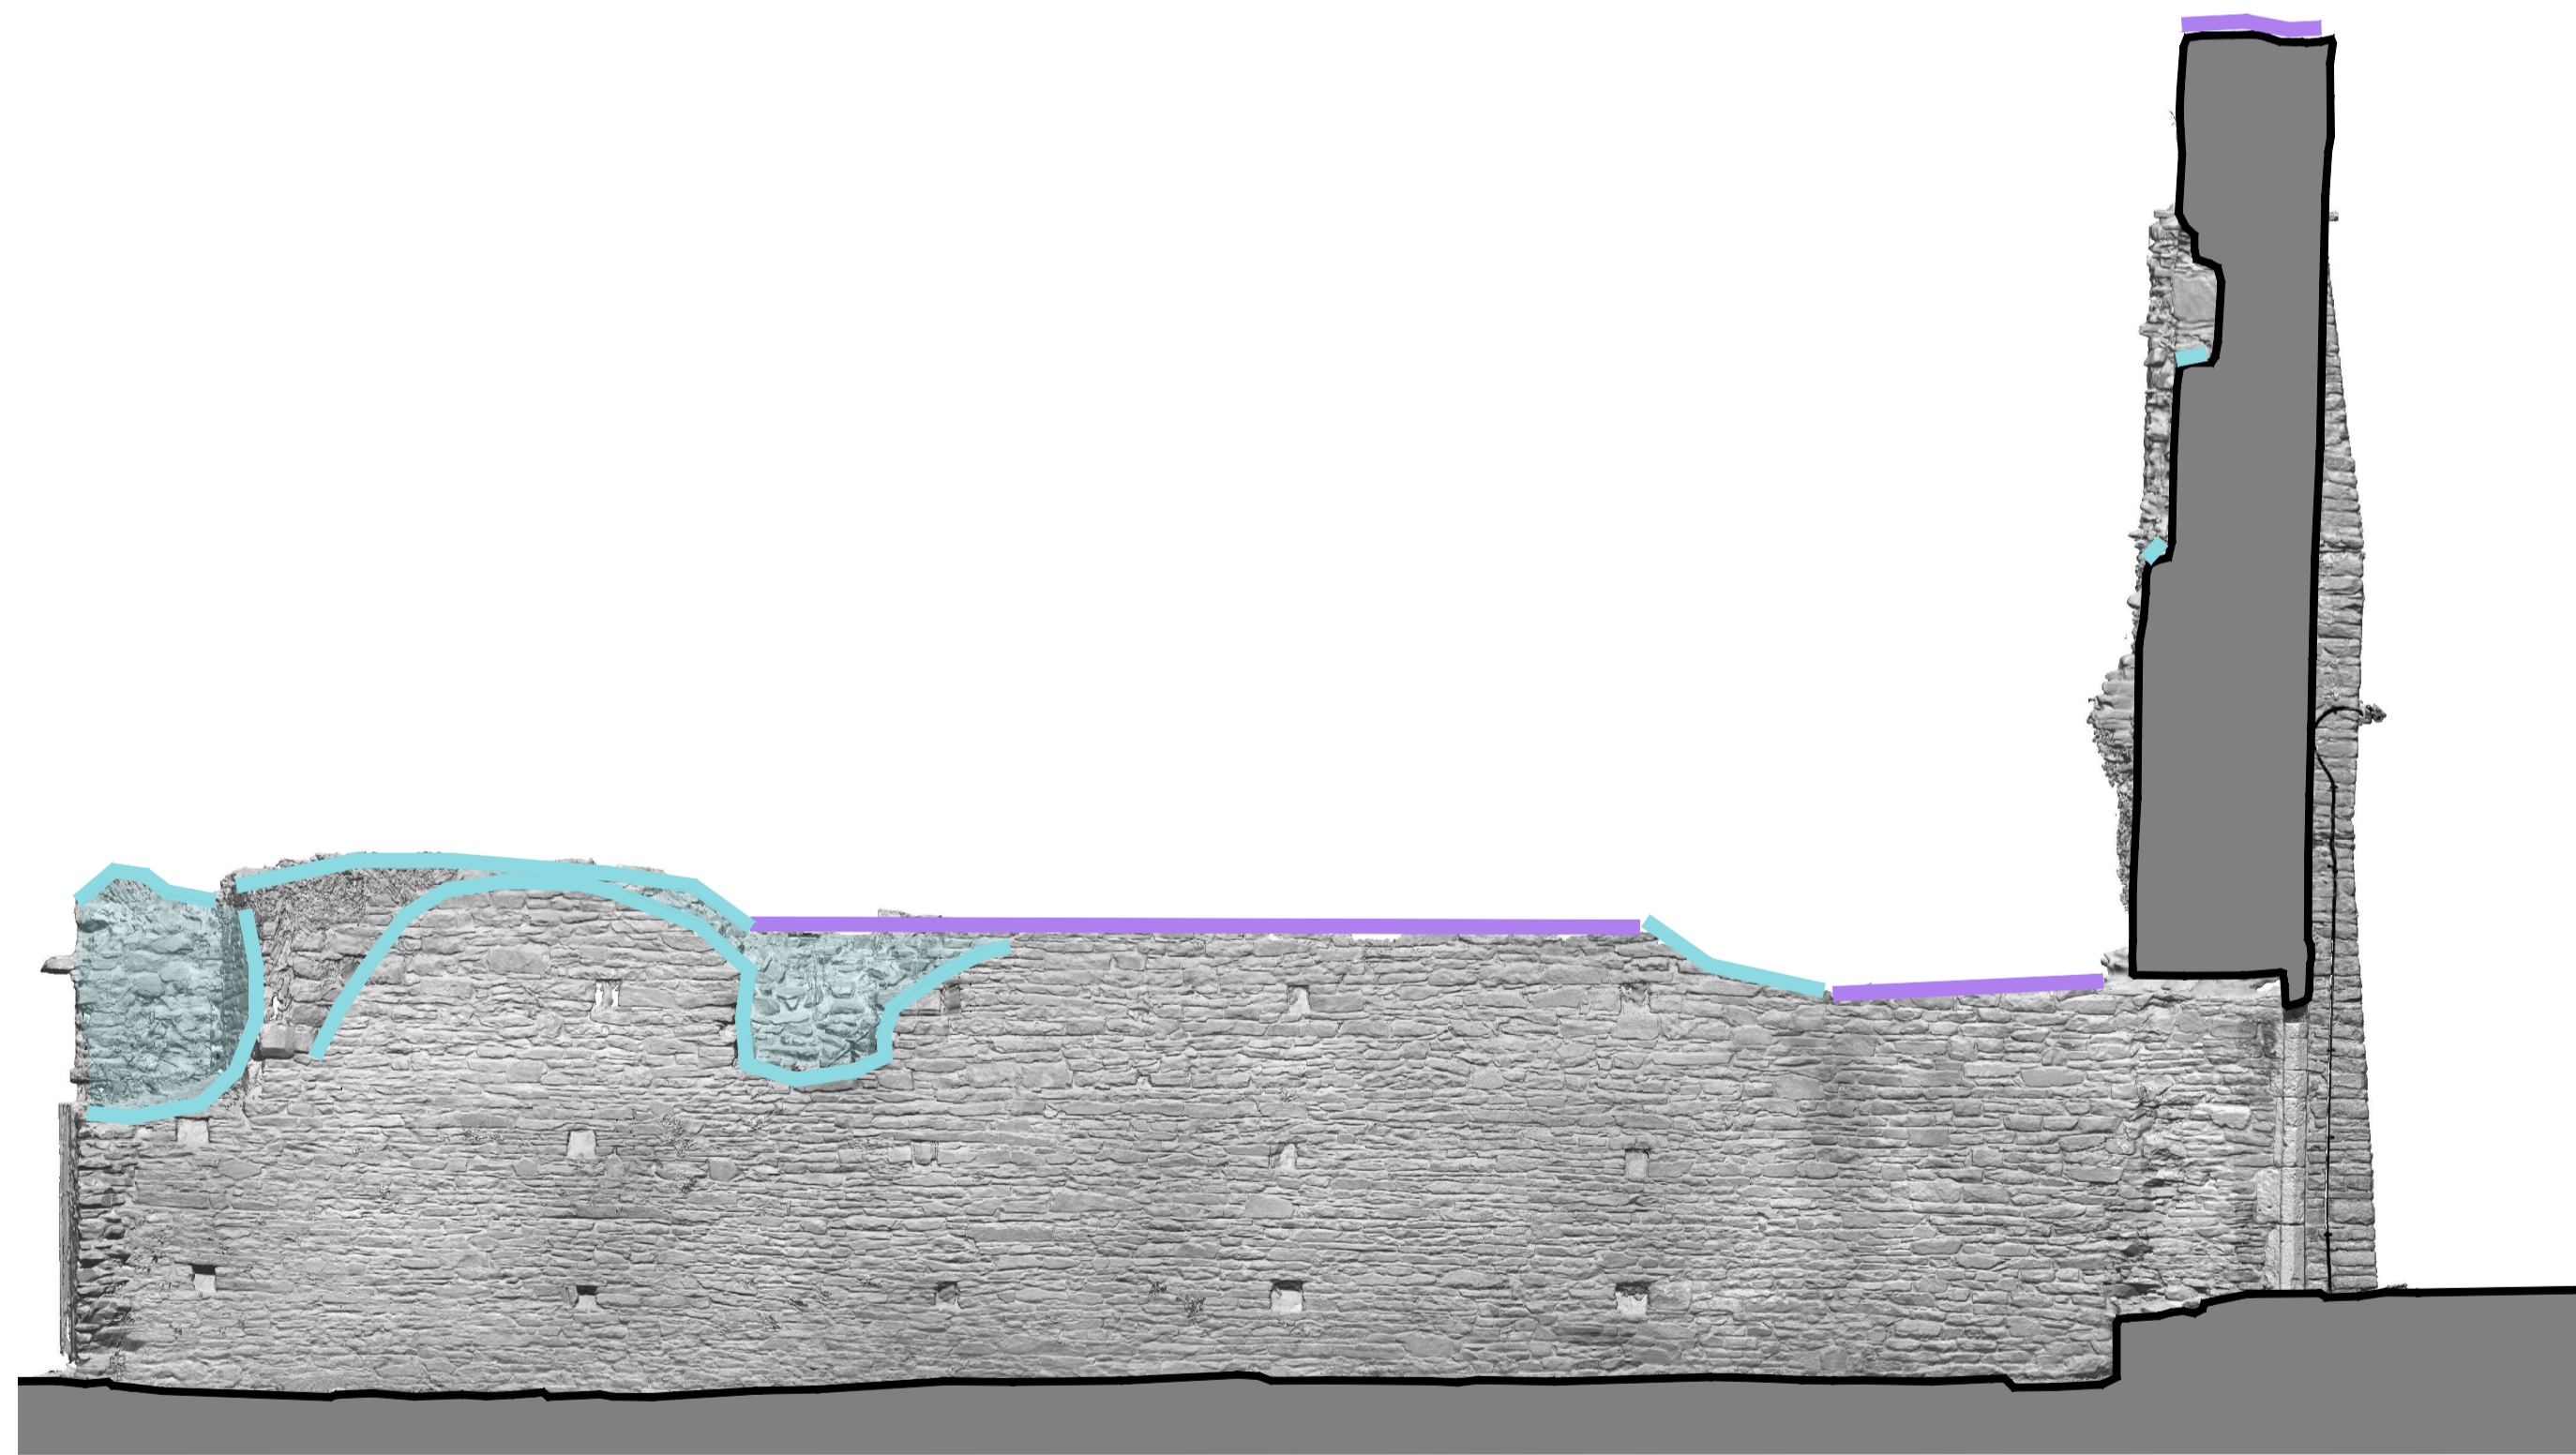
QUANTITY OF WORK - ELEVATION 1.4.20

- A: Wall capping - stone slabs = As indicated
- B: Wall capping - mortar works = As indicated
- Da: Repointing to random coursed pennant stone = 10%
- Db: Repointing to dressed ashlar stone = 100% ; Dowel pinning = Allow 5 dowels
- E: Removal of vegetation = As indicated

Elevation approximately measures 49m²

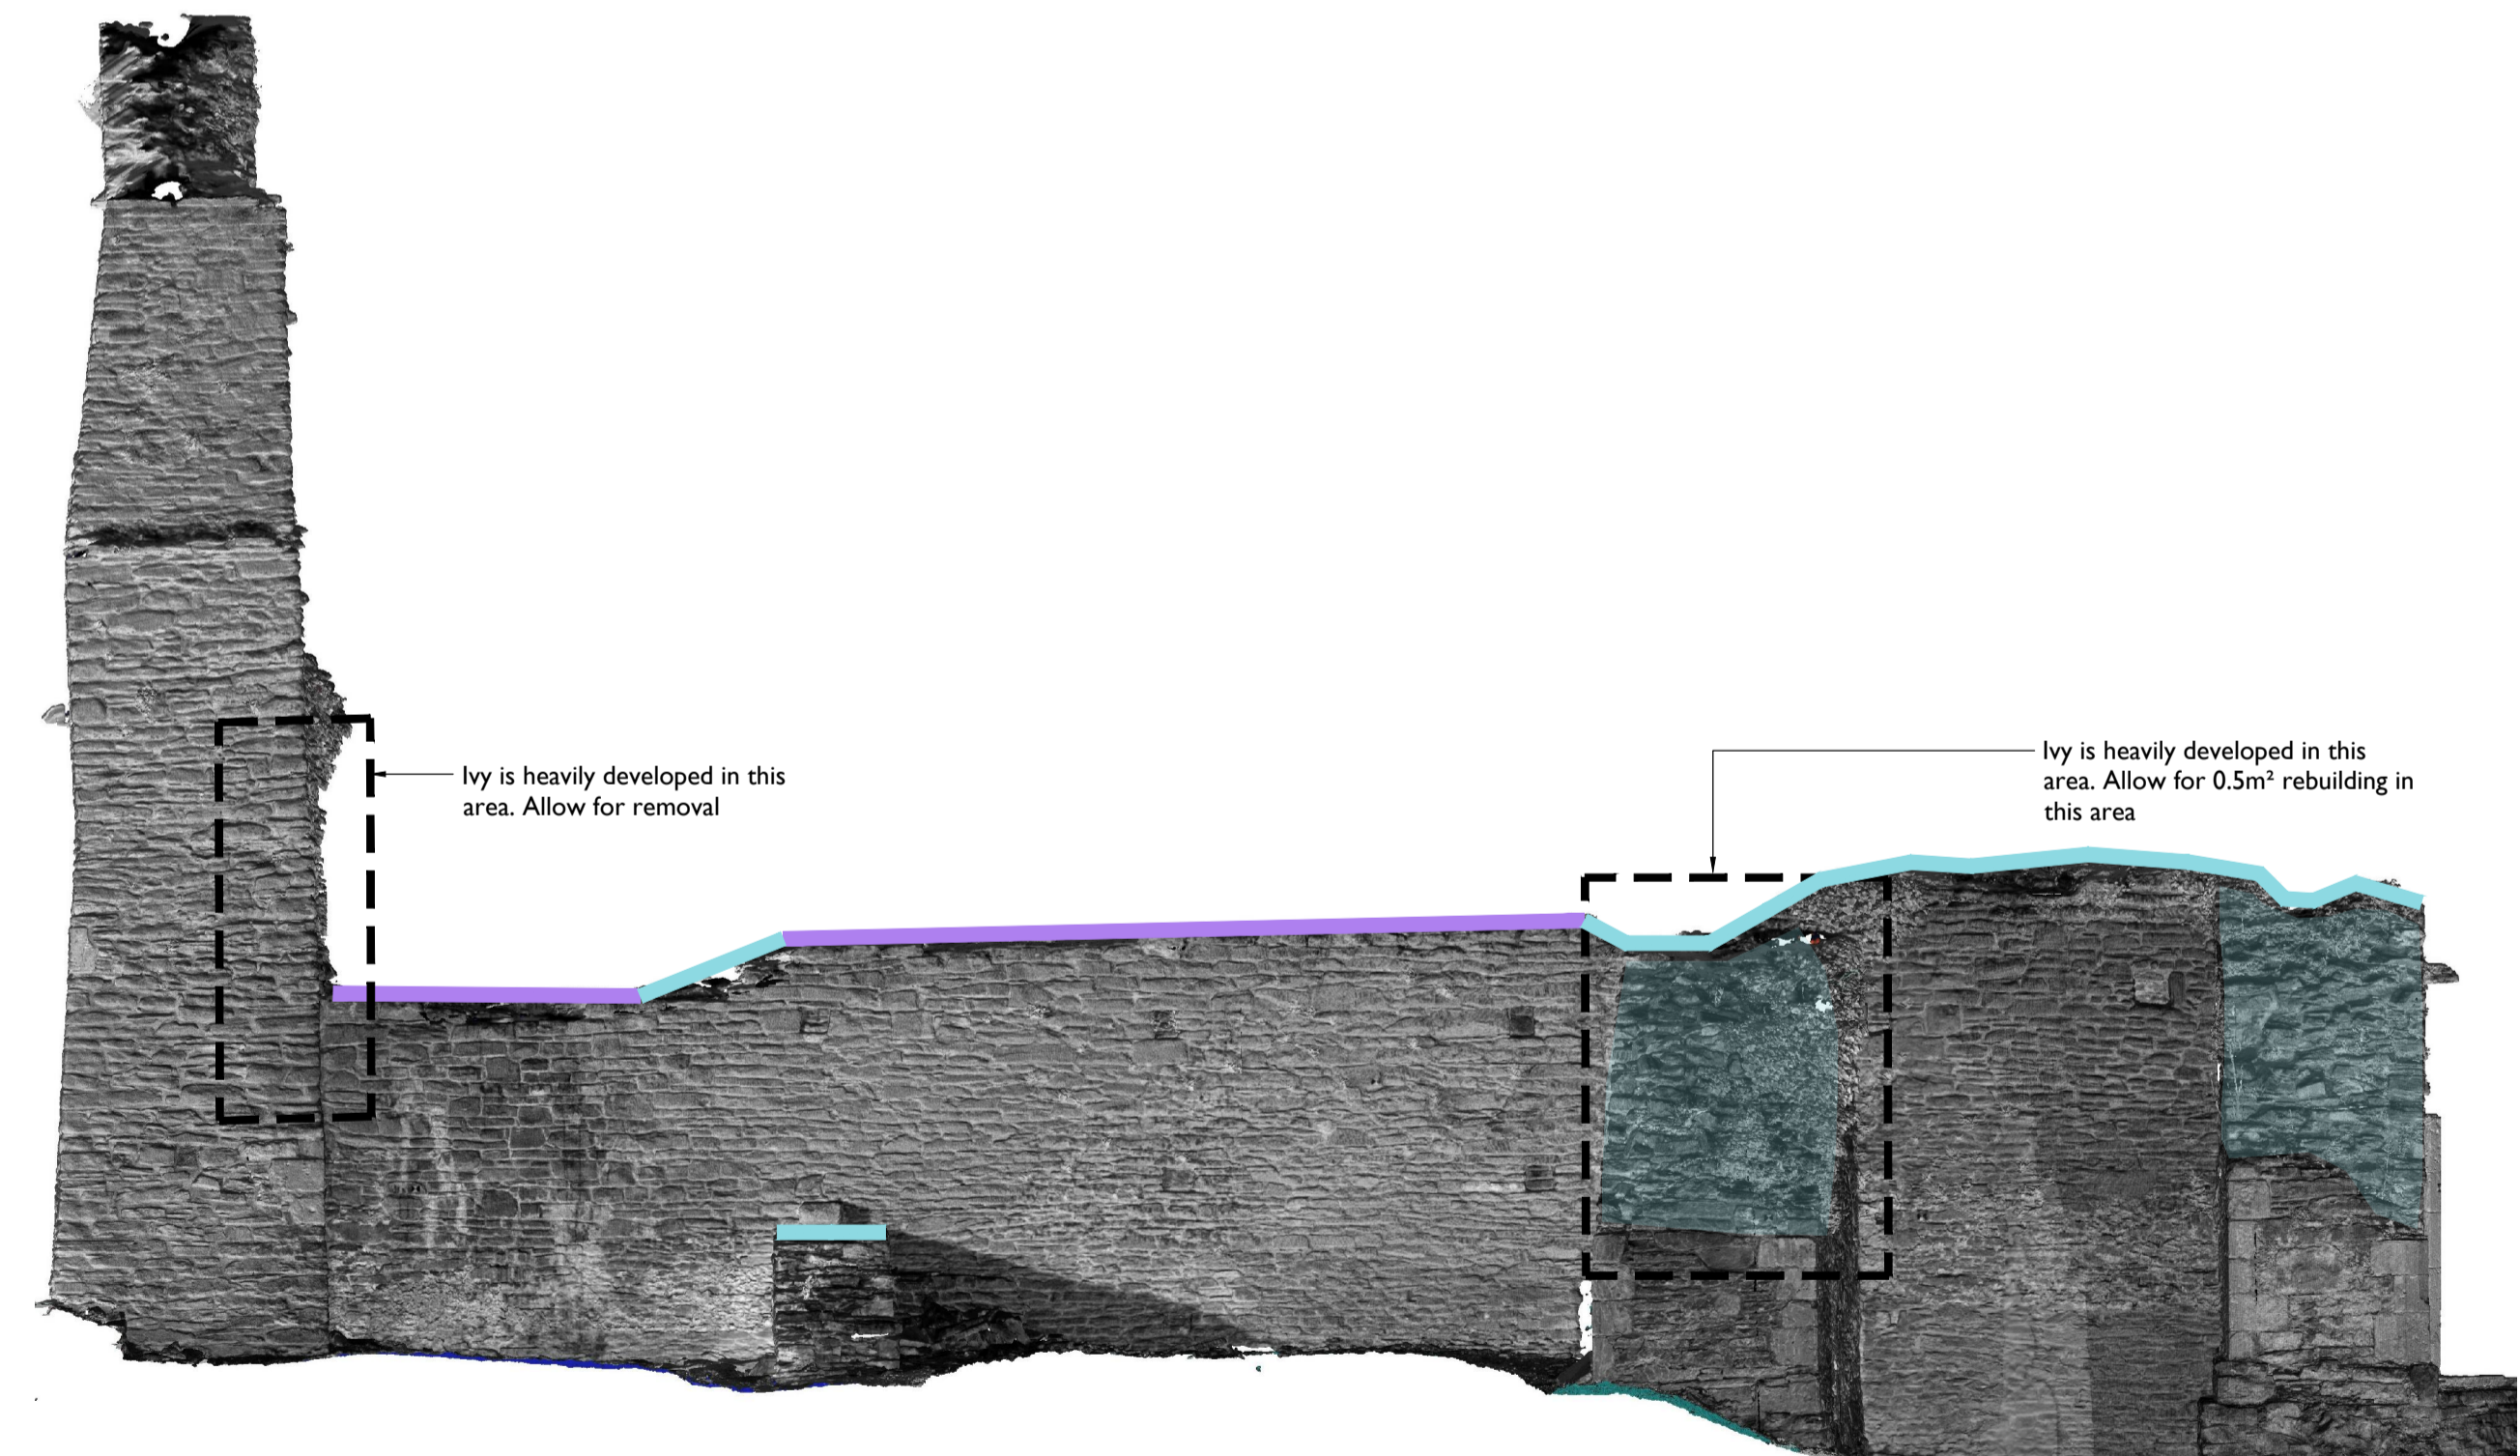
2 Elevation 1.1.4.2 (East face)
214 1:50

QUANTITY OF WORK - ELEVATION 1.1.4.2

Several loose rubble stones exist in this area on the ground, these are to be reused in any rebuilding works within this area
