# Park House, 20 Park Place Cardiff

Level 3 Historic Building Record

In November 2024 Richard Hayman was commissioned to undertake historic building recording of Park House, 20 Park Place, Cardiff. The building is listed grade I and has been described as the most important Victorian town house in Wales. A historic building record, equivalent to Historic England's Level 3, is required to inform a forthcoming Heritage Impact Assessment, which is to form part of a listed-building consent application for alterations the building. Level 3 is an analytical record that comprises a description followed by systematic account of the building's origins, development and use.

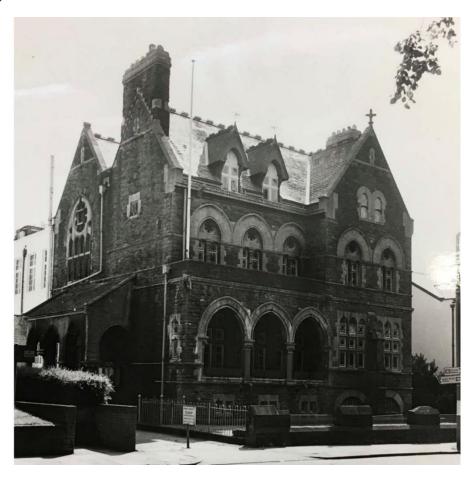
Figure 9. Mid-twentieth century photograph from Park Place, showing the added rear wing on the left.

From 1926 the building was occupied by Cardiff Rural District Council and the building was altered and extended to accommodate its office requirements. The plans drawn up by Ivor Jones and Percy Thomas, architects of Cardiff, in 1926 show how the building had been altered by the Vachell family, and how the building was adapted to its new use (Glamorgan Archives BC/S/1/24806). The building was extended by taking down the original service-stair projection and adding a L-shaped rear wing, set slightly back from the north front. A midcentury photograph shows this wing to have been of white-rendered concrete under a flat roof (fig 9).

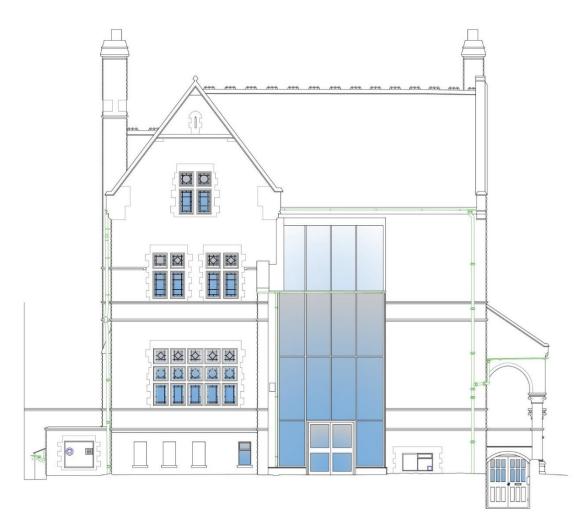
Figure 24. East elevation.

The east front was the rear of the house, facing the courtyard buildings. It is structured in a similar way to the front, with an advanced gable on the left side (fig 24). In the gabled bay are mullioned and transomed windows: a five-light double-transomed library window on the ground floor, two cross windows on the first floor and a single cross window in the attic. In the right-hand angle of this projection is the glazed lean-to in a thin metal frame, housing the 1990 escape stairs (fig 25). On its right-hand side is a basement window and further right are external steps leading to a basement doorway below the porch, boarded up at the time of survey but concealing a pair of half-glazed panel doors. The 1900 town plan shows basement steps leading to the original stair projection, but the extant steps appear to be integral with the original building. On the left hand side are four simple basement windows: three of them are toilet windows inserted in 1926 and are boarded over; the fourth, on the right-hand side, is first shown on the 1998 survey, replacing a doorway here that was inserted in 1926.

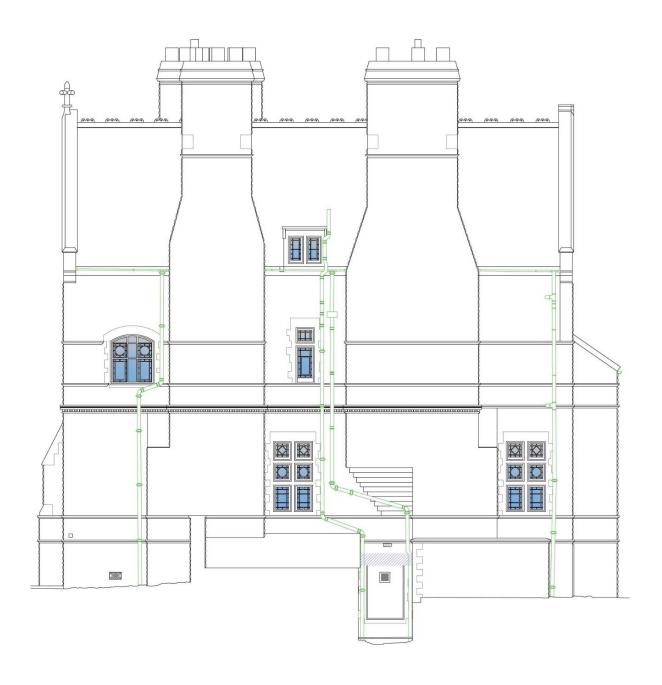
Figure 26. South elevation.

The south front faces the neighbouring number 19 Park Place and was always the least conspicuous side of the building. It is dominated by its two external stacks, and the fenestration is less regular than the other fronts (fig 26). On the ground floor are two square-headed double-transomed two-light windows – at the right hand end lighting the library, and left of centre lighting the dining room – both of them inserted in 1926 but respecting the original character of the building. The narrow first-floor window left of centre is the one included in the 1871 plan, while to the left side is a three light window under a segmental arch, also inserted in 1926, but it is not the mullioned window suggested on the 1926 plan (fig 11). Between the stacks is a small two-light attic window. At basement level there is a boiler house on the right-hand side, under a flat roof, and lean-to on the left

side, part of the kitchen. Both of these projections are shown on the 1900 Ordnance Survey map. Steps lead down to a doorway to the main range and to the boiler house.

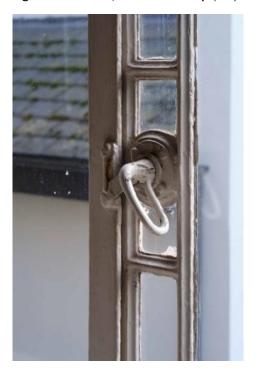
Figure 28. Iron handle to casement window.

The interior retains many of its original fittings. Original doors have been retained for the most part, which are panelled with broach-stopped chamfers (plainer stop-chamfers to the attic), in panelled reveals. Many retain simple triangular brass handles set in a round plate, but in places the handles are missing (fig 27). The casements mostly retain their iron handles (fig 28). Apart from the entrance/stair hall and drawing room there are floorboards in all of the rooms.

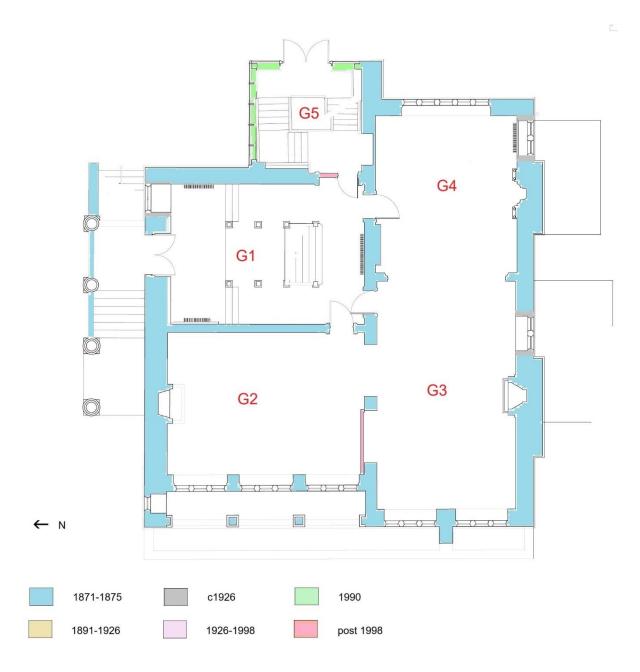
Figure 29. Ground floor plan.

The ground floor consists of the full-height entrance/stair hall, former drawing room, dining room and library, as first built (fig 29).

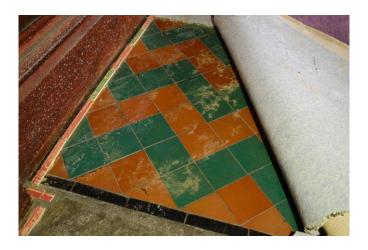
Figure 30. Tile floor beneath the stairs.

The entrance opens to the stair hall (GI) and faces directly to the underside of the stair. There is a tile floor made up of red and green tiles, forming a simple pattern where visible (the room was laid with carpet at the time of survey) (fig 30). The imperial stair is of teak (the list description says mahogany), with square castellated newels and intermediate posts, and turned balusters like ringed shafts (figs 31, 32). The three-bay Gothic window lights the half landing and is the dominant feature. The stair hall is spanned by a keeled wagon roof on a corbel table, with painted panels (fig 33).

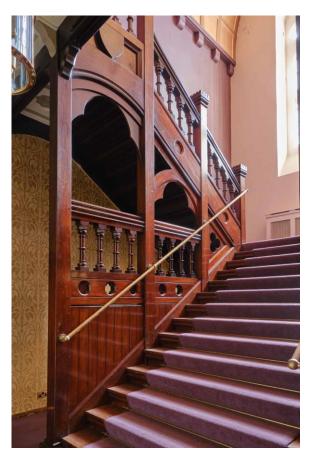
Figure 31. Main stair.

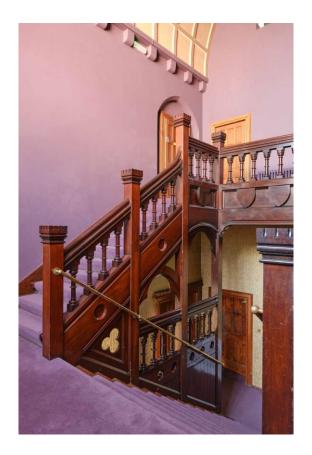
Figure 32. Main stair, viewed from the half landing.

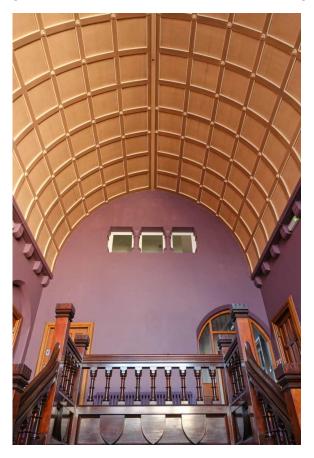
Figure 33. Roof of entrance/stair hall.

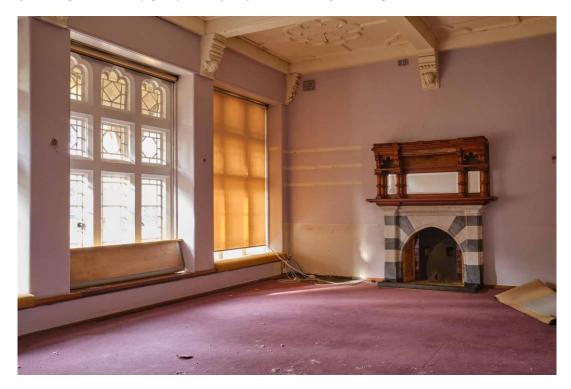
Figure 34. Drawing room.

The drawing room (G2) is the most richly decorated of the principal rooms (fig 34). It has a ceiling divided into six panels by heavy beams, with head corbels and, at the angles, foliage corbels, and panels with octfoil decoration (fig 35). The fireplace, of cast iron with decorative tiles, is set within a grand white and grey marble surround, with teak overmantel incorporating a mirror (fig 36). The parquet floor may be original.

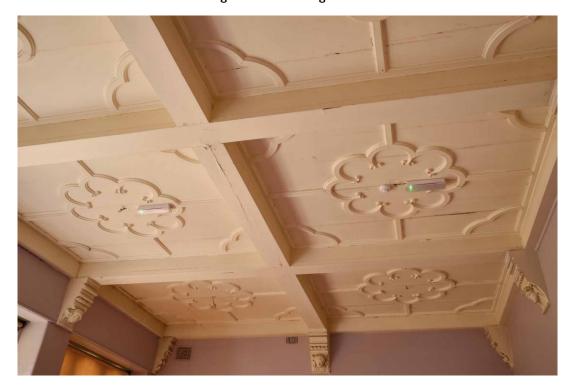
Figure 35. Drawing room ceiling.

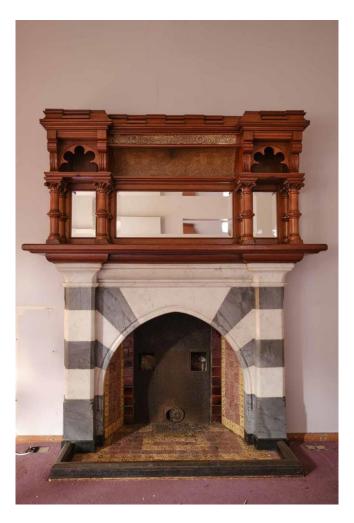
Figure 36. Drawing room fireplace.

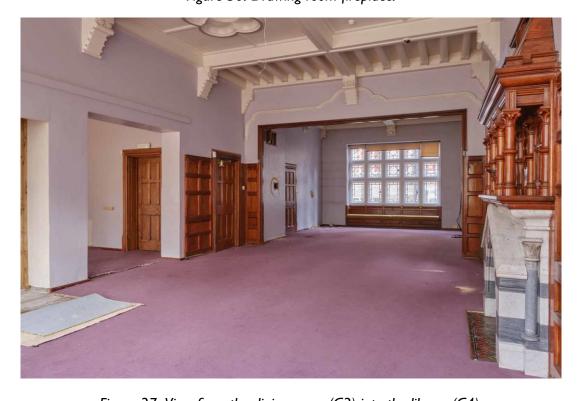
Figure 37. View from the dining room (G3) into the library (G4).

Originally there was no opening between the drawing room (G2) and dining room (G3), but the dividing wall has been opened up to give the impression of a single space. There is no longer a division between the dining room (G3) and library (G4): the wide opening between them was created in 1926 and had folding doors, which no longer survive following the proposal in 1998 to remove them (fig 37). The dining room has mahogany-panelled walls, extending round to the west wall, where there are window seats (figs 38, 39). These are simple panels with cusped decoration to the upper tier. The fireplace is similar to the drawing room fireplace. It has the same white and grey marble surround, teak overmantel with a small mirror, and fireplace of cast iron and decorative tiles laid in a chevron pattern (fig 40). The beamed ceiling is divided into eight bays. The central four have quatrefoil decoration, while in the outer bays are stylised round joists (fig 41).

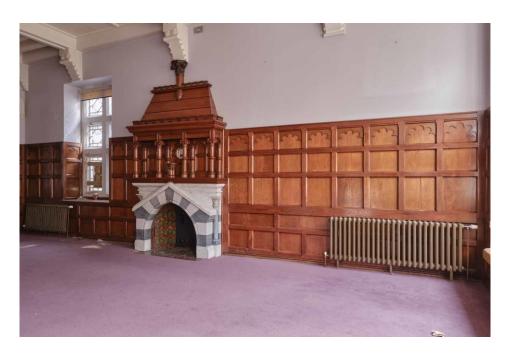
Figure 38. Dining room (G3), with mahogany wall panels.

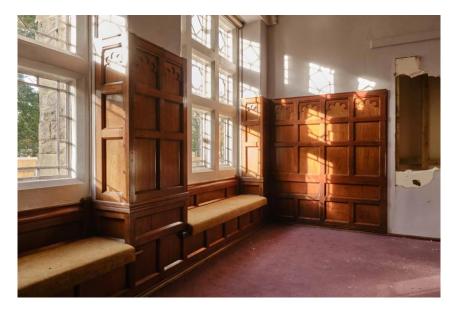
Figure 39. Window seats in the dining room (G3).

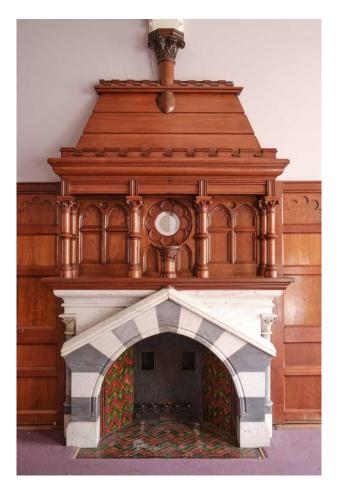
Figure 40. Dining room fireplace.

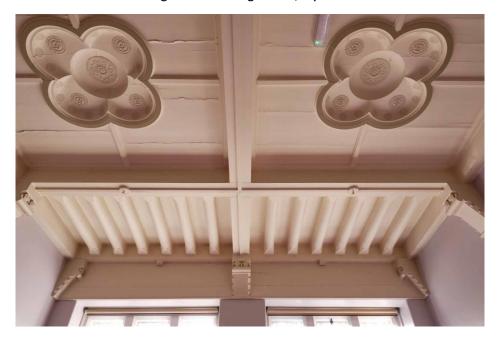
Figure 41. Dining room ceiling.

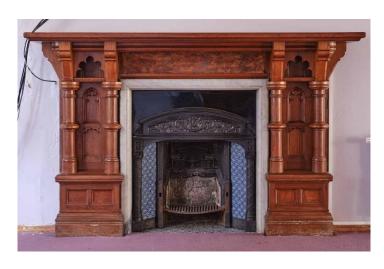
Figure 42. Library fireplace.

In the library (G4) is a fireplace in a mahogany surround, with ornate classical cast iron fireplace and decorative blue and white tiles (fig 42). The beamed ceiling is divided into six bays, with simple panelled decoration. In the east wall is a mahogany window seat.

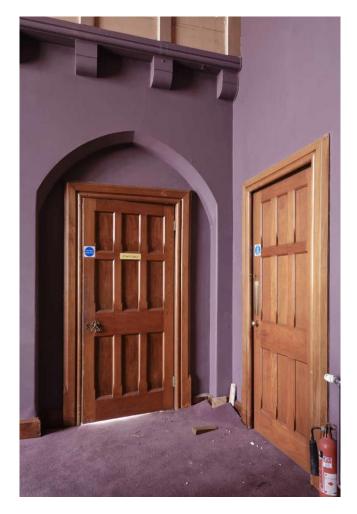
Figure 44. Doorways on the landing. The right-hand door was added in 1926.

The first floor consisted originally of three bedrooms and a dressing room between two of them (fig 3). It has been altered significantly since first built (fig 43). On the landing (1.7) the three doorways marked on the plan published in 1871 have been retained. There is an additional door, in a similar style to the original doors, inserted in 1926 for the Assistant Surveyor's office (fig 44). It is now a false door because it opens to the side of one of the attic stairs.

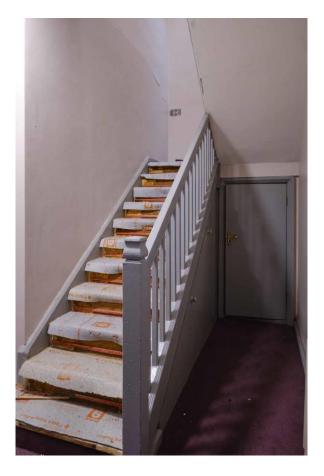
Figure 45. Dog-leg stair on first floor, inserted 1926.

The space on the east side of the dressing room has been divided up (1.4, 1.5, 1.6) since it was a single bedroom. The dog-leg stair was inserted in 1926 and incorporates simple details typical of the period — plain square newels and stick balusters (fig 37). The closed-string straight stair is not shown on the 1998 plan but was presumably added soon after. There are also inserted gents' toilets (1.5), all reached from a small lobby (1.4), the partitions for which have been inserted after 1998, perhaps contemporary with the straight stair.

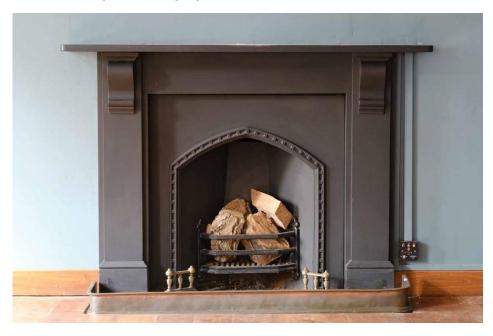
Figure 46. Fireplace, first floor (1.1).

A simple cast-iron fireplace survives in the former dressing room (1.3), set diagonally across the angle, as shown on the 1871 plan. The only other extant fireplace on the first floor is in 1.1, a cast-iron fireplace within a slate surround (fig 46). The first floor has a suspended ceiling, concealing the original ceiling.

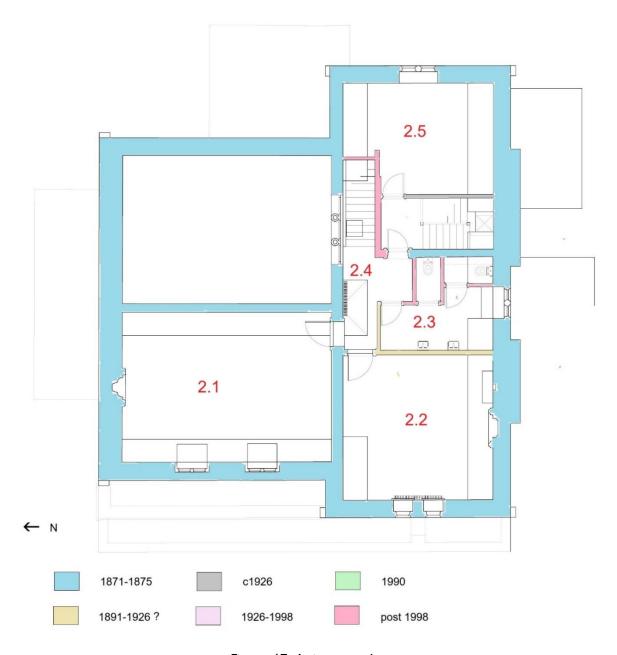
Figure 47. Attic room plan.

The attic rooms were presumably always intended for servants, except for the billiards room (2.1) (fig 47). There have been some changes to the original attic plan, such as the addition of the two attic stairs, already described. There are cast-iron fireplaces in slate surrounds in the two rooms on the west side (2.1, 2.2) (fig 48). On the east side is a ladies' toilet (2.3), which was a ladies' toilet and store in 1926, but perhaps housed the original toilets on the attic floor mentioned in 1889; then landing (2.4), which is post-1998 in its present form; and an unheated room (2.5) at the east end, again modern in its present form but erstwhile a larger heated bedroom and caretaker's kitchen. In this room, raising of the floorboards has revealed a composite steel beam supporting the attic floor, presumably the result of a later intervention (fig 49). The roof trusses were not visible.

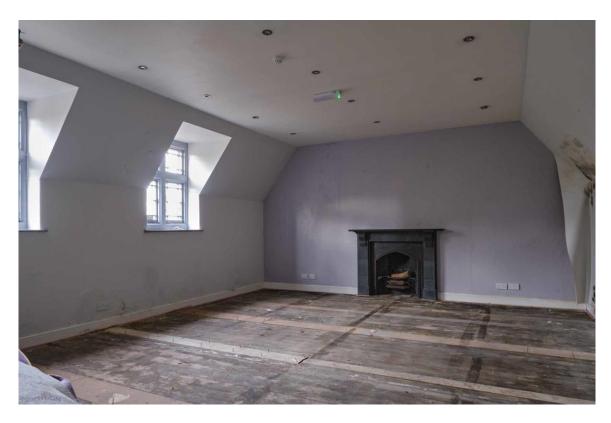
Figure 48. Attic, room 2.1, former billiards room.

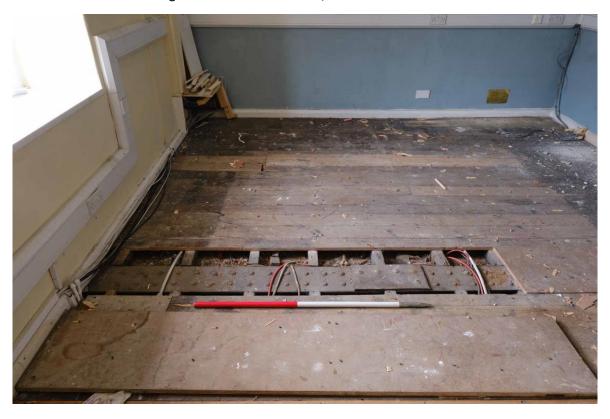
Figure 49. Composite beam in room 2.5.

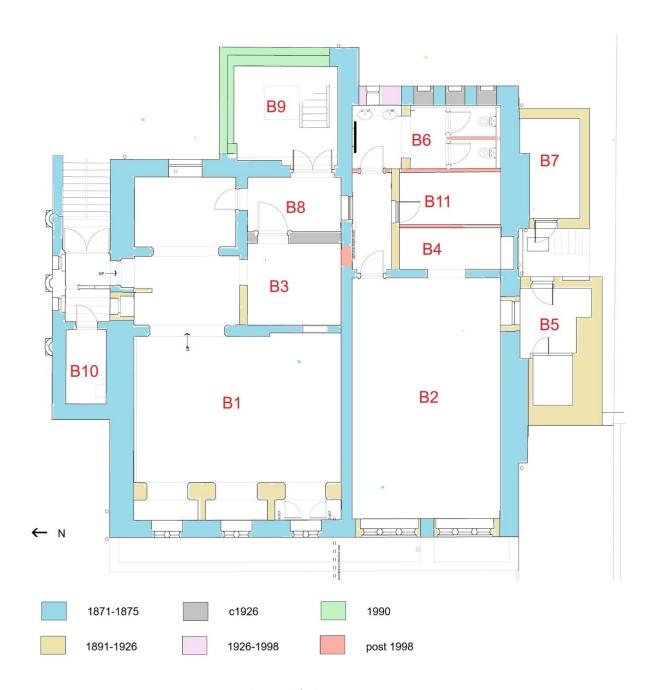
Figure 50. Basement plan.

The basement is reached from the modern escape stairs (B9, replacing the original stairs), and by external steps that lead to a doorway beneath the porch (fig 50). It consists of two principal rooms (B1, B2). On the north side B1 has been created post-1998 by removing original partitions to the butler's pantry, following removal of earlier partitions to the breakfast room and larder, and the corridor inserted by the Vachells before 1926. On the west side it has a three-bay arcade supporting the main west wall where the ground-floor loggia projects outwards (fig 51). This insertion also belongs to the Vachell period of ownership. The room on the south side (B2) is shown as early as 1889 and contains a modern kitchen, with associated white-tiled pantry and cold store (B4, B5), both post-1998 in their present form, and access to the boiler room (B7). There is also a toilet (B6), but occupying half the space of the toilet inserted in 1926, in order to create a small store room

(BII). Most of these rooms have no historic features and some were not accessible – the boiler room (B7) and former wood store (B10).
