# PANT-GLAS (Stable B), YSBYTY IFAN, CONWY

## Architectural Record

### Architectural Record

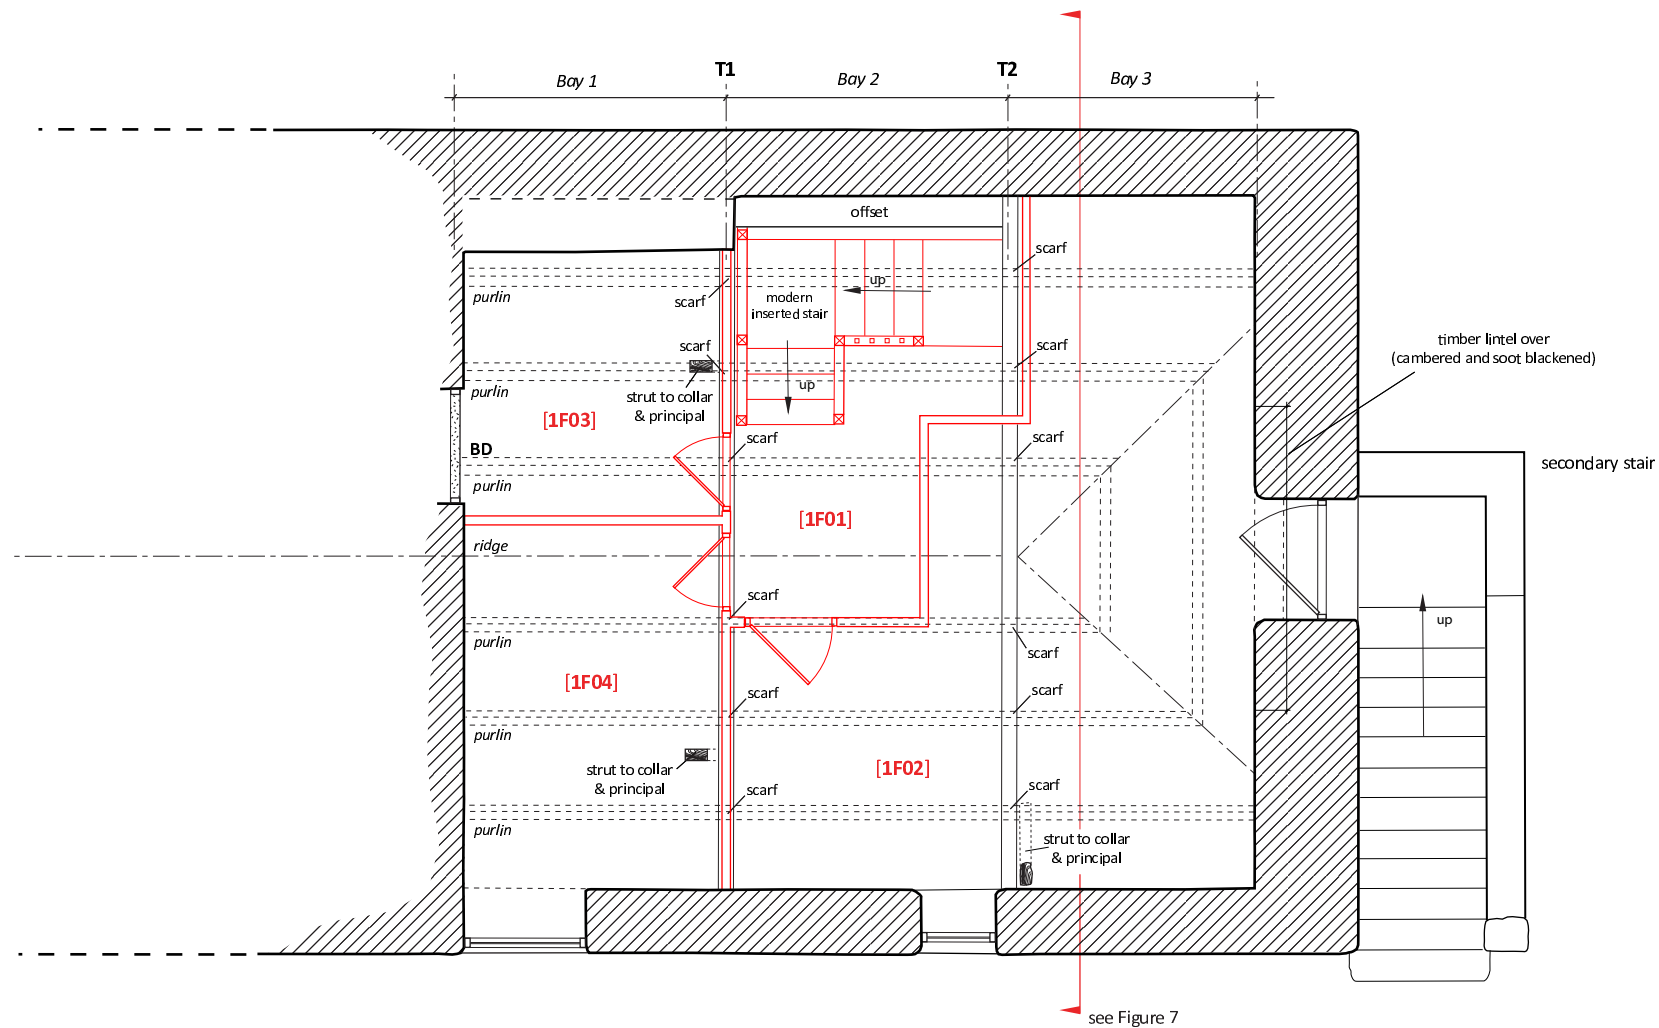
**Pant-Glas (Stable B), Ysbyty Ifan, Conwy**  
**Figure 6: First floor plan (as existing)**

#### *First Floor (Figures 6)*

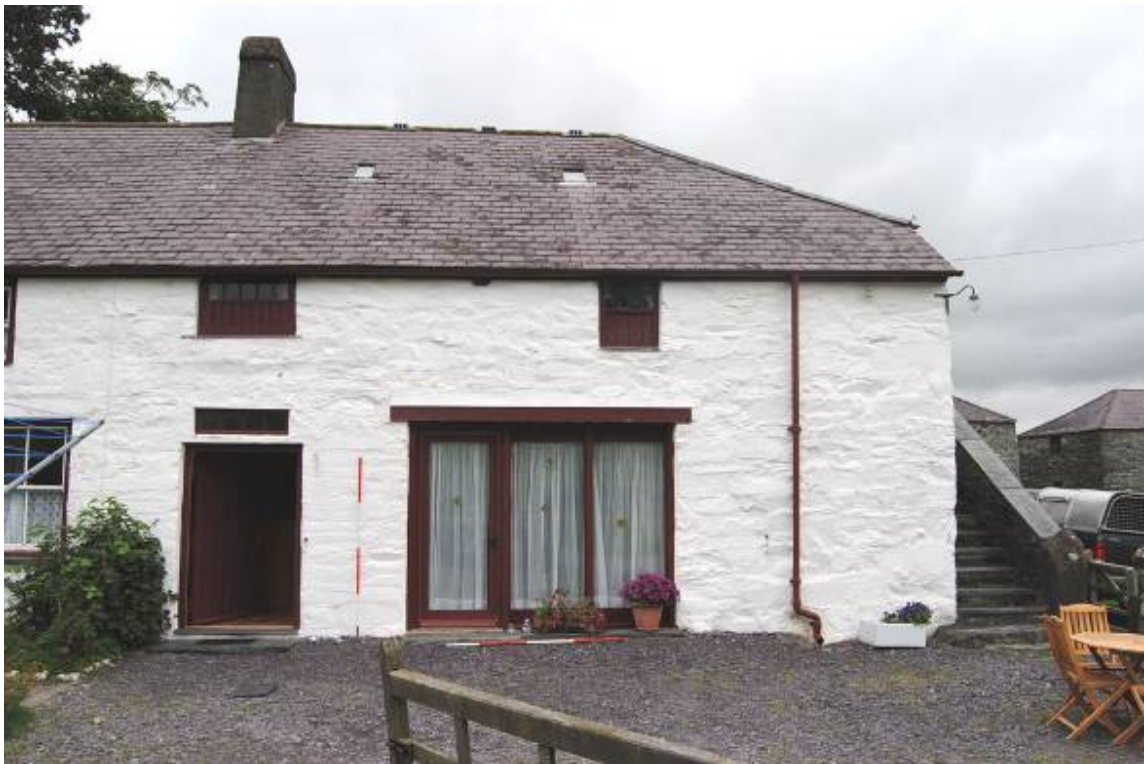
**Plate 2:** Stable B; south elevation.

- 4.2.1 The principal **south elevation** (Plate 2) is stone-built, whitewashed, rising through 1½ storeys to a pitched, slate-clad roof, half-hipped to the east; a ridge stack rises immediately west of the stable block section. The roof includes two small, glazed skylights. At ground floor level, two doorways open to the interior. The first, a wide pedestrian door of vertical planks, opens at the west with a shallow four-pane fixed light over, slightly narrower than the doorway opening. To the east, a large (?) carriage doorway opening has been converted to house modern, full length 'French' windows (installed in 2000/1, to replace former timber double-doors). The low upper floor is lit by two windows; that to the east is of eight (4 x 2) fixed-panes over a lower, bottom hinged hopper, that to the west (located directly above the western door) is shorter and wider, with ten fixed-panes (5 x 2) over a vertical slatted vent; both are set hard beneath the eaves.

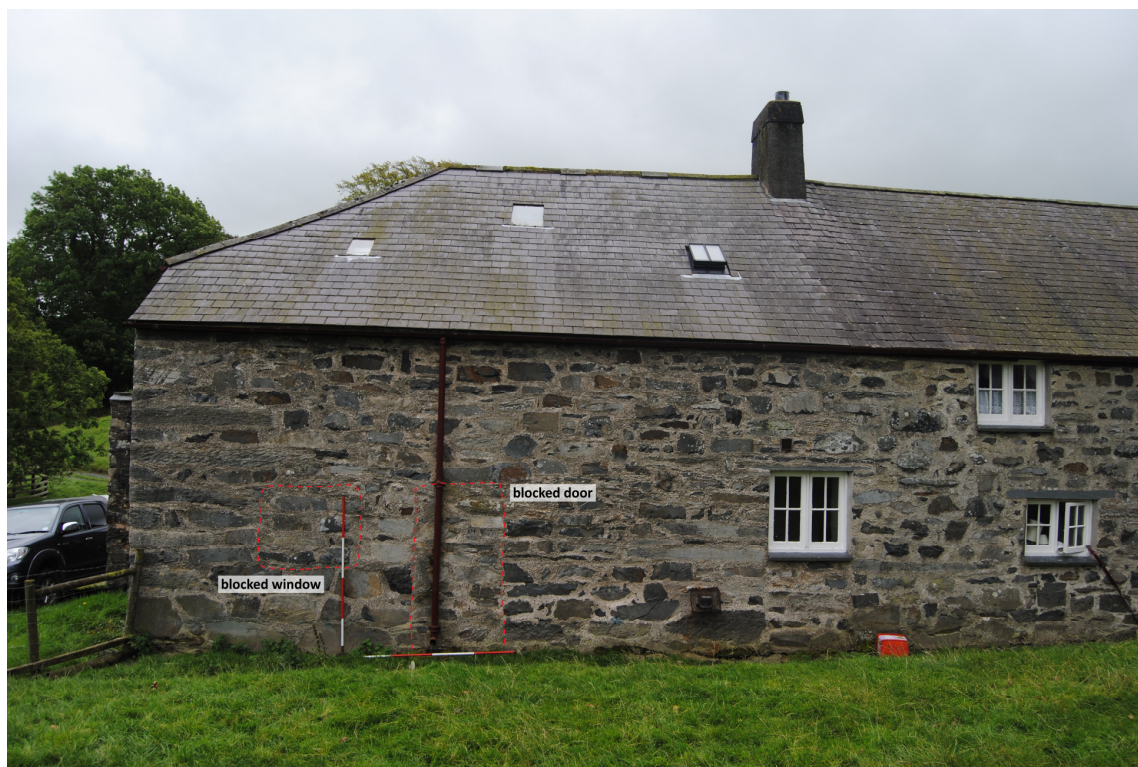
**Plate 3:** Stable B; north elevation

- 4.2.2 The **north elevation** (Plate 3) is stone-built of exposed, un-coarsed rubble masonry, including a number of large blocks, particularly at the north-east angle, up to 1½ m (5ft) in length. The elevation rises through 1½ storeys to a pitched, slate-clad roof, half-hipped to the east with a ridge stack rising to the west. The roof includes three small, glazed skylights. Ground floor level includes a clear blocked doorway (Plate 4) approximately central to the stable block with a blocked window opening to the east.<sup>5</sup> To the far west, just beyond the interior extent of the stables, a former doorway has been partly blocked and a two-light timber casement inserted (Plate 5), lighting the 'dairy' internally (see §.4.3.1, fn.6).

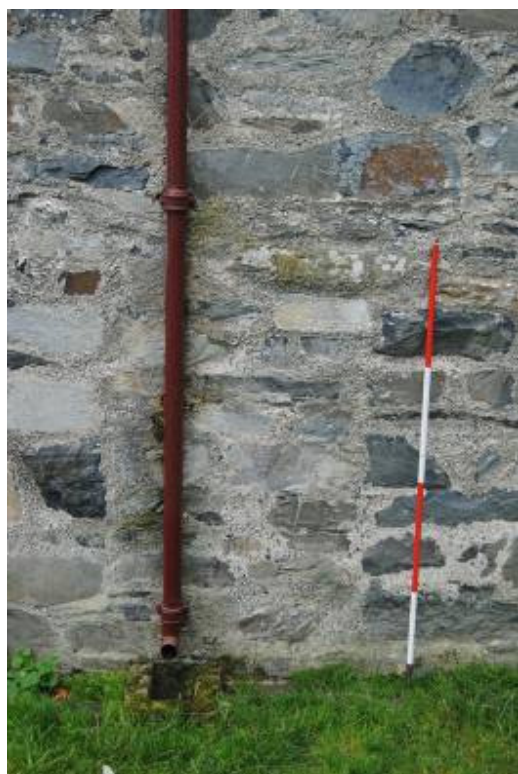
**Plate 4:** North elevation; blocked door.

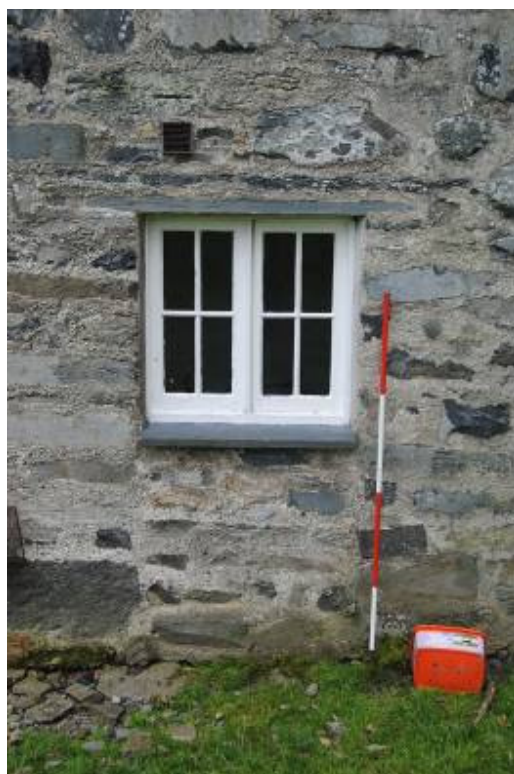
**Plate 5:** North elevation; door converted to window.

<sup>6</sup> This space would also have originally have been accessed from the exterior by the partially blocked doorway in the north wall (see §.4.2.2; Plate 5). Hughes (1983) gives its function as the dairy.

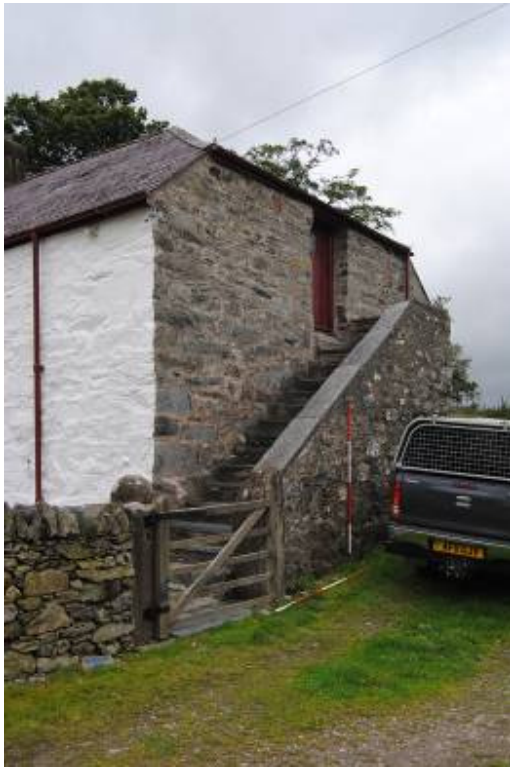
Plate 6: Stable B; east elevation, oblique.

- 4.2.3 The **east elevation** (Plate 6) is again of exposed stone rubble construction, rising through 1½ storeys to half-hipped, slate-clad roof. A central doorway at first floor level, with flat head hard beneath the plate, is accessed via a stone built stair (secondary), rising from south to north against the elevation, with a slate-topped parapet wall.

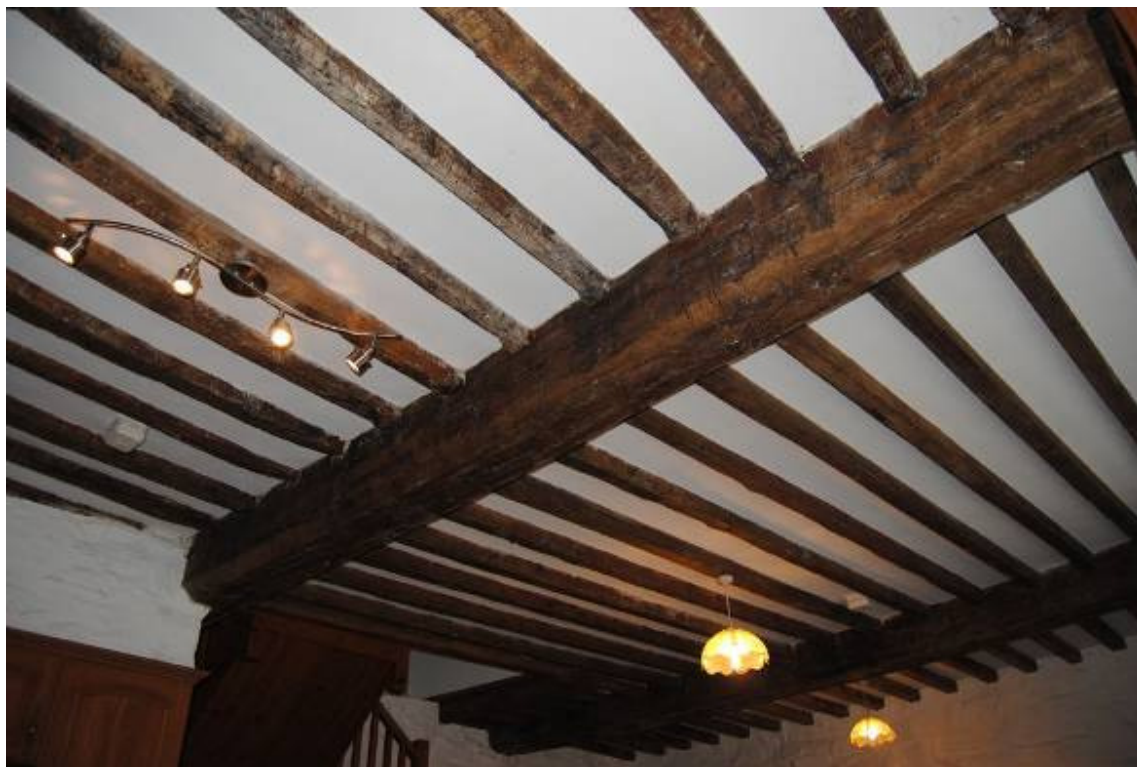
Plate 8: Room [GF01], ceiling structure (beams B and C).

- 4.3.2 Room [**GF01**] is spanned by three substantial (1ft square), plain-chamfered transverse beams (**A-C** from west to east; Plate 8); beams **B** and **C** are stopped with plain run-outs to the south though not to the north, while beam **A**, which rests to the south on the timber lintel over the pedestrian doorway, is unstopped. The carpentry of the ceiling to either side of beam **A** is of superior quality, with plain-chamfered and stopped common joists (3 x 4 in @ 13 in centres.), while those east of beam **B**, while following the spacing of the western joists, are plain and probably renewed; those in the easternmost bay are new. The soffit of beam **A** displays a longitudinal groove, offset to the west side of the timber (Plate 9) indicating, together with a regular series of peg holes (x 7 total @ 20 in. centres) within the west face, a former partition; the location of a wall in this location, offset only 1ft from the stone-built west wall, is problematic and suggests either that the beam and related joists have been re-set or, more likely, that the western wall of [**GF01**] represents a secondary insertion.<sup>7</sup> Murphy (1983) argues that the area to the west of beam **B** may formerly have

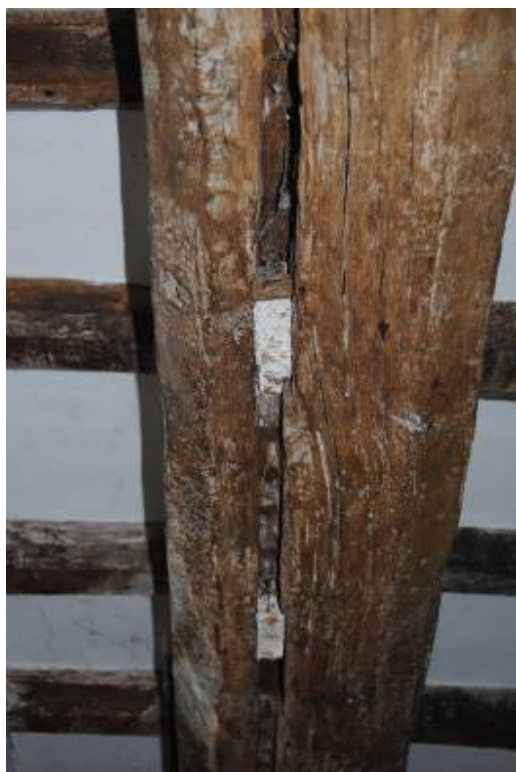
Plate 9: Groove to soffit of beam A.

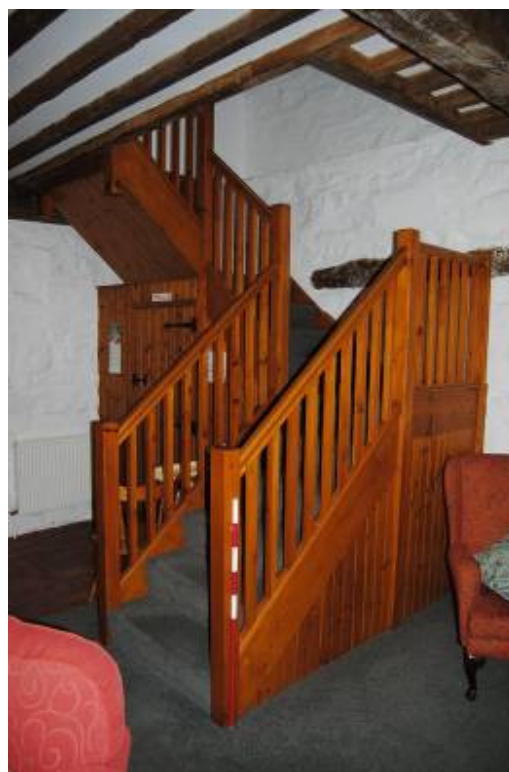
Plate 10: Modern inserted stair.

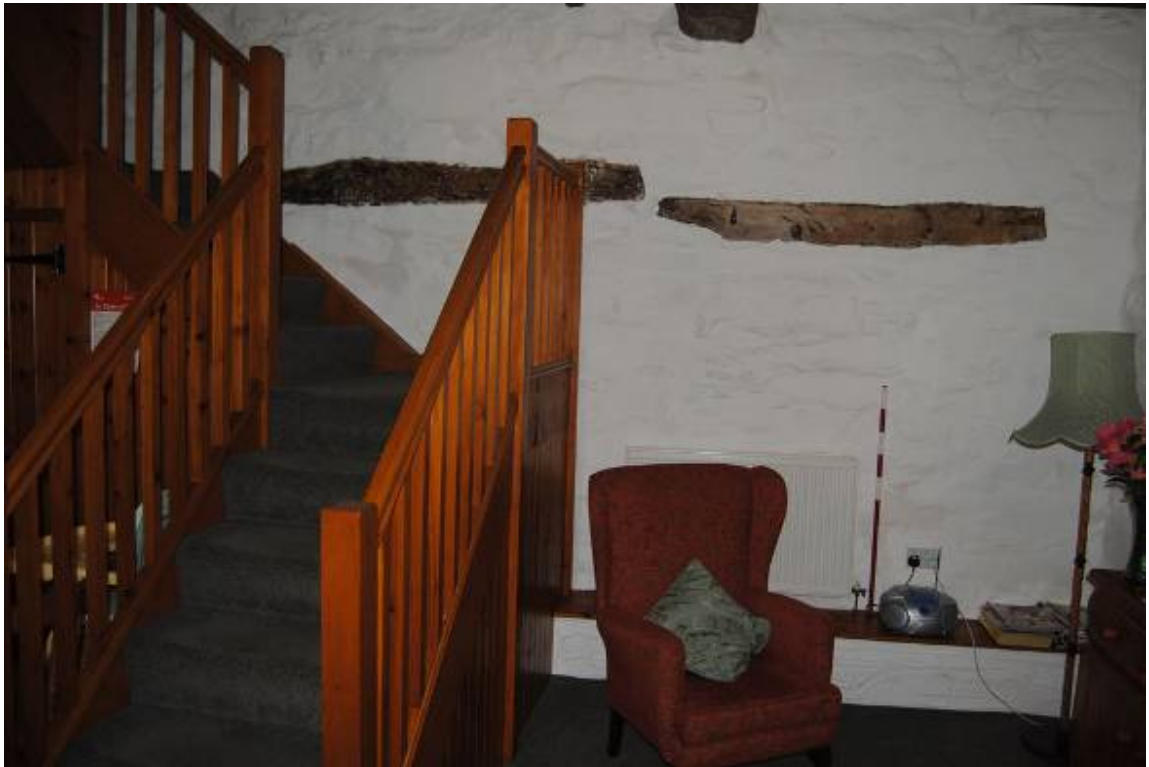
Plate 11: Timber lintels within north wall.

<sup>5</sup> This feature is only faintly traceable externally, though it is additionally evidenced by timber lintel internally (see §.4.3.3; Plate 11).

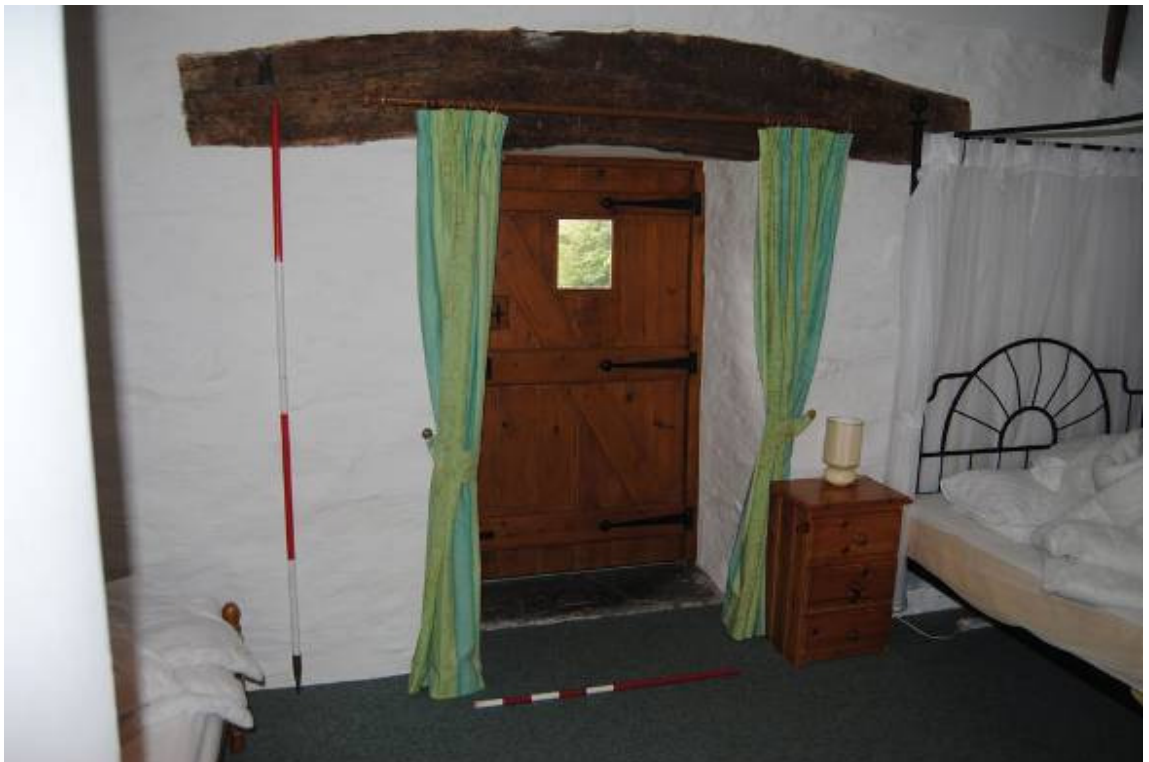
Plate 12: [1F02]; doorway to east gable. **NB:** oversized lintel (re-used FP bressumer).

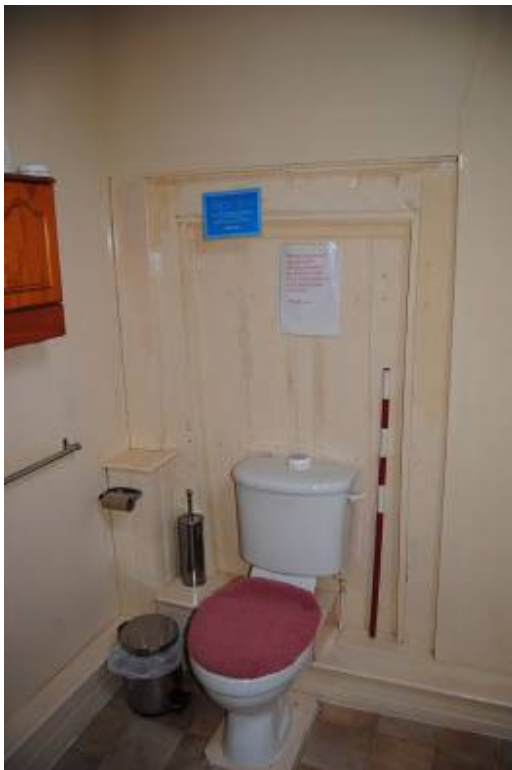
Plate 13: Blocked door to main house [1F03] (W).

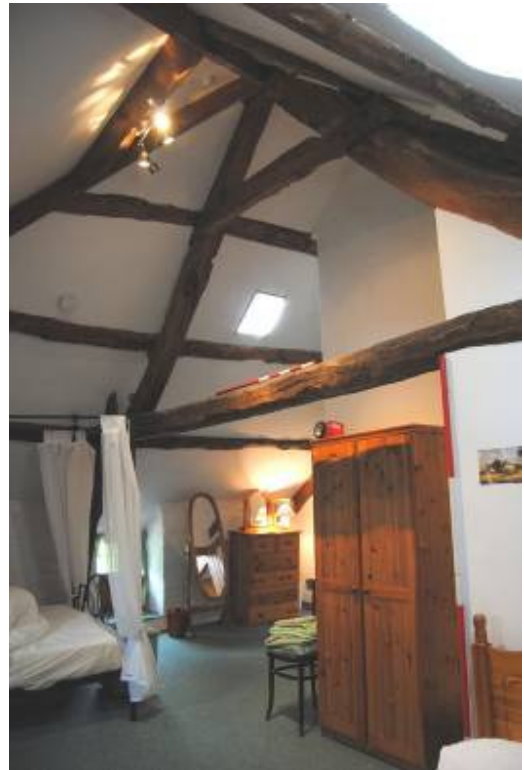
Plate 14: Room [1F02]; Truss T2, looking SW.

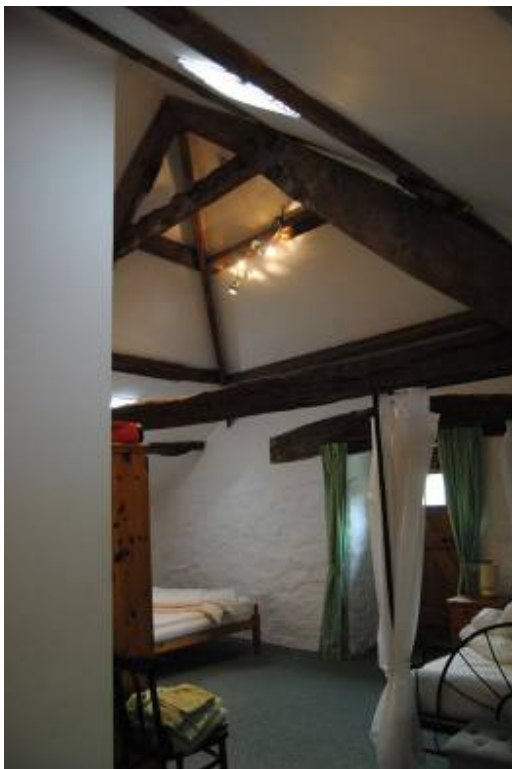
Plate 15: Room [1F02]; Truss T2, looking NE.

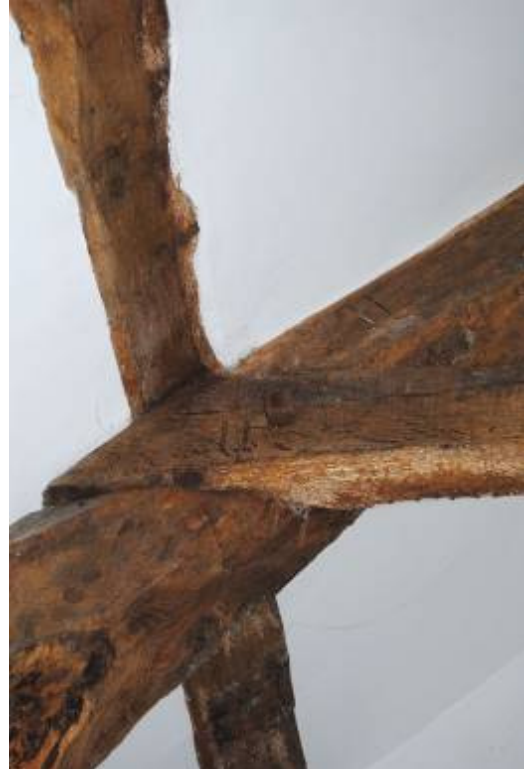
Plate 16: Detail of lap jointing and square pegs;  
NB: carpenter's numbering ('11') to collar and principal.

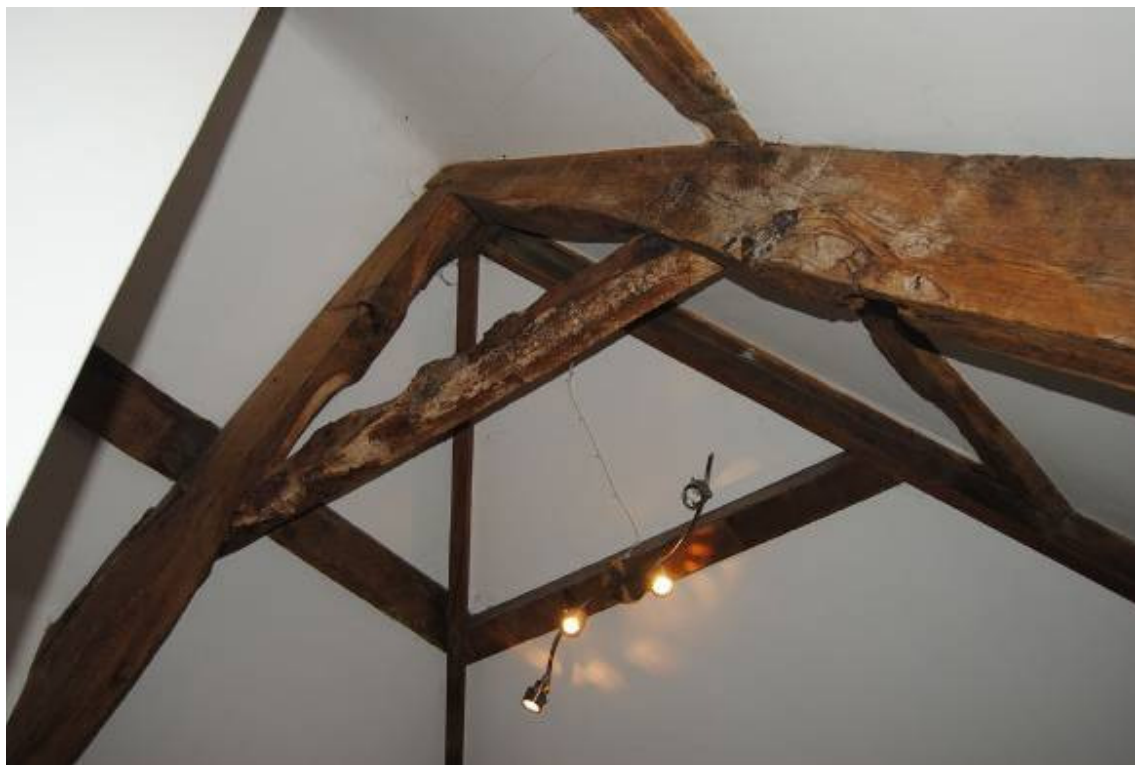
Plate 17: Truss T2 apex detail, plus secondary roof hip.

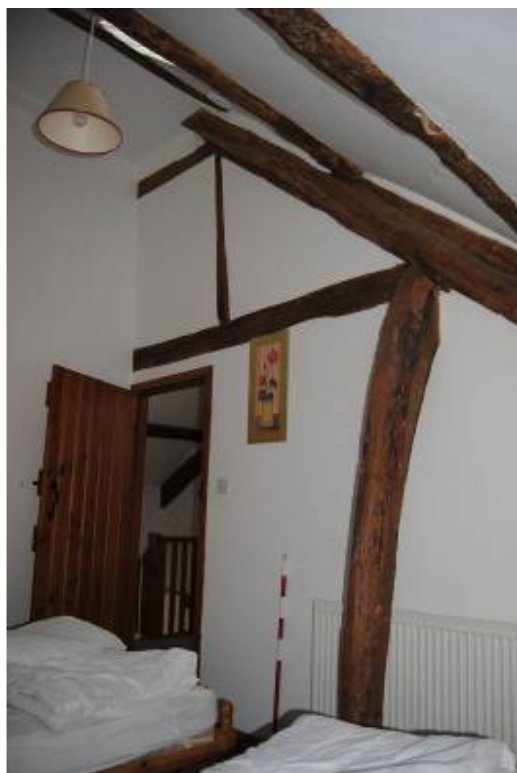
Plate 18: Inserted strut to T2 [1F04].

<b>DSC_0248*</b>	<b>18</b>	Room [1F04], T2, inserted strut to collar/principal	→ NE	09.09.11	R Tyler
DSC_0249		Room [1F04], T2, inserted strut to collar/principal	→ NE	09.09.11	R Tyler
DSC_0250		Room [1F03], T2, inserted strut to collar/principal	→ E	09.09.11	R Tyler

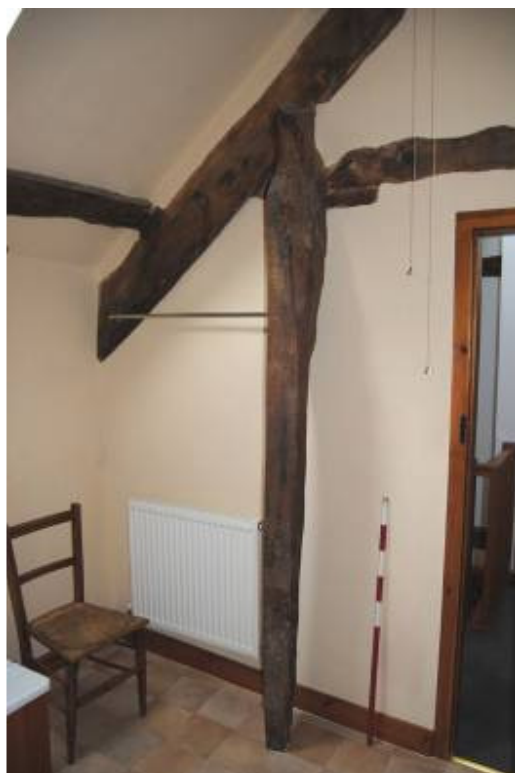
Plate 19: Inserted strut to T2 [1F03].

<b>DSC_0251*</b>	<b>19</b>	Room [1F03], T2, inserted strut to collar/principal	→ NE	09.09.11	R Tyler
DSC_0252		Room [1F03], T2, inserted strut to collar/principal (detail)	→ E	09.09.11	R Tyler
DSC_0253		Room [1F03], T2, inserted strut to collar/principal (detail)	→ E	09.09.11	R Tyler
DSC_0254		Room [1F03], T2, inserted strut to collar/principal (detail)	→ SE	09.09.11	R Tyler
DSC_0255		Room [1F03], T2, inserted strut to collar/principal (detail)	→ SE	09.09.11	R Tyler
DSC_0256		Scarf detail	→ S	09.09.11	R Tyler
<b>DSC_0257*</b>	<b>17</b>	T1, apex detail	↑	09.09.11	R Tyler
DSC_0258		Scarf to east of T1	↑	09.09.11	R Tyler
DSC_0259		Lap joint at lower collar, T2 (south)	→ W	09.09.11	R Tyler
DSC_0260		Truss T2 at head of stair	→ N	09.09.11	R Tyler
<b>DSC_0261*</b>	<b>13</b>	Room [1F03], blocked door to farmhouse	→ W	09.09.11	R Tyler

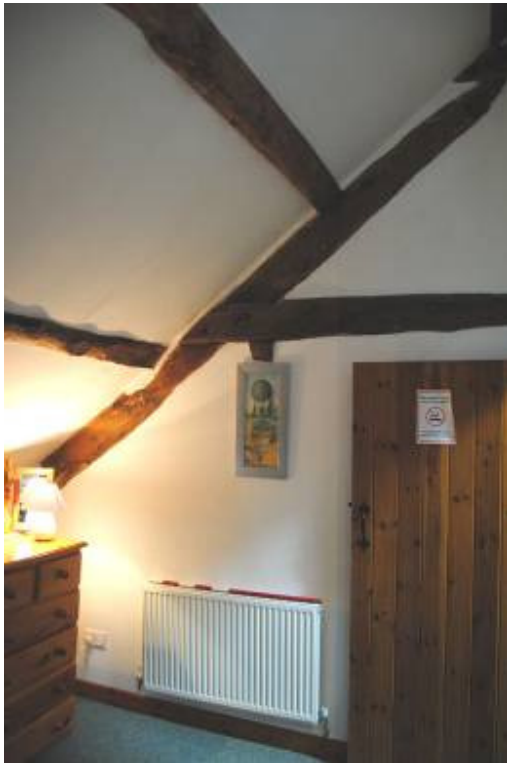
**Plate 20:** Inserted strut to T2 (south).

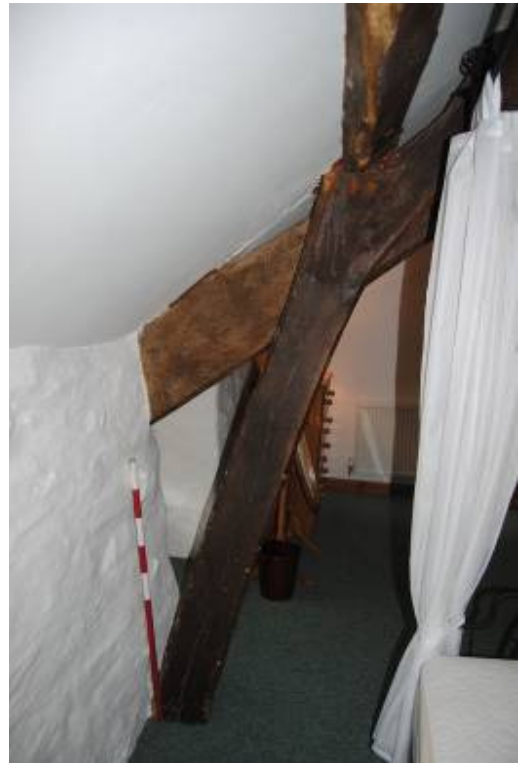
**Plate 21:** Truss T1 (south).
