Clyndu Street, Morriston, Swansea

Archaeological Watching Brief

Archaeological Evaluation

Report No: 635

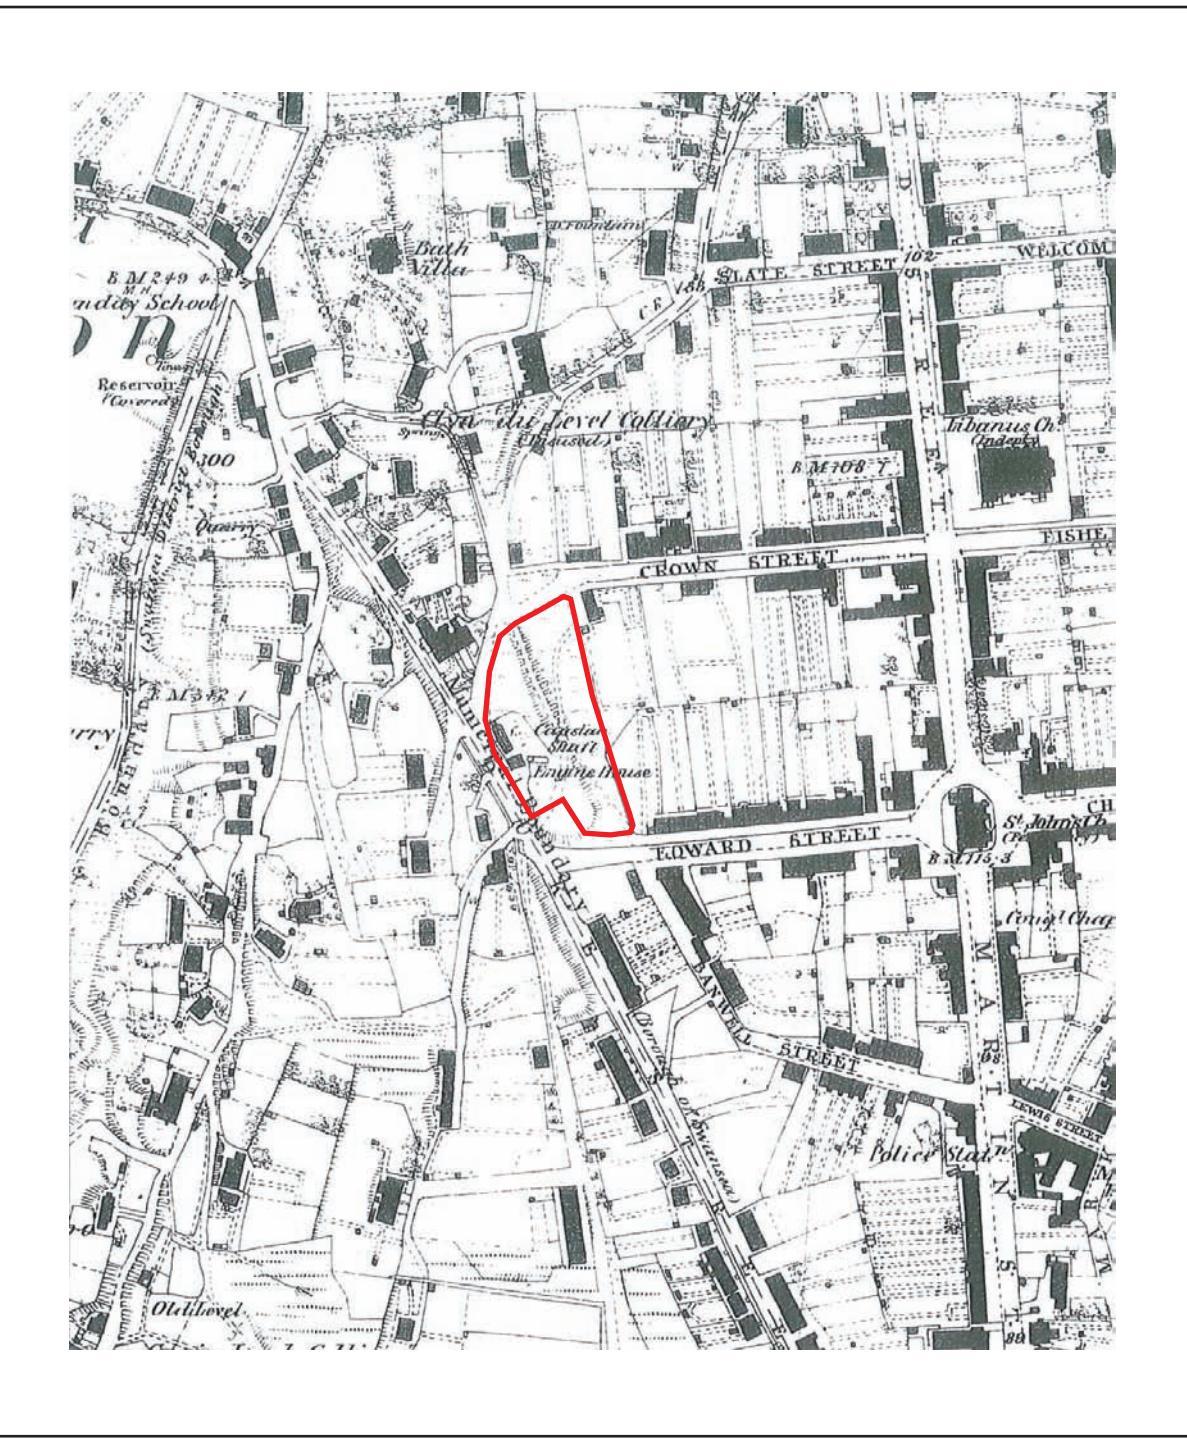
Fig. 3 The site as shown on OS Map of 1876

The OS County Series Map of 1876 depicts the site as containing two buildings, an Engine House and a Capstan Shaft (fig. 3). The Clyn-Du Level Colliery is marked as disused on the map, indicating that the shaft and engine house were no longer functioning by the late 19th century. A linear feature running north-west/south-east across the northern half of the site could be the remains of the underground canal. The OS County Series Map of 1899 shows that the Engine House and one of the other buildings were still standing (fig. 4), with the line of the linear feature also just visible. In both of these early OS maps, the coal road that was to become Clyndu Street is depicted as Duke Street.

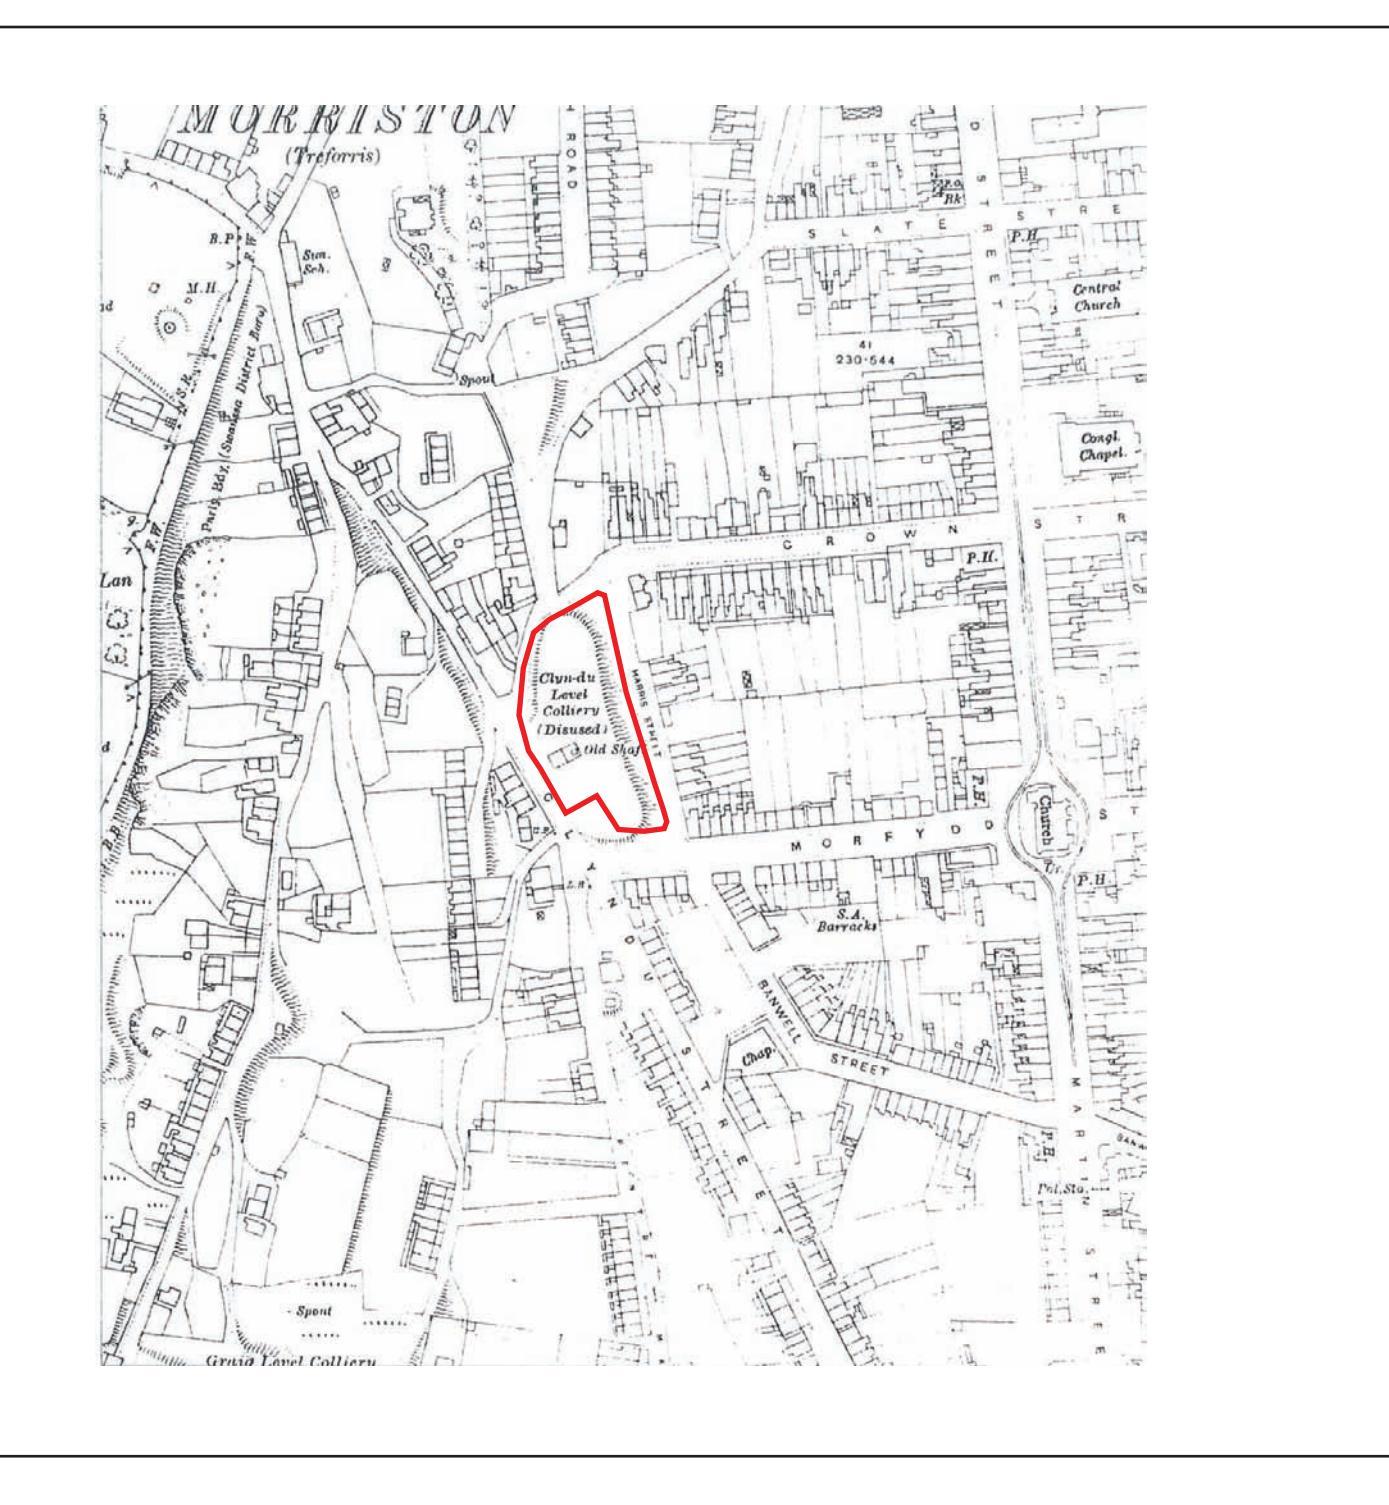
Fig. 5 The site as shown on OS Map of 1917

The 1917 OS County Series Map labels the site as the disused Clyn-Du Level Colliery (fig. 5). By now all the buildings on the site have been removed, with just the location of the former shaft depicted. The later 20th century OS maps depict changes to the use of the site, with small buildings appearing in the 1940s (fig. 6). The lock-up

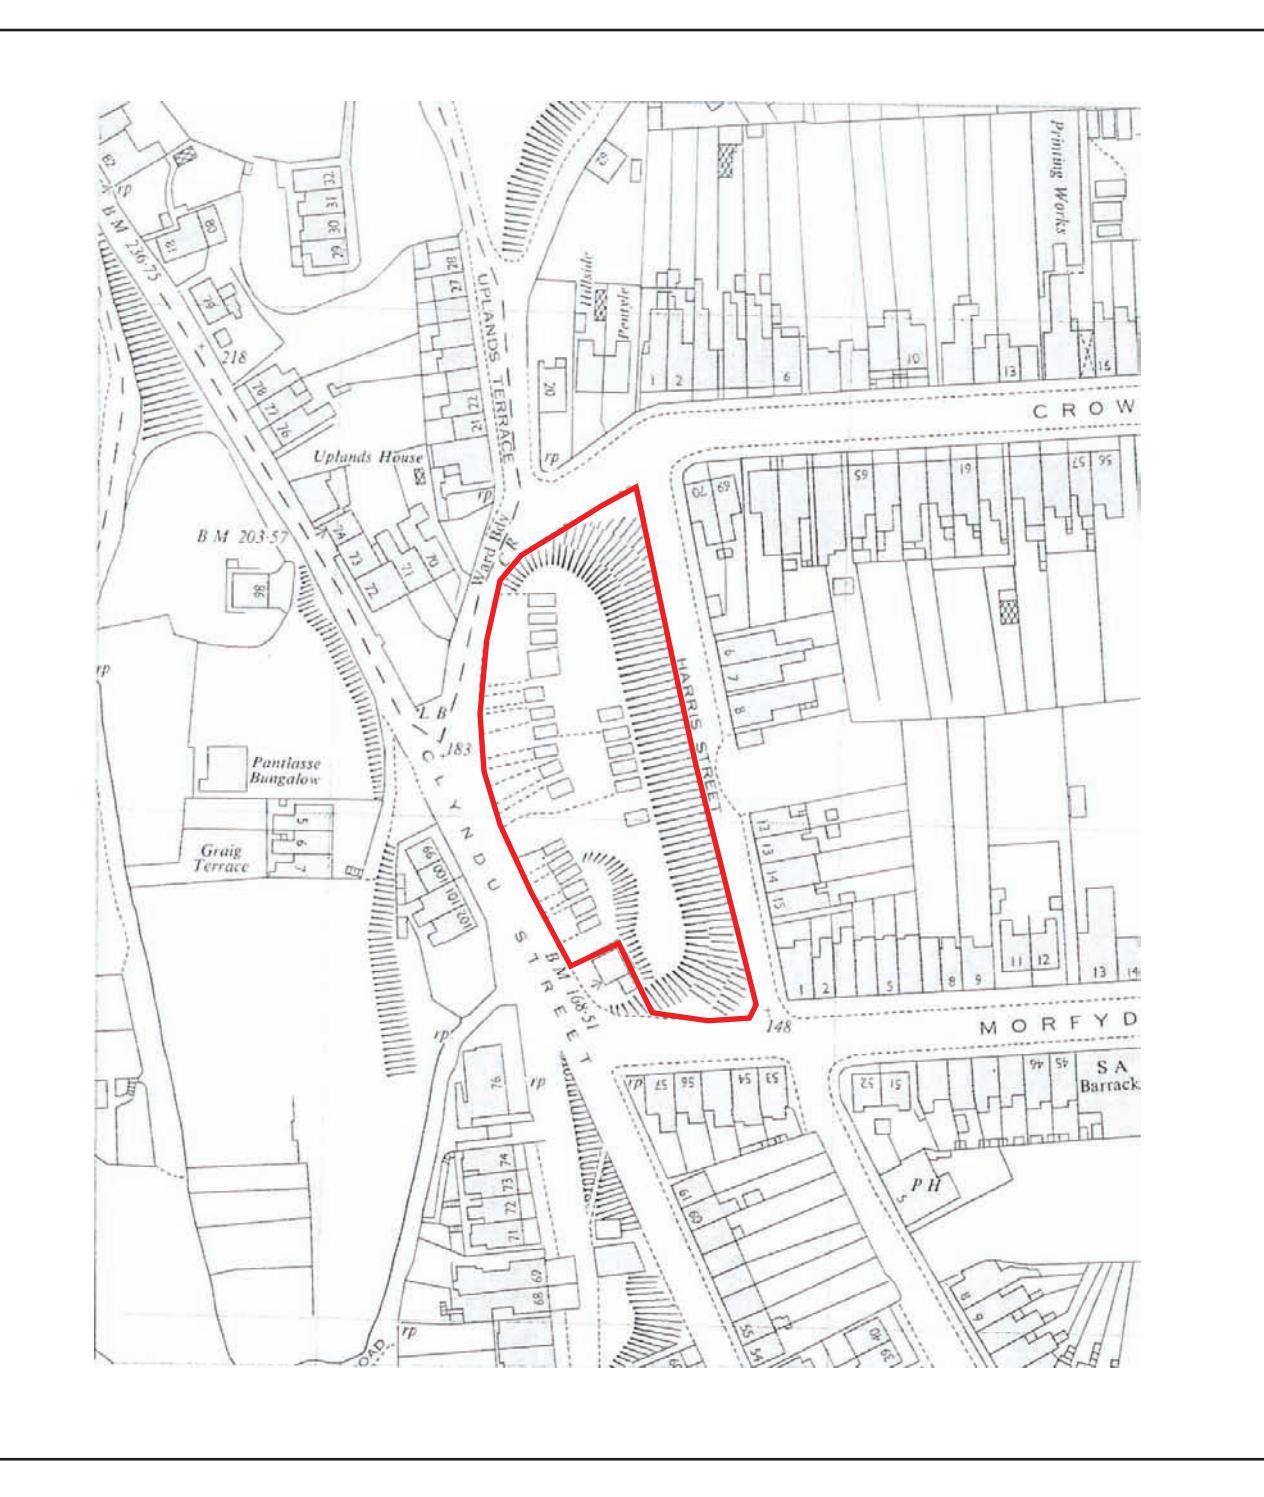
Fig. 7 The site as shown on OS Map of 1966

garages that are still evident on the site today, surviving as a series of concrete bases, were built between 1950 and 1966 (fig. 7) and remained in use until the late 1990s.

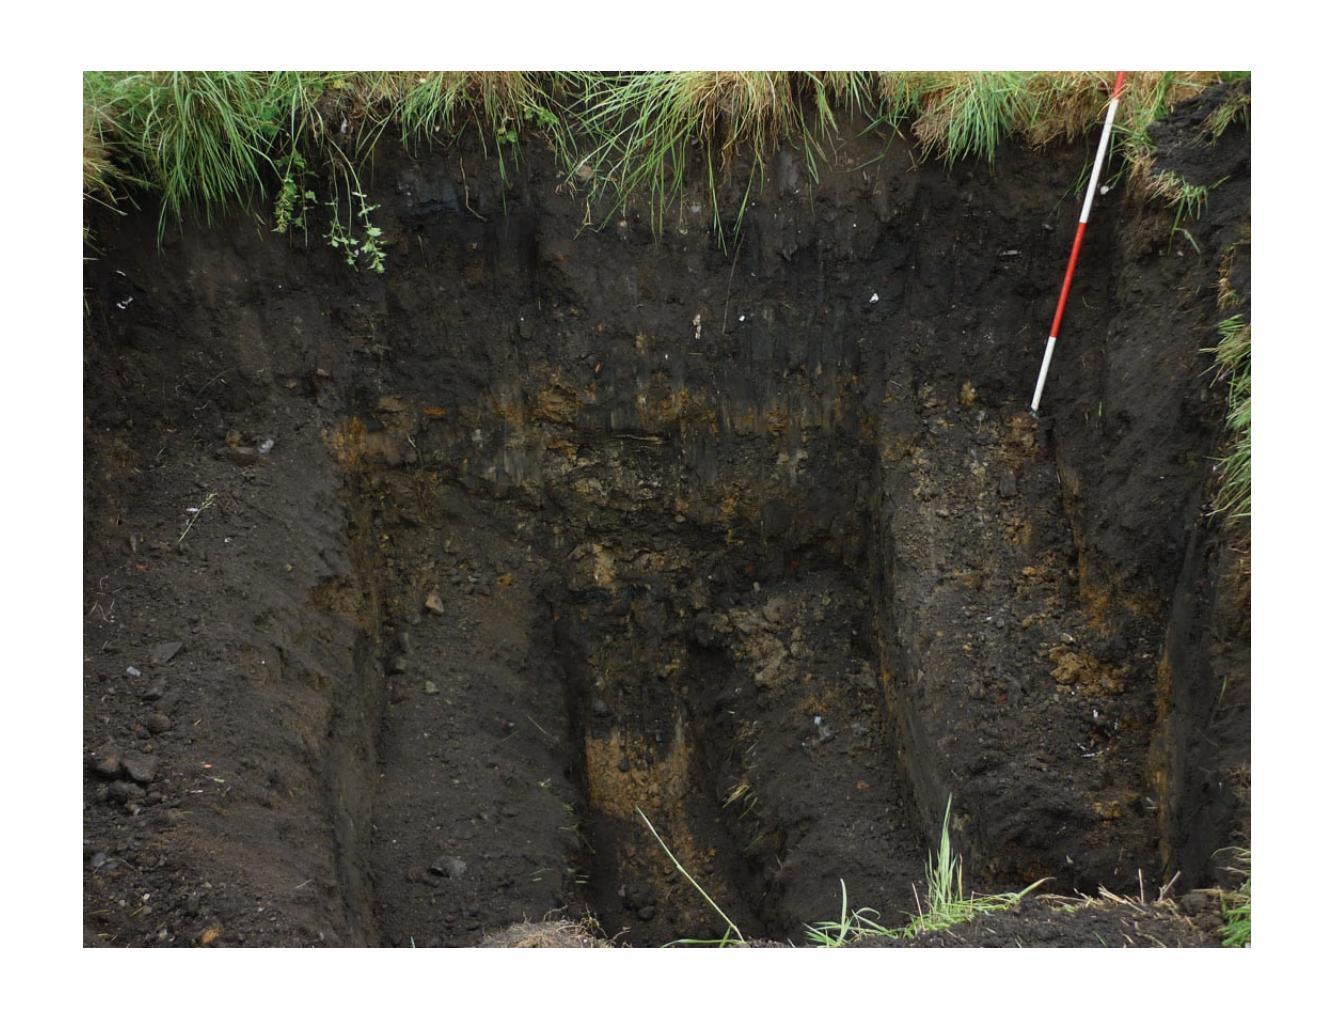
Plate 1 Trench 1 Looking North

Trench 1 was located at the northern end of the site, within the footprint of proposed House 1. The trench measured 7m wide by 7m long and was excavated to a depth of approximately 3.2m (plate 1).

The natural surface was exposed in the base of the trench, covered by over 3m of redeposited material. No evidence for an old ground surface was noted.

The redeposited material comprised coal debris, ash, rubble and shattered sandstone. Distinct tip lines were evident in the deposits. A large quantity of modern rubbish was also present in the upper 0.3m of the trench.

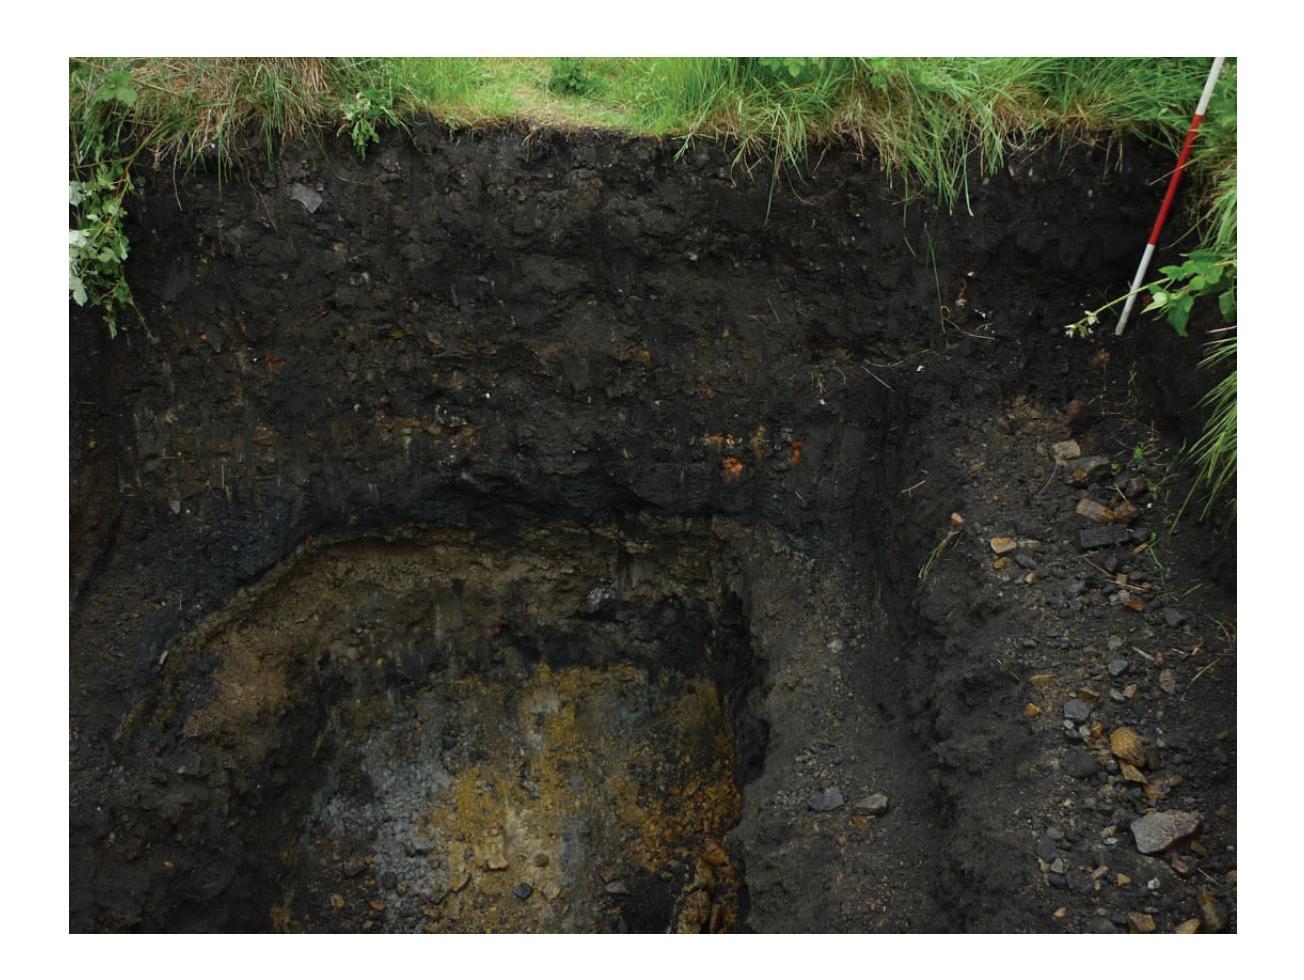
Plate 2 Trench 2 Looking South

Trench 2 was located at the southern end of the site, within the footprint of House 2. It measured 7m wide by 7m long and was excavated to a depth of approximately 3m (plate 2).

The natural surface was not reached, although at the base of the trench a thick layer of shattered natural sandstone was encountered. Overlying the shattered stone approximately 2.5m of redeposited material was identified. This comprised predominantly coal debris and ash. A thick layer of greasy, possibly oil-contaminated, stony clay soil was identified, together with a layer of large angular stones. These had the remains of lime mortar on their edges, and probably derived from one of the structures associated with the Capstan shaft. Distinct tip lines were evident in the layers of redeposited material, and modern rubbish was abundant in the upper levels of the trench.

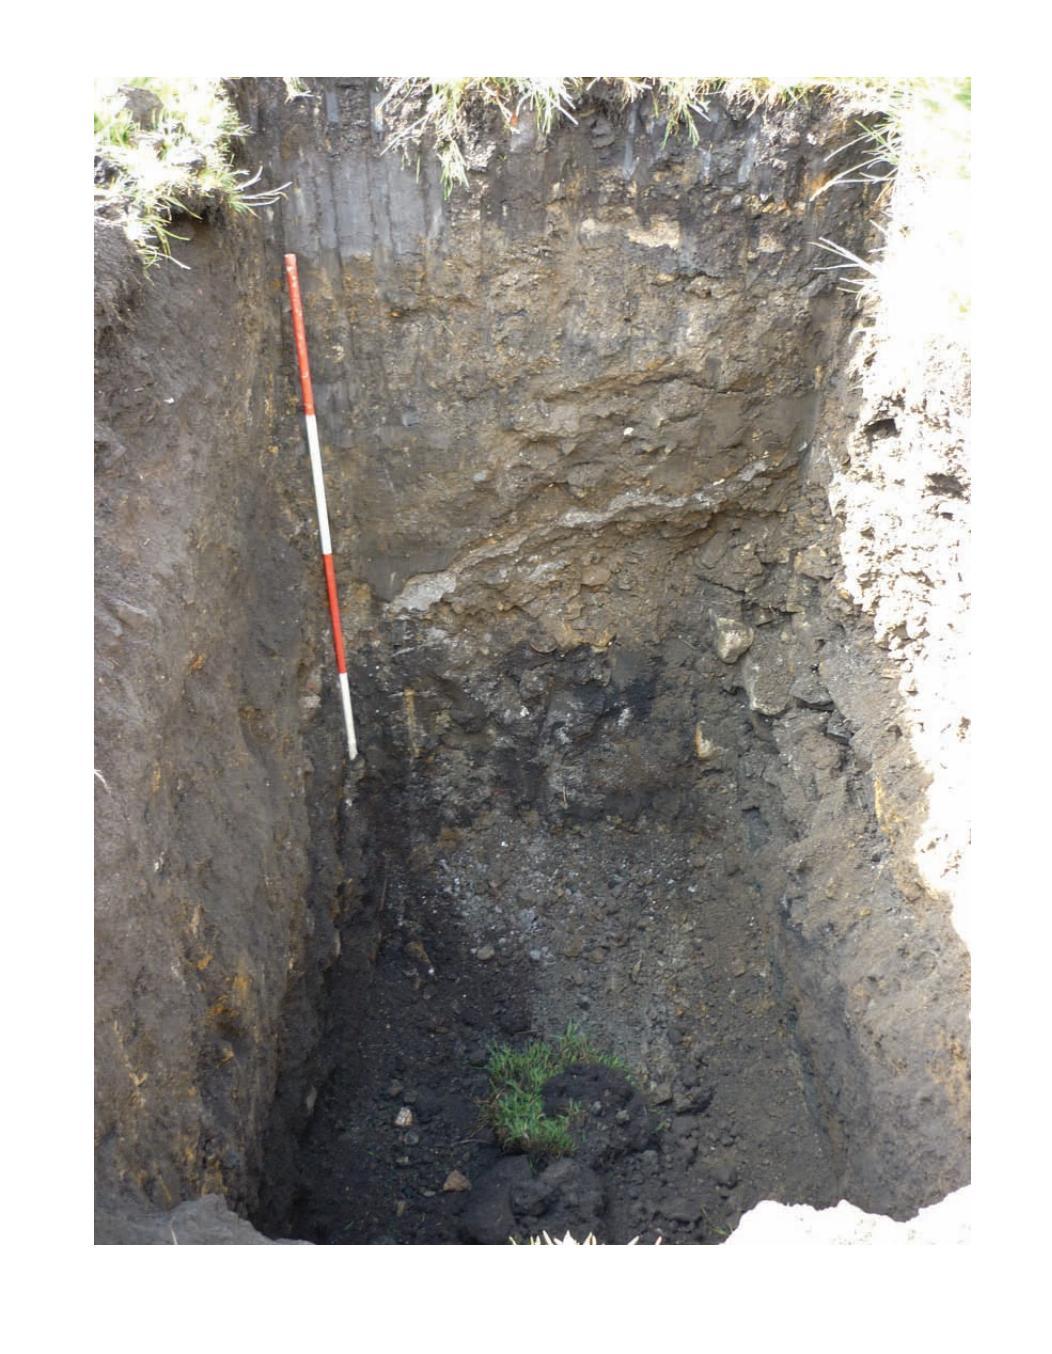
Plate 3 Trench 3 Looking North

Trench 3 was located on the eastern side of the site, within the proposed parking area. It measured 2m wide by 5m long and was excavated to a depth of approximately 3m (plate 3).

The natural surface was not reached in the trench. The deposits revealed comprised entirely of redeposited materials – these were extremely loose towards the base of the

trench causing significant collapse. The redeposited materials differed from those encountered in trenches 1 and 2, comprising coal dust and ash in the lowest 1.5m with distinct layers of clay, mortar, rubble and a clay silt soil above. Abundant modern rubbish was again found in the uppermost layers.

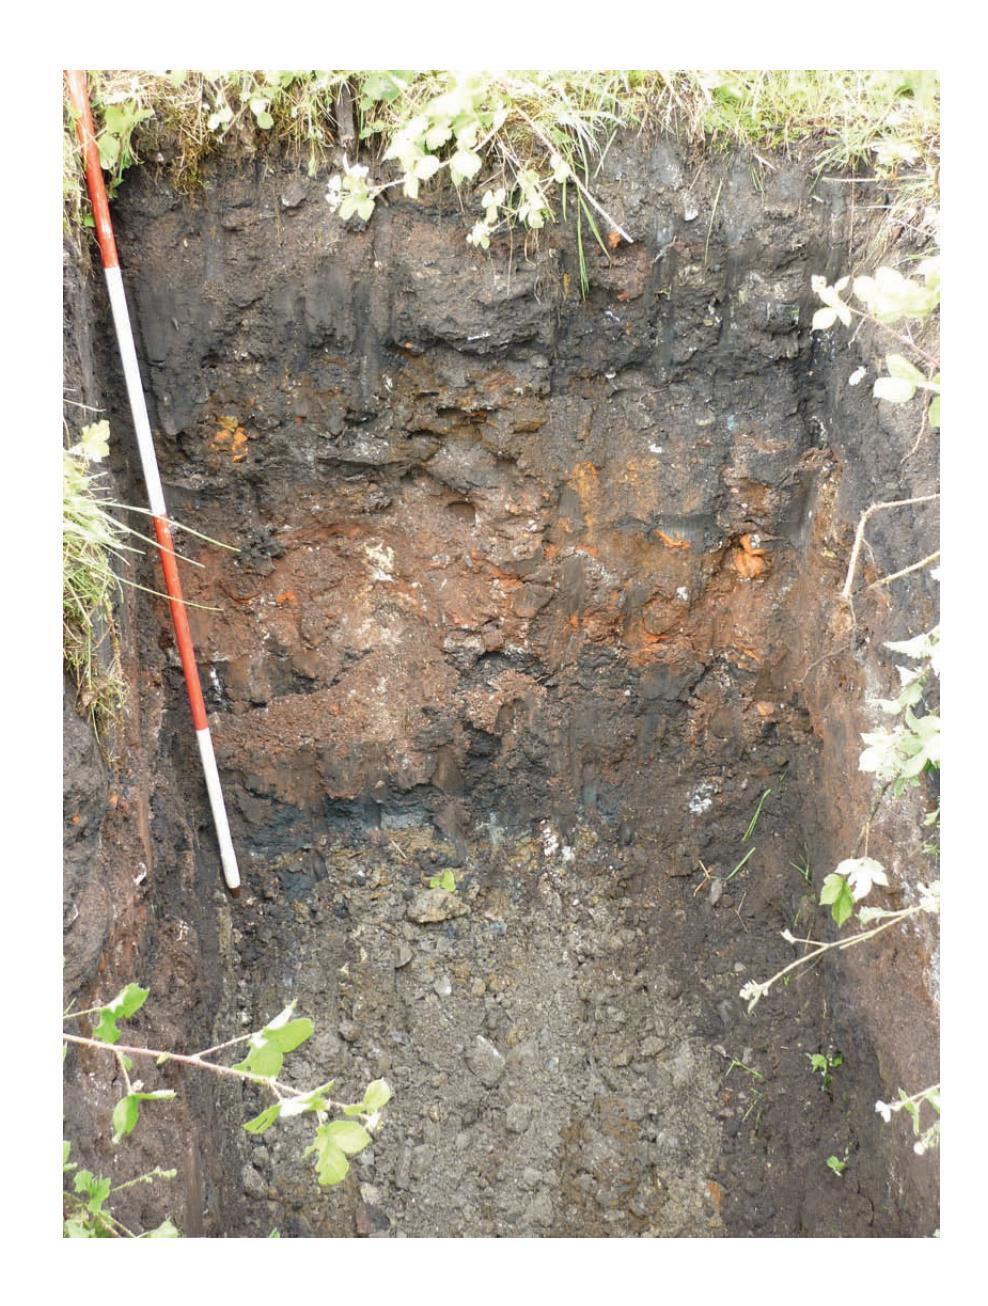
Plate 4 Trench 4 Looking West

Trench 4 was located on the south-western edge of the site, within the footprint of the proposed block of flats. It measured 2m wide by 5m long and was excavated to a depth of 1.8m (plate 4). The trench was located in the approximate position of the former Engine House to test for the survival of structural remains.

The deposits comprised distinct layers of redeposited materials overlying the sandstone natural. At the base of the trench a deposit of shattered sandstone was overlain by a thick layer of coal debris and ash. Above this a deposit of bricks, brick fragments and what appeared to be crushed brick was identified. This was approximately 0.7m thick and was covered by further bands of coal debris and finally topsoil.

No evidence for structure was revealed.

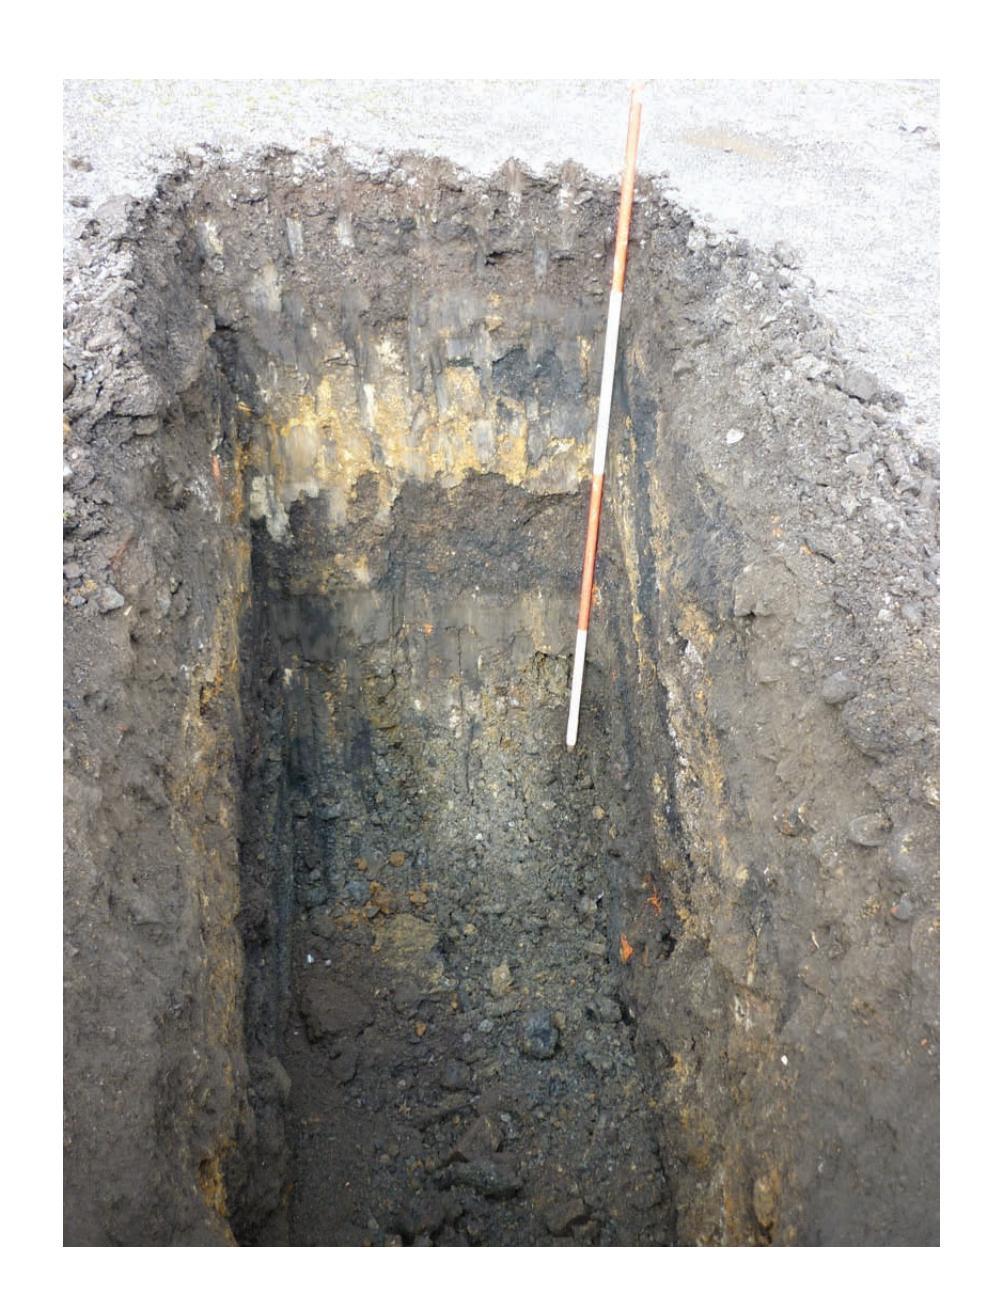
Plate 5 Trench 5 Looking West

Trench 5 was located on the north-eastern side of the side, within the footprint of House 3. It measured 2m wide by 5m long and was excavated to a depth of 2.4m (plate 5). The trench was located slightly to the north of the site of the former Engine House.

The natural sandstone was revealed in the base of the trench, overlain by a series of distinct deposits. The basal deposits comprised predominantly coal debris and were extremely unstable, causing the sides of the trench to collapse. Overlying the coal deposits layers of clay, rubble, brick, ash and mortar were identified. No evidence of structure was identified.
