CPAT Report No. 1713

Former Cwrt-y-Gollen Army Camp, Crickhowell, Powys

Heritage Assessment

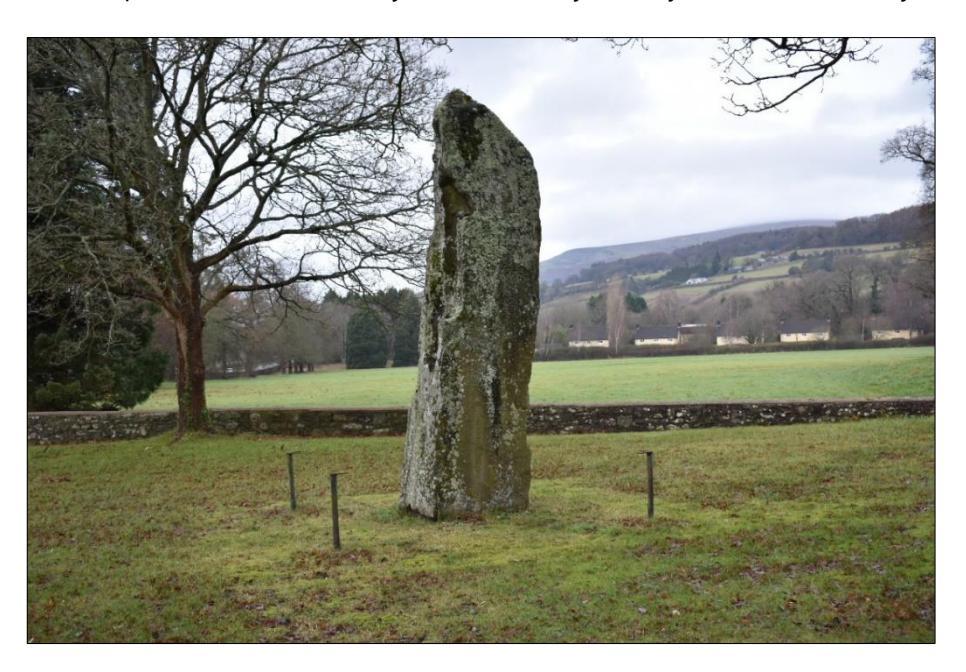
Fig. 3 Cwrt-y-Gollen standing stone BR 113

3.3. At the former main entrance to Cwrt-y-Gollen is a large Bronze Age standing stone, 4.15m high, 1.05m wide and 0.7m thick (Fig. 3). There is a crescent-shaped notch 1m from top of the east edge. The standing stone, and a small area around it, have been afforded statutory protection as a scheduled monument (BR113).

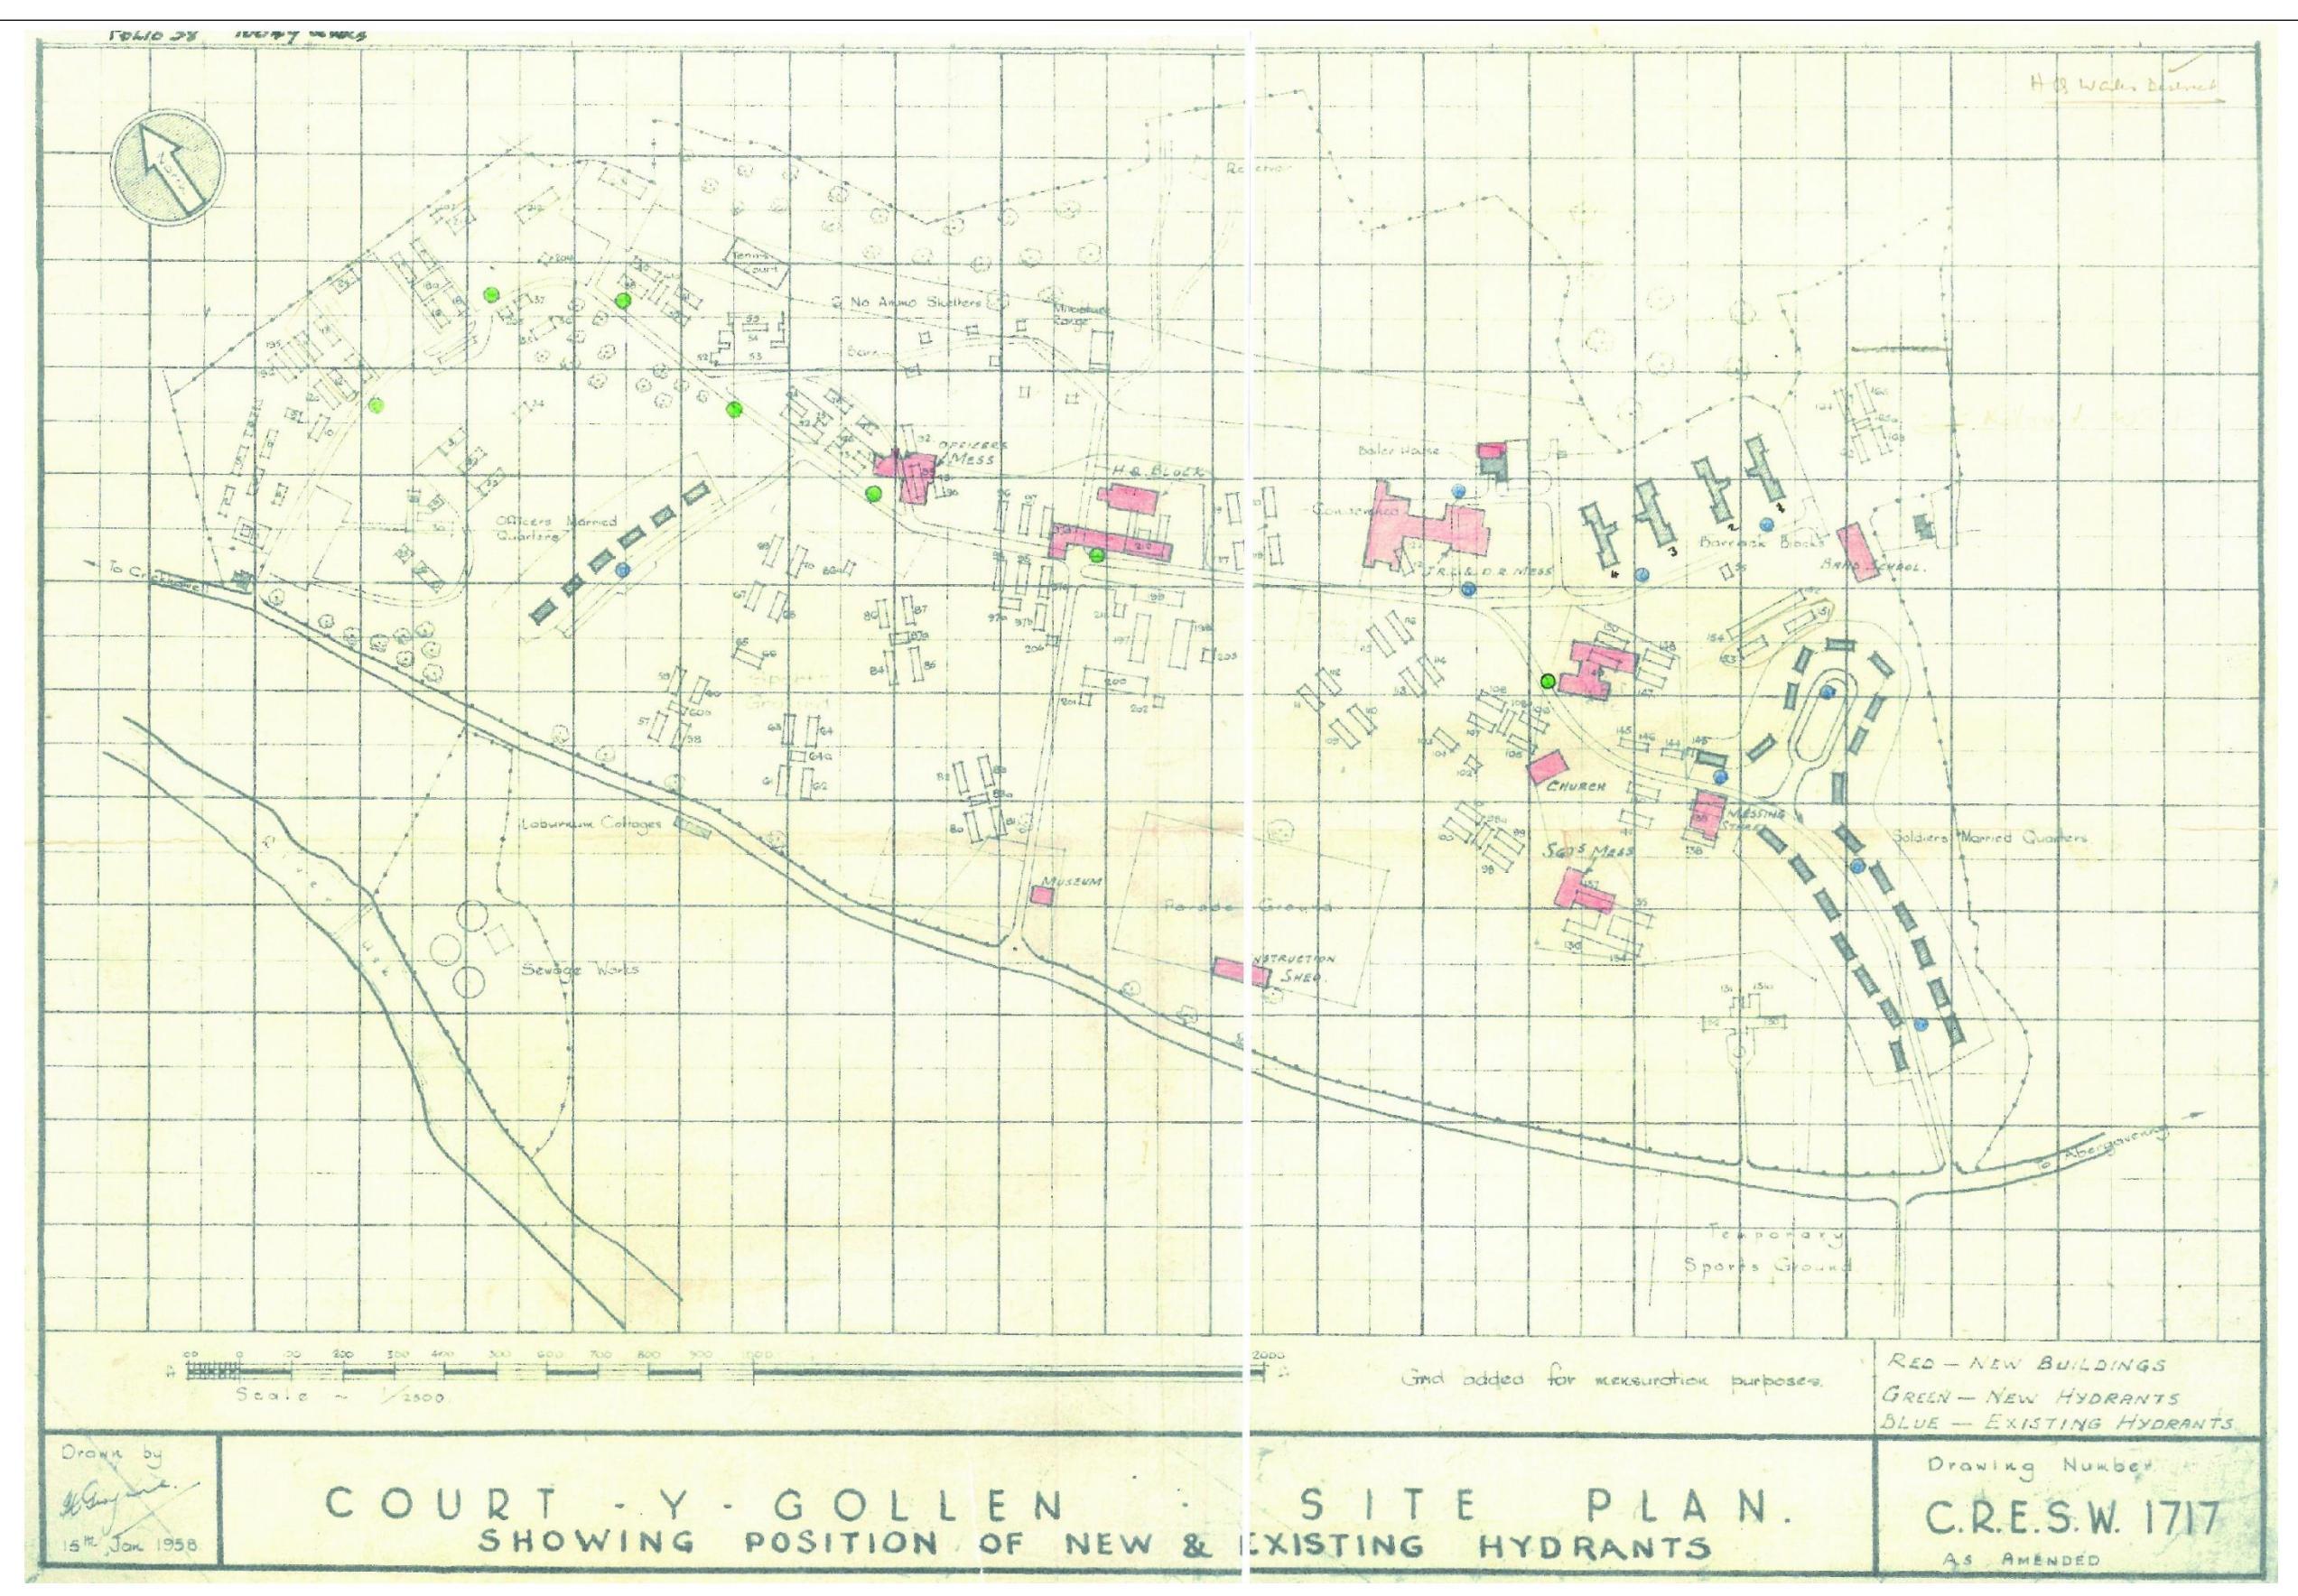
Fig. 8 Plan of Cwrt-y-Gollen in 1958 showing the layout of the new, permanent buildings

- 4.1. The development of the camp has been traced from vertical aerial photographs dating from the 1940s, Ordnance Survey mapping (Figs 5-7) and a detailed plan of the camp dated 1958 (Fig. 8). It should be noted that the Ordnance Survey mapping, while providing useful information regarding the layout of the camp, does not provide an accurate depiction of the camp at the date the maps were published. This is particular true for the 1964 mapping (Fig. 5), which depicts a layout predating the construction of permanent buildings which commenced in 1958.

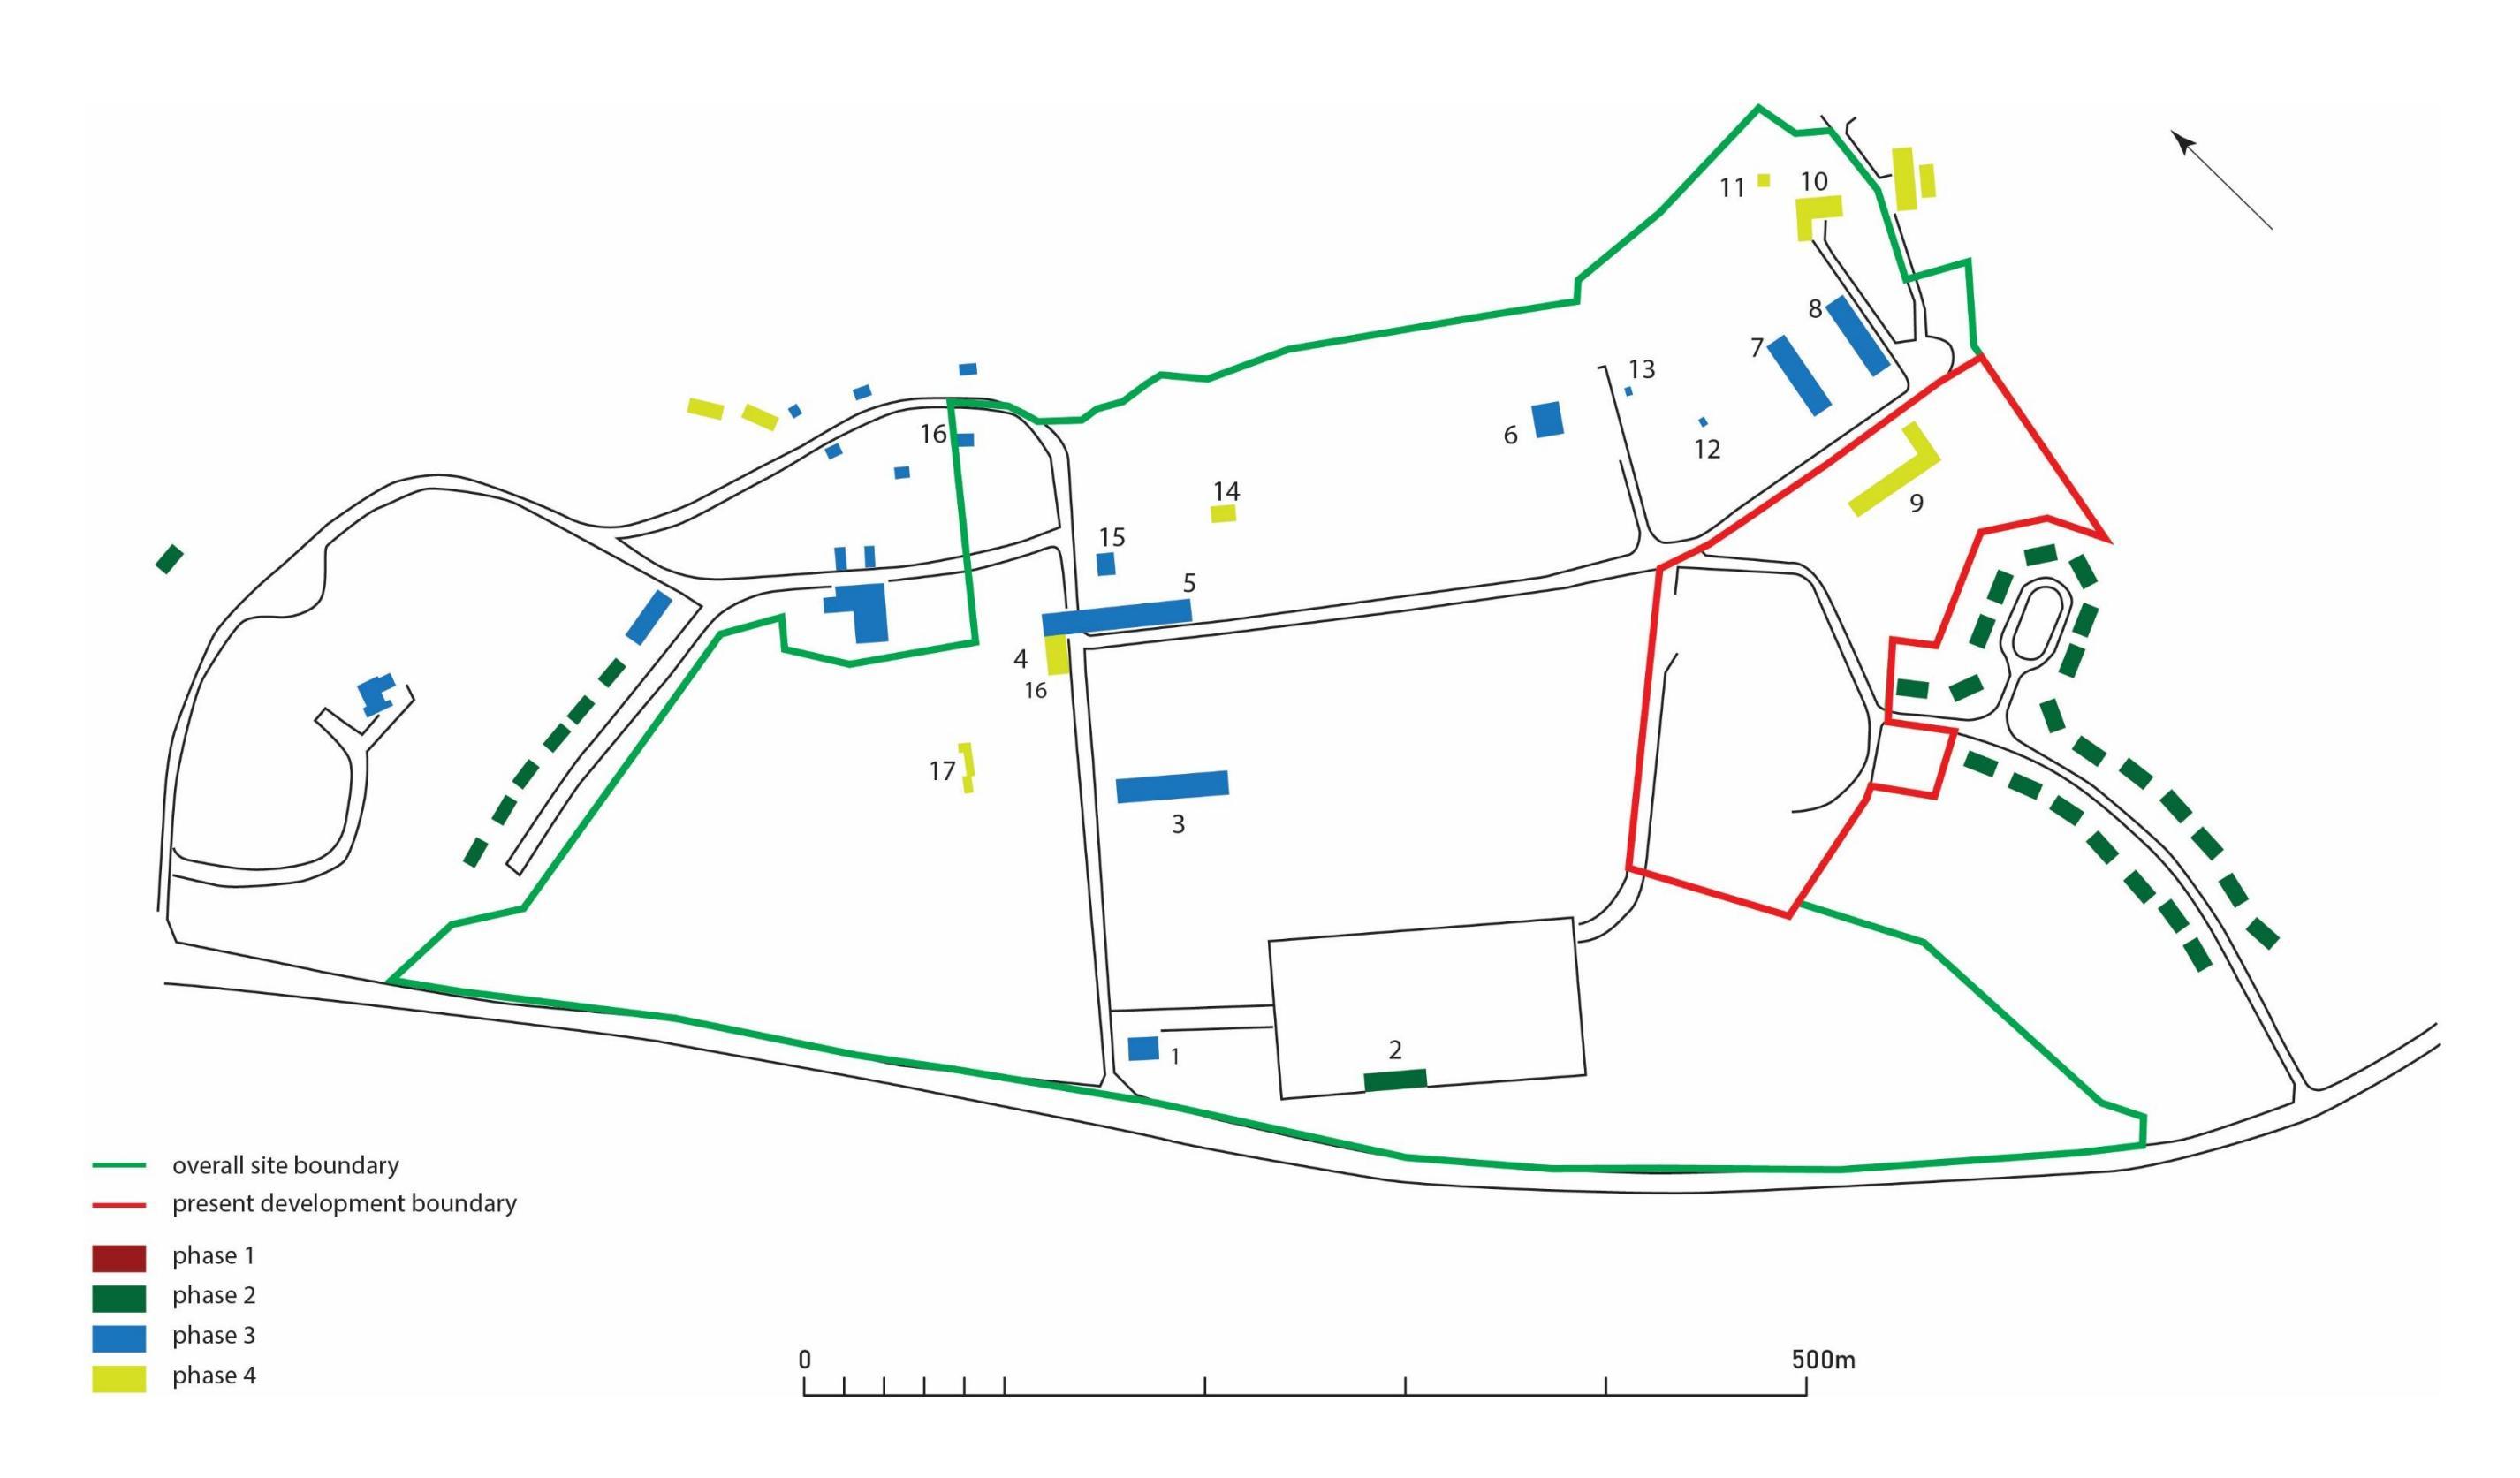
Fig. 13 Cwrt-y-Gollen present day showing surviving buildings within the development site (1-17)

- 4.4. The present day layout of the camp is shown in Fig. 13. The assessment has determined that within the development site there are no surviving buildings dating from Phase 1, while the only surviving building from Phase 2 is the review shelter (Building 2), although even this may be later.

- 4.5. Field survey has confirmed that there are 17 standing buildings within the development site, which are summarised below.
- 4.6. The current development includes Section 278 access improvement works to amend the former main access to the camp, in the area of the presumed Roman road and in close proximity to the scheduled area of the standing stone BR 113 (Fig. 32). Although the detailed

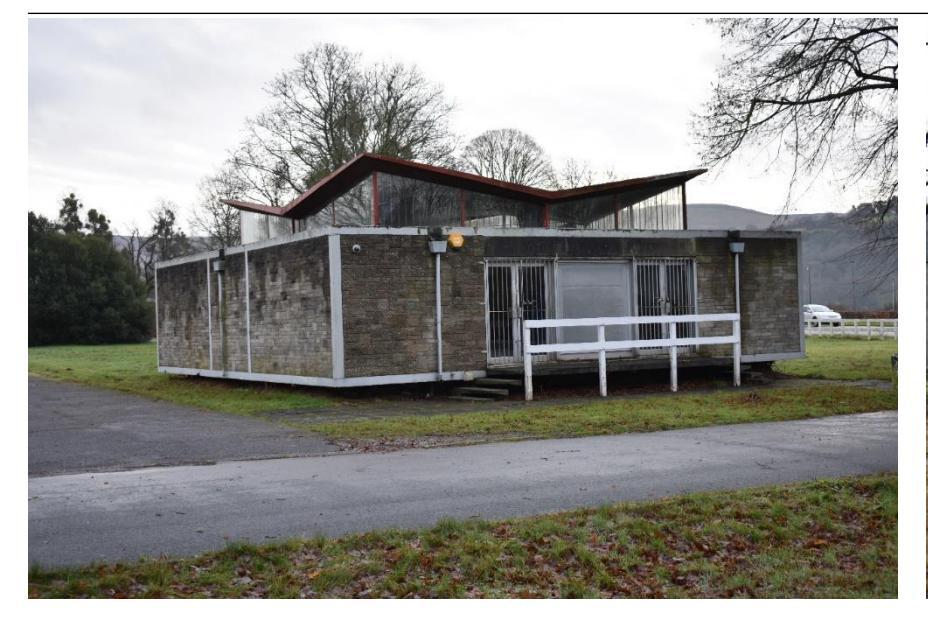
Fig. 15 Building 1 – Museum, Phase 3. Photo CPAT 4720-0004

4.7. Purpose-built military Museum (Fig. 15) dating from 1958-63, sited at the main entrance to the site. Built in a modernist style in concrete, stone, steel and glass. The walls were faced with dressed stone, while the roof had a central raised section in glass and steel, presenting a striking profile and provides light to the interior.

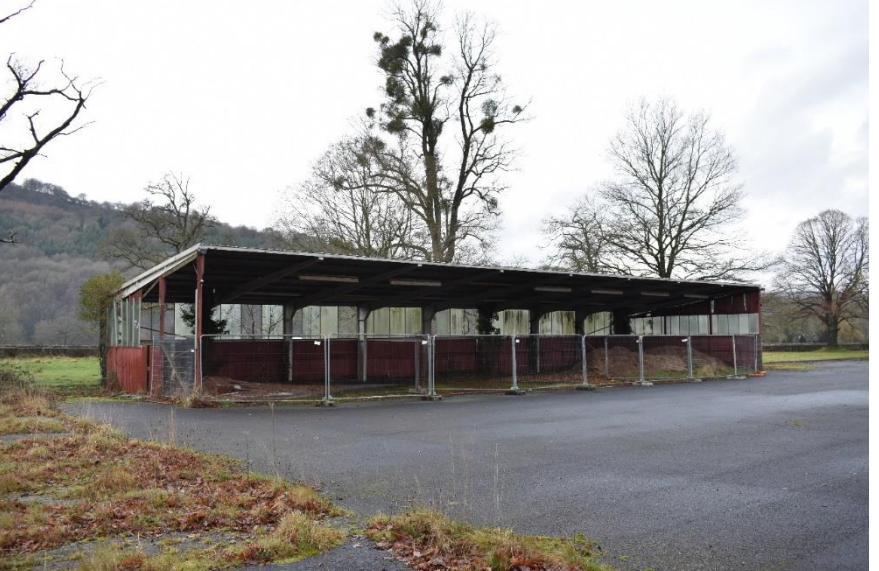
Fig. 16 Building 2 – Review Shelter, Phase 2? Photo CPAT 4720-0006

4.8. The Review Shelter (Fig. 16) was located alongside the parade ground and provided shelter for dignitaries. The structure was certainly in place by 1958 and may date from the earlier 1950s. It was an open-fronted shed with steel frame, planked and glassed sides and a sheet metal roof.

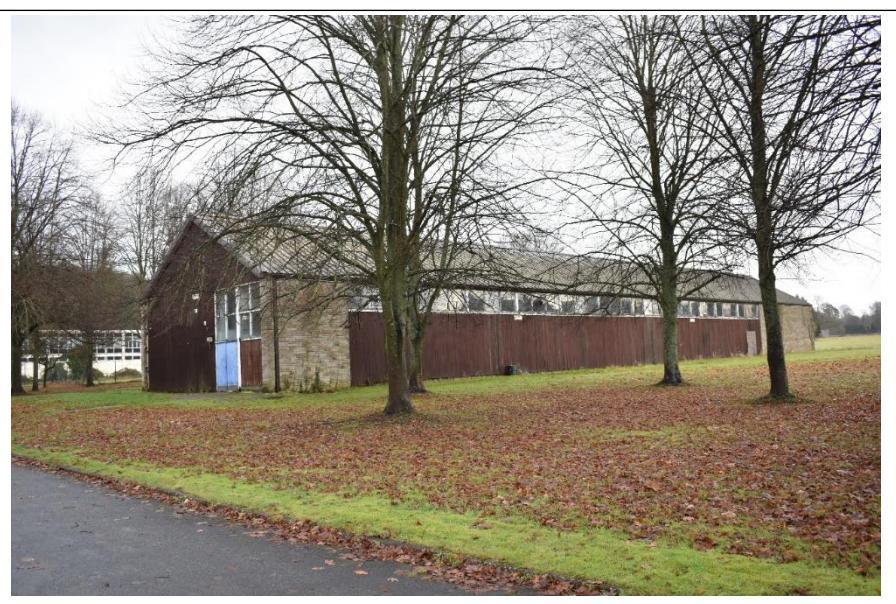
Fig. 17 Building 3 – Gymnasium, Phase 3. Photo CPAT 4720-0010

4.9. The Gymnasium (Fig. 17), sited along the south-east side of the main access road, dates from 1958-63. The single-storey building had a pitched sheet metal roof and dressed stone walls at each corner, with vertical timber planking and glassing above elsewhere.

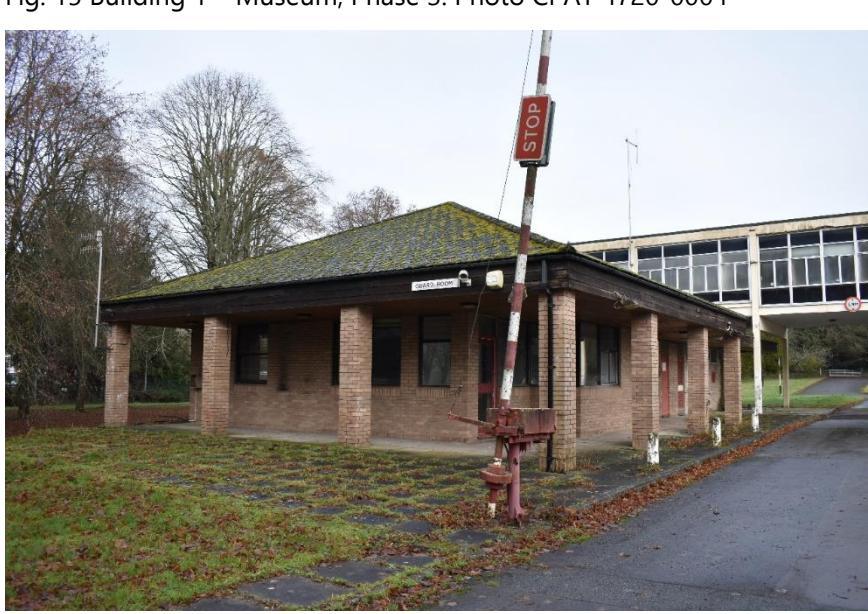
Fig. 18 Building 4 – Guard Room, Phase 4. Photo CPAT 4720-0017

4.10. The guard room lay at the north-east end of the main access road, adjacent to the security fence. It was single-storey and built from red brick, with a pitched slated roof which extends over a veranda on two sides. A flat-roofed wing extends beneath the Headquarters Building, which it post-dates.

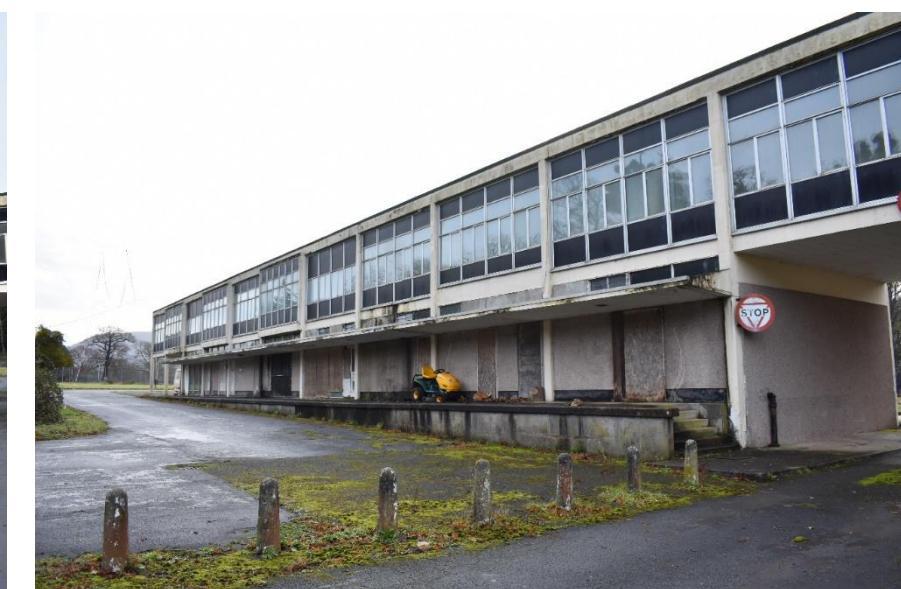
Fig. 19 Building 5 – Headquarters, Phase 3. Photo CPAT 4720-0020

4.11. The Headquarters Building (Fig. 19) had two storeys and was built in concrete and glass with a flat roof. The building was divided into 14 sections, of which four at the north-west end and two at the south-east end were open on the ground floor.

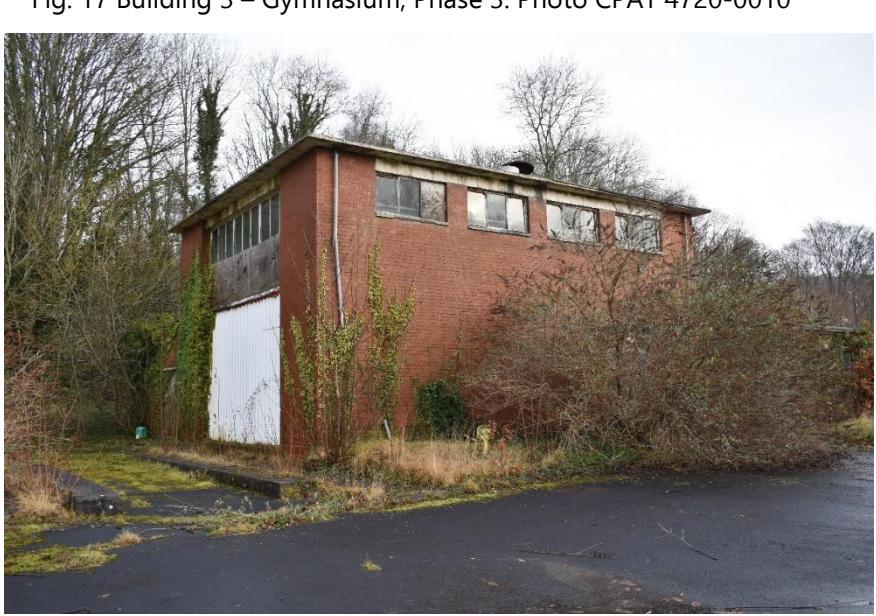
Fig. 20 Building 6 – Boiler House, Phase 3. Photo CPAT 4720-0029

4.12. The Boiler House (Fig. 20) lay east of the Headquarters Building and dates from 1958-63. It was built of red brick with a flat roof. The main building had two storeys, with single-storey additions to the south-east side.

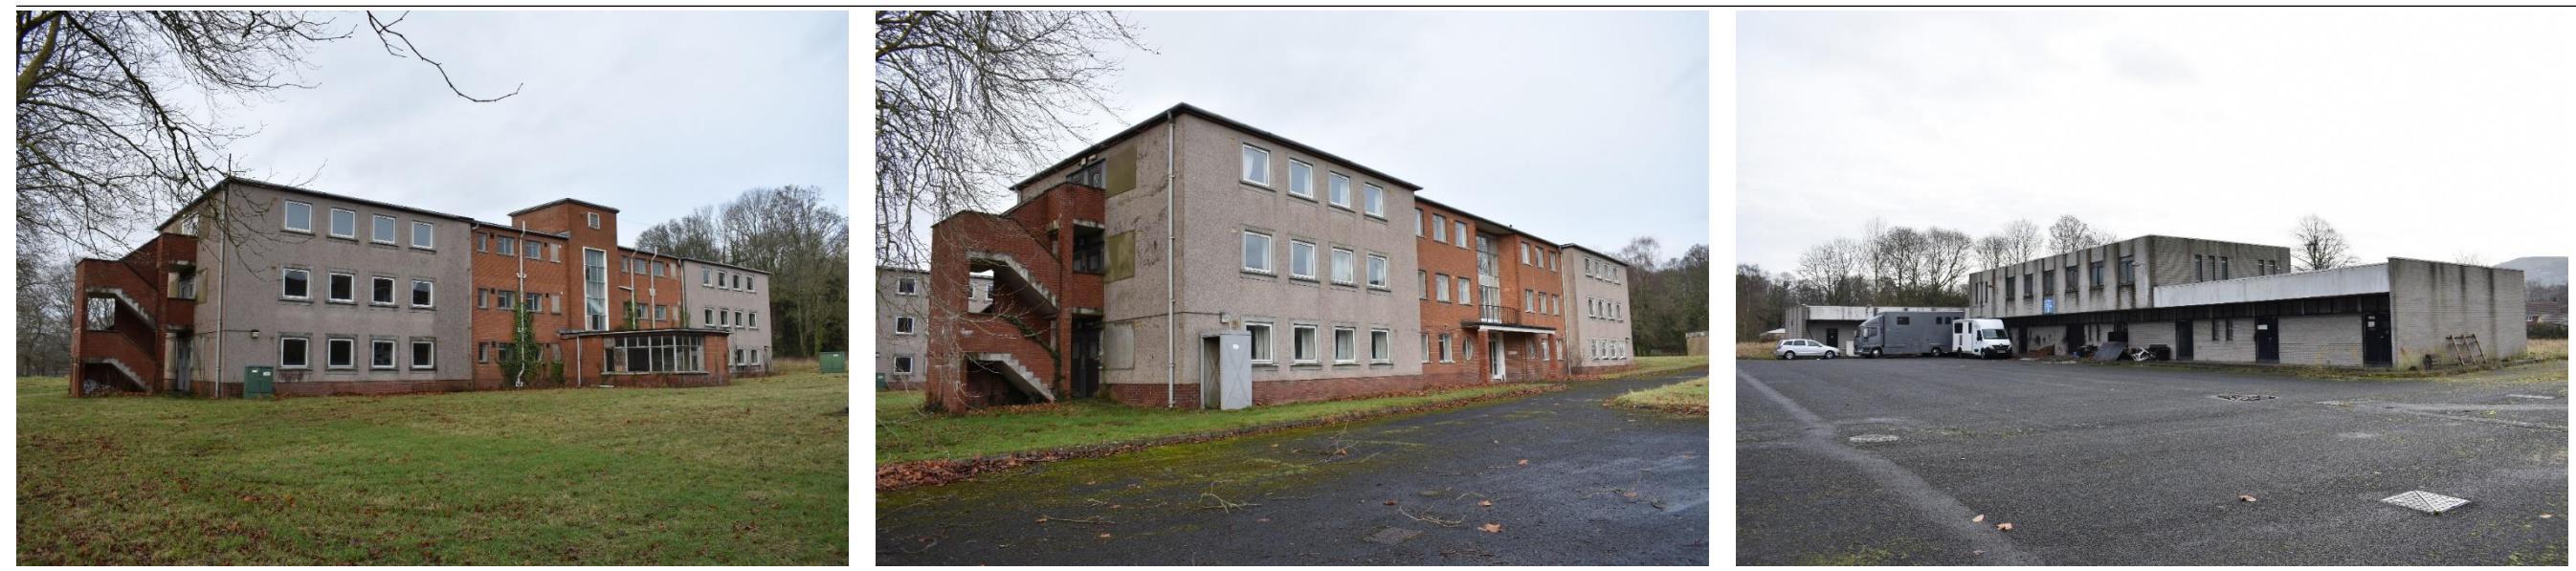
4.13. Four identical accommodation blocks were built in 1958-63 in the eastern part of the site, of which only the eastern pair survives (Figs 21-22). They were built in red brick and had three storeys. The central section housed the entrance and stairwell and had floor to ceiling glazing. To either side the main elevation had exposed red brick with three windows on each floor. The end sections were rendered, with four windows on each floor. There was an external brick

staircase at the southern end of each building and a central single-storey wing on one side of each building. The central section of building, above the stairwell, had a fourth floor, presumably housing a water tank.

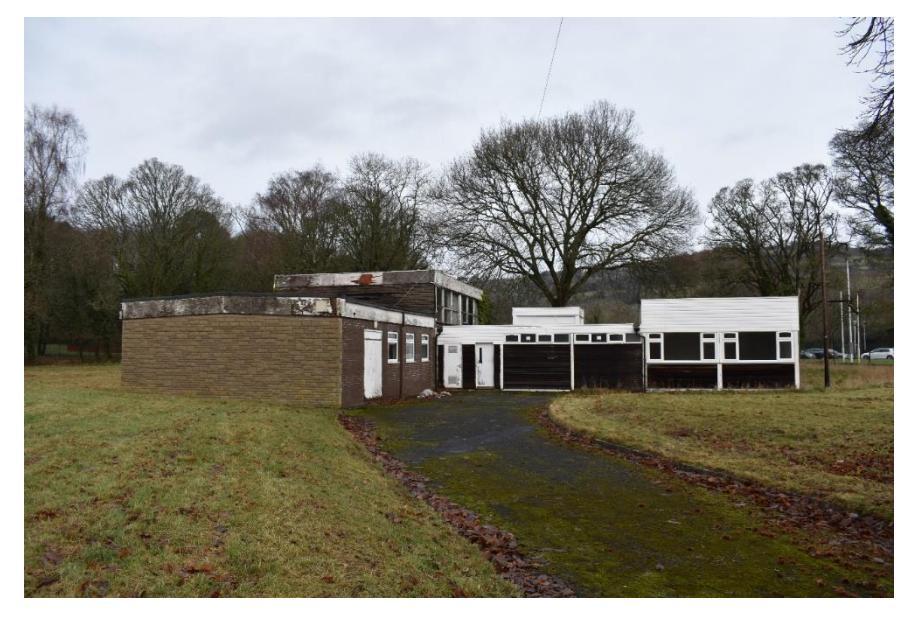
4.15. The building (Fig. 24) appears to have two phases, both probably dating from the 1970s. The original building comprised a two-storey block in dark brickwork, with a single-storey block adjoining to the south-west, built in the same brick, but with a dressed stone end wall. Both sections had a flat roof. The building was extended to the south-east by the addition of two single-storey, flat-roofed structures built in a pre-fabricated style.

Fig. 24 Building 10 – Hang Gliding Centre, Phase 4. Photo CPAT 4720-0043 Fig. 25 Building 11 – 'Gas Chamber', Phase 4. Photo CPAT 4720-0045

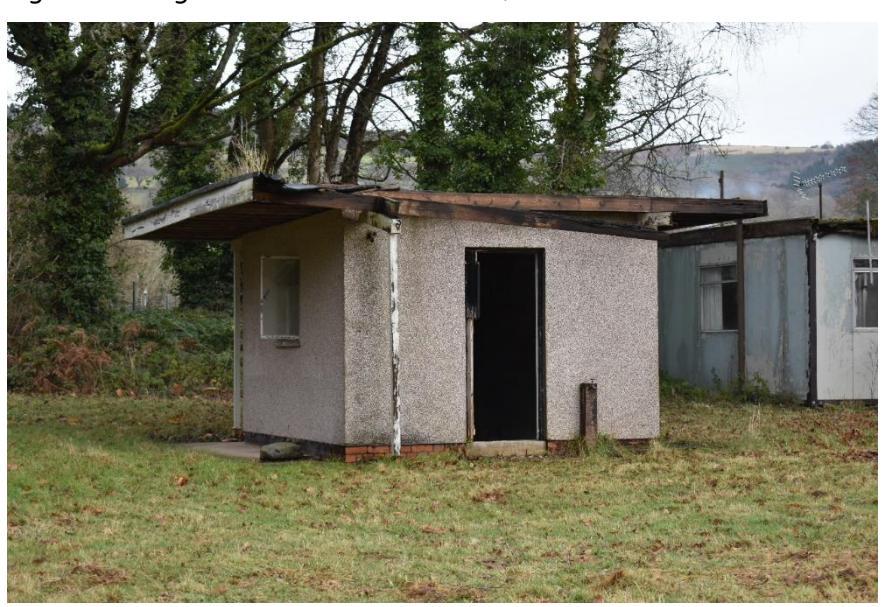
4.16. The small building (Fig. 25), dating from the 1970s, was of brick and render construction with a flat roof which extended beyond the walling to provide a covered area on all sides. It was built to train troops in the use of gas masks and is usually referred to as the 'gas chamber'.

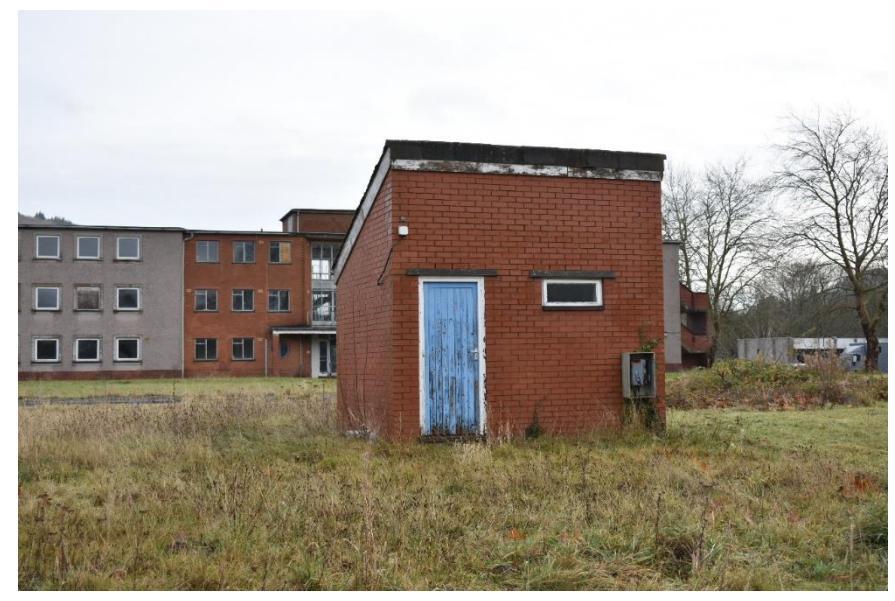
Fig. 26 Building 12 – Unknown, Phase 3. Photo CPAT 4720-0033

4.17. A small, brick-built structure with a sloping roof (Fig. 26), lying between two demolished accommodation blocks. Its function is not known.

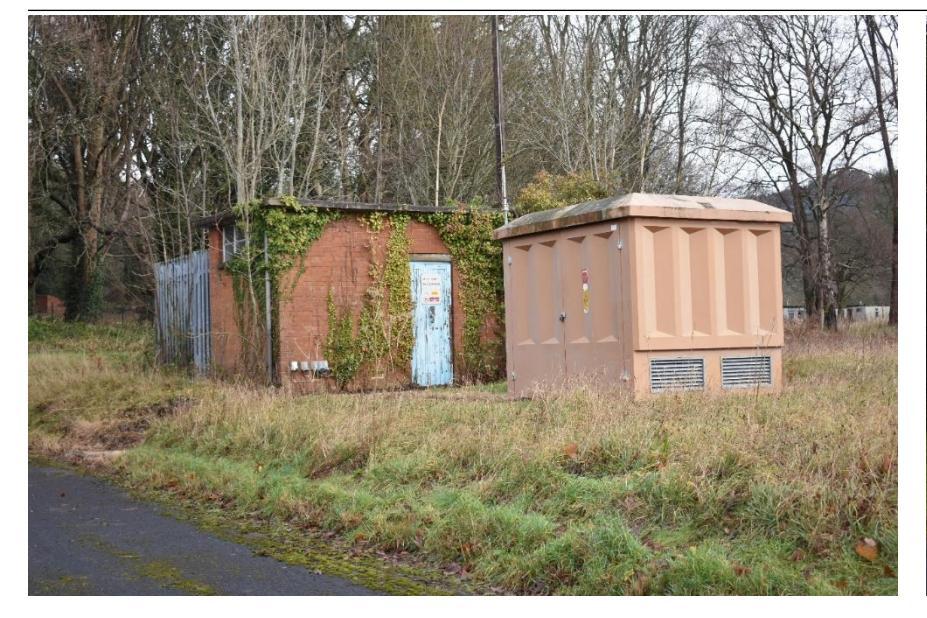
4.18. The Switch Room (Fig. 27) lay east of the Boiler House and dates from 1958-63. It was built of red brick with a flat roof.

Fig. 27 Building 13 –Intake Switch Room, Phase 3. Photo CPAT 4720-0031 Fig. 28 Building 14 – Squash Court, Phase 4. Photo CPAT 4720-0027

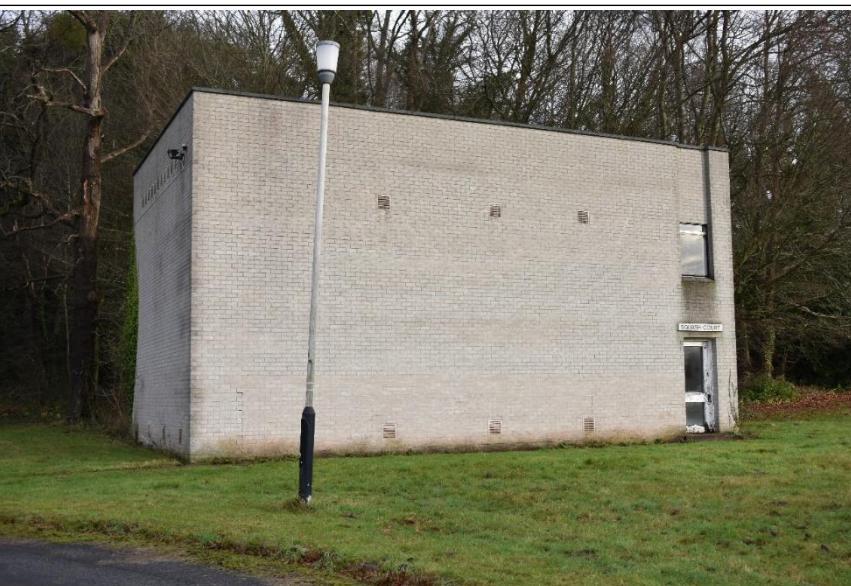
4.19. The Squash Court (Fig. 28) lay to the north-east of the Headquarters Building and dates from the 1970s. It was built of pale brick with a flat roof. The south-eastern end had an entrance door with a window above on the first floor viewing gallery.

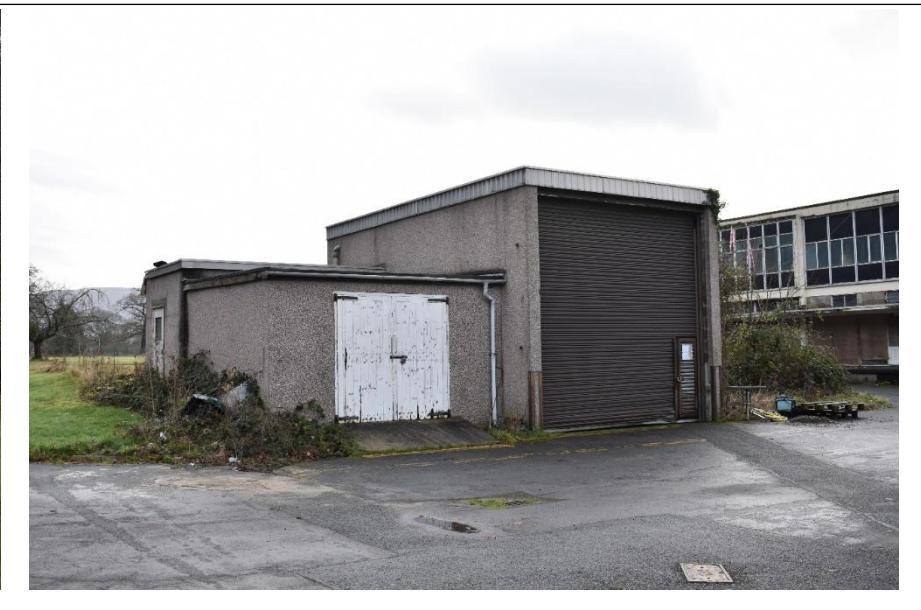
Fig. 29 Building 15 – Store, Phase 3. Photo CPAT 4720-0023

4.20. The store block lay north-east of the Headquarters Building and dates from 1958-63. It comprised three adjoining concrete structures with flat roofs (Fig. 29). The taller building had a floor to ceiling door on the north-west side.

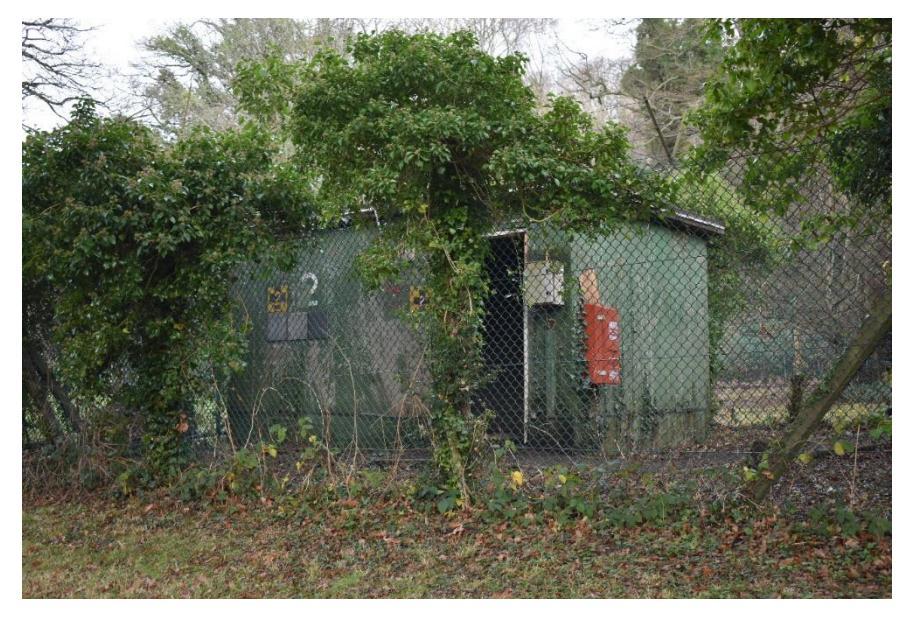
Fig. 30 Building 16 – Ammo Store, Phase 3. Photo CPAT 4720-0025

4.21. The Ammo Store (Fig. 30) lay to the north of the Headquarters Building and was one of six which date from 1958-63. Of these only two lay within the development site, one of which has been demolished. The store was built in concrete with a single door and flat roof. The stores were used a temporarily store ammunition brought in by troops during training and exercises at Cwrt-y-Gollen.

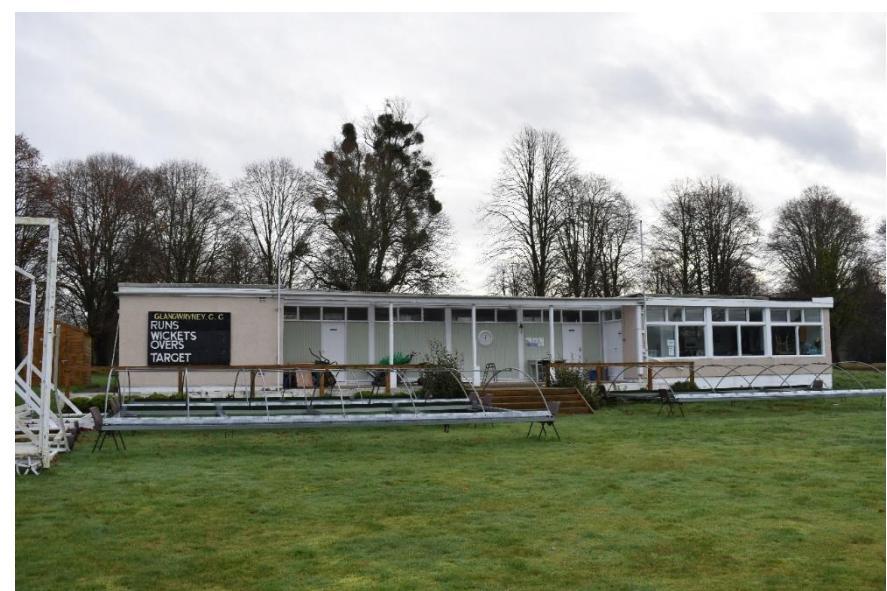
Fig. 31 Building 17 – Pavilion, Phase 4. Photo CPAT 4720-0014

4.22. The pavilion lay to the north-west of the main access road, on the south-east side of what is now a cricket pitch, being the ground of Glangrwyrney Cricket Club. The building was of rendered block or brick, with timber and glassing facing the cricket pitch, and a flat roof.

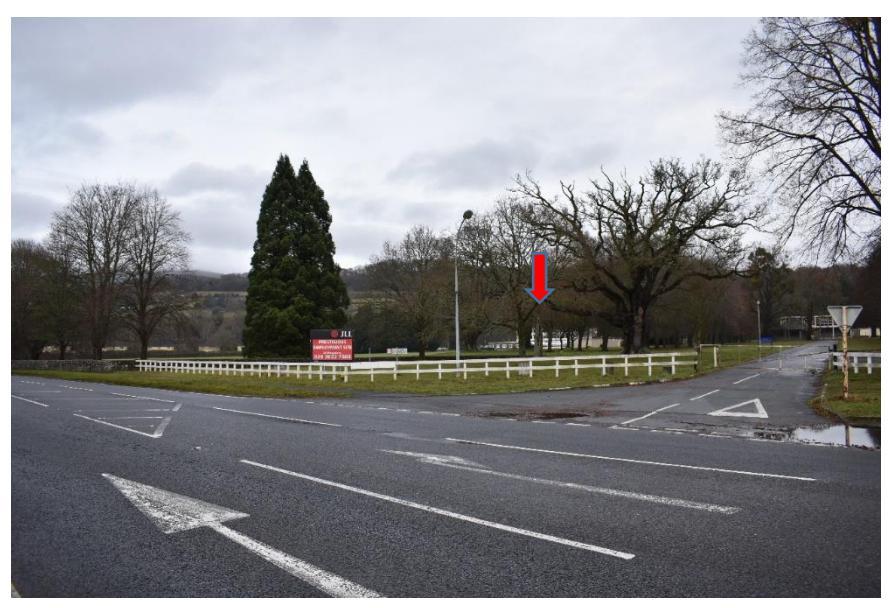
Fig. 32 Location of the Section 278 works showing standing stone BR 113 arrowed

arrangements are not currently available it is understood that work will be limited to replacing kerbs, reducing the height of a stone wall to the north-west of the entrance and replacing existing road markings with a new layout and signage. This will not involve any significant groundworks and the potential for impacts to any buried archaeological deposits is considered to be negligible. The proposals are also considered to have no more than a negligible visual impact on the scheduled standing stone and its setting, although Cadw should be consulted once the proposed changes have been finalised in order to elicit their views on the scheme.
