# West Penyllan, Montgomery, Shropshire Heritage Impact Assessment

Report by: Trysor

**For:** Roger Parry and Partners

Trysor Project No. 2016/507

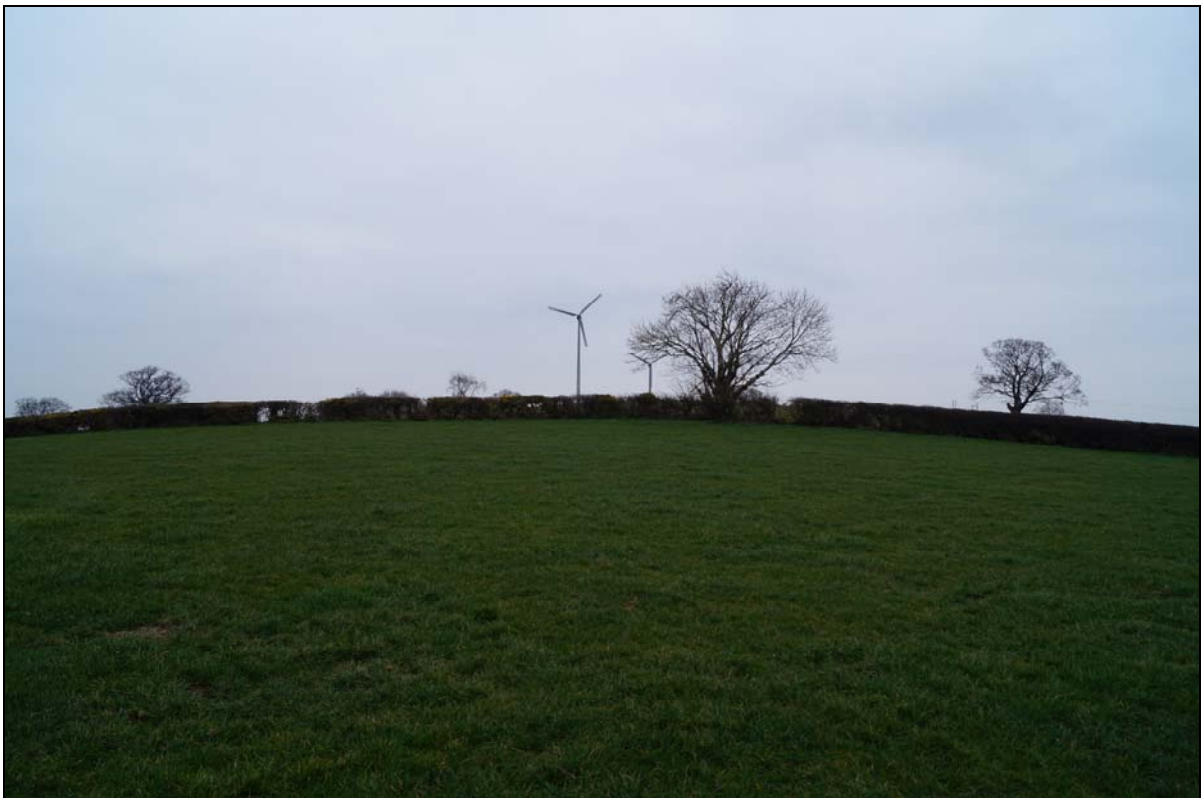
*Cover photograph: Looking east towards the existing turbines in the adjacent field with the top of the phone mast just visible to the right. Offa's Dyke and Brompton forts are over 1.5 kilometres from the turbine in this direction*
