Building Survey and Photographic Record (Level 1)

Photographic Record (Volume 2)

Former Custom House, Custom House Street, Cardiff

July 2018

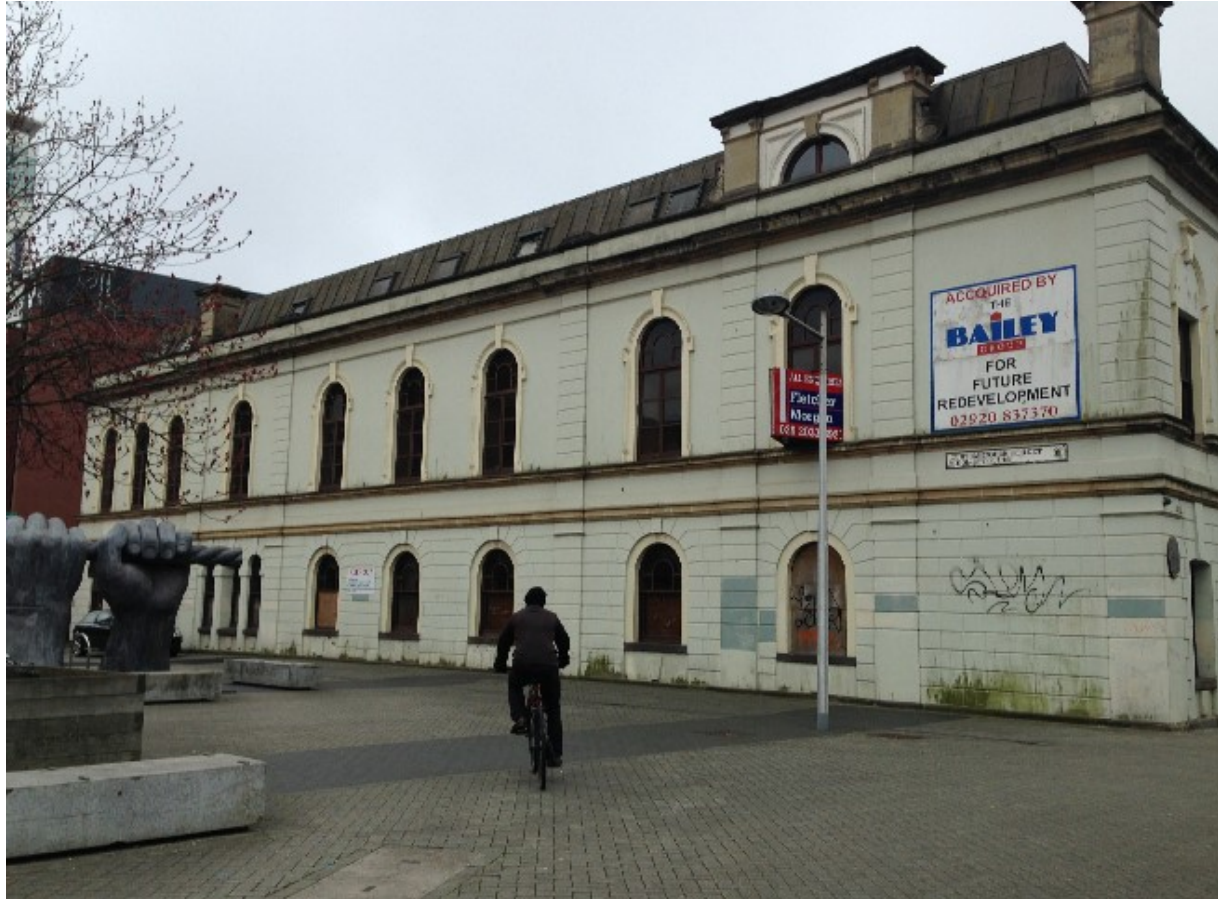
North Elevation

Photo ref	01
Photo Location	North Elevation.
Details	Two storey building with modern hipped Mansard roof above, as viewed from the north west of the Site. Frontage is comprised of stucco with some bathstone dressings. Rusticated ground floor. The north elevation is asymmetrical articulated by banded pilasters into six bays, with windows grouped 3+1+3+1+1+blank.

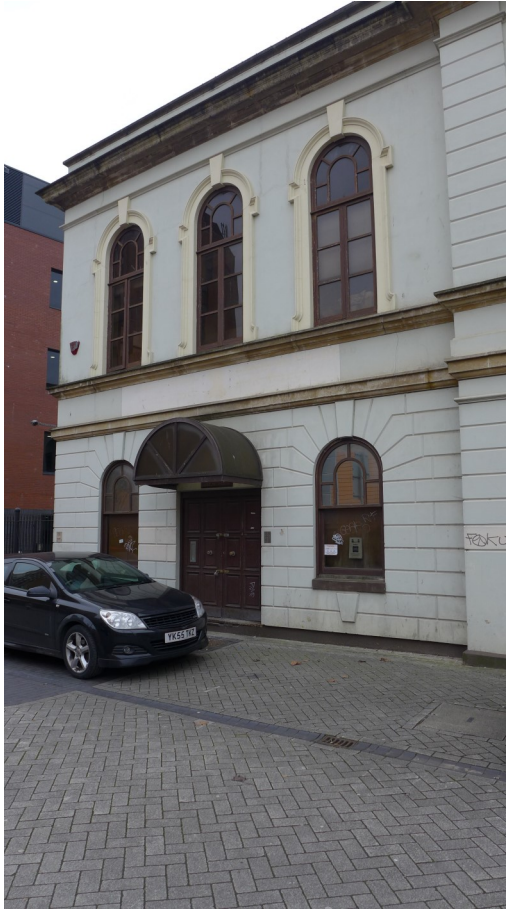
North Elevation (Eastern Bay)

Photo ref	02
Photo Location	North Elevation (Eastern bay)
Details	Eastern bay of North Elevation, showing doorway under modern canopy flanked by round-headed windows.

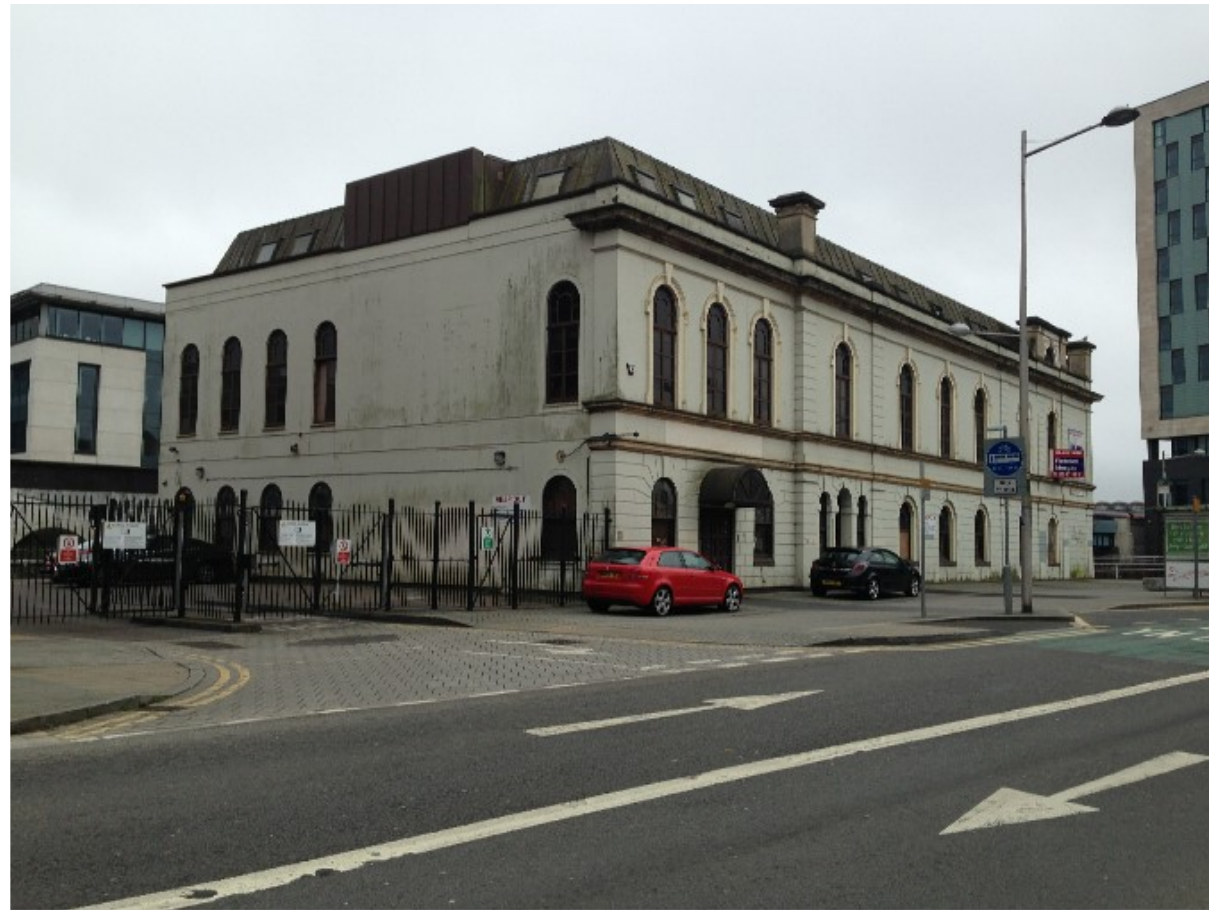
Photo ref	03
Photo Location	East and North Elevations
Details	View of the eastern and northern elevations, from the north east. The eastern elevation is late 20 th century in date and of a plain, utilitarian character. The return of the North Elevation has storeys articulated by channelling in render. The image shows the road infrastructure close to the site.

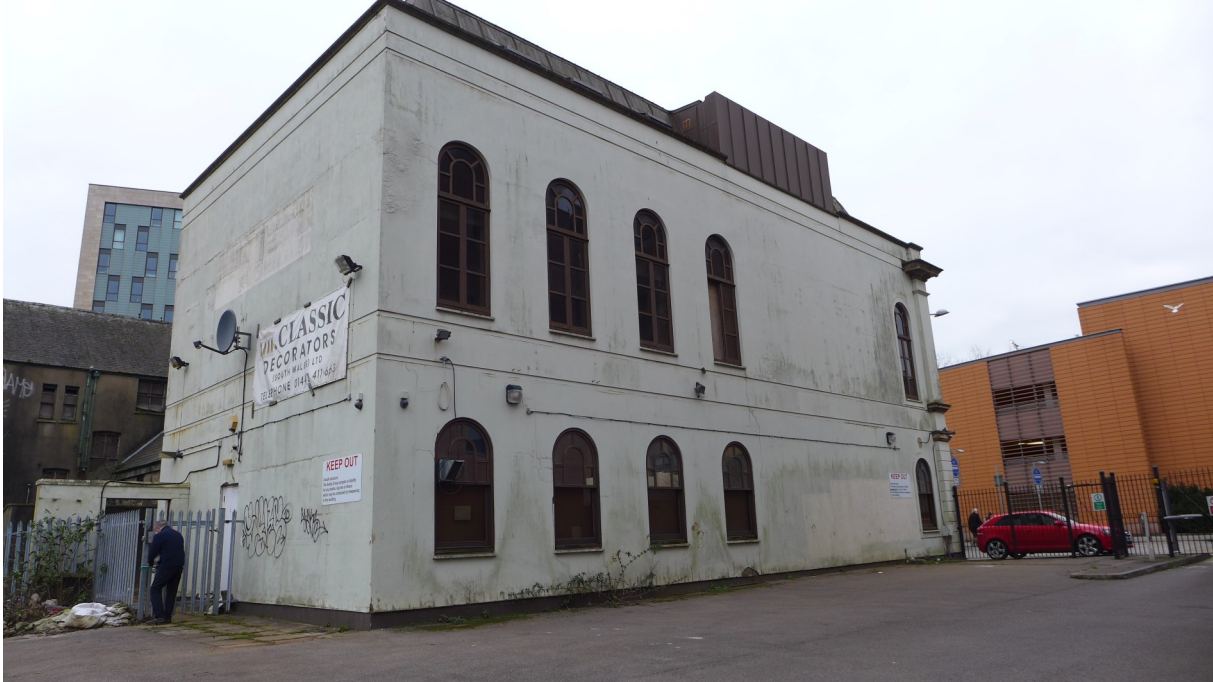
Photo ref	04
Photo Location	East Elevation
Details	The eastern elevation is late 20 th century in date and of a plain, utilitarian character.

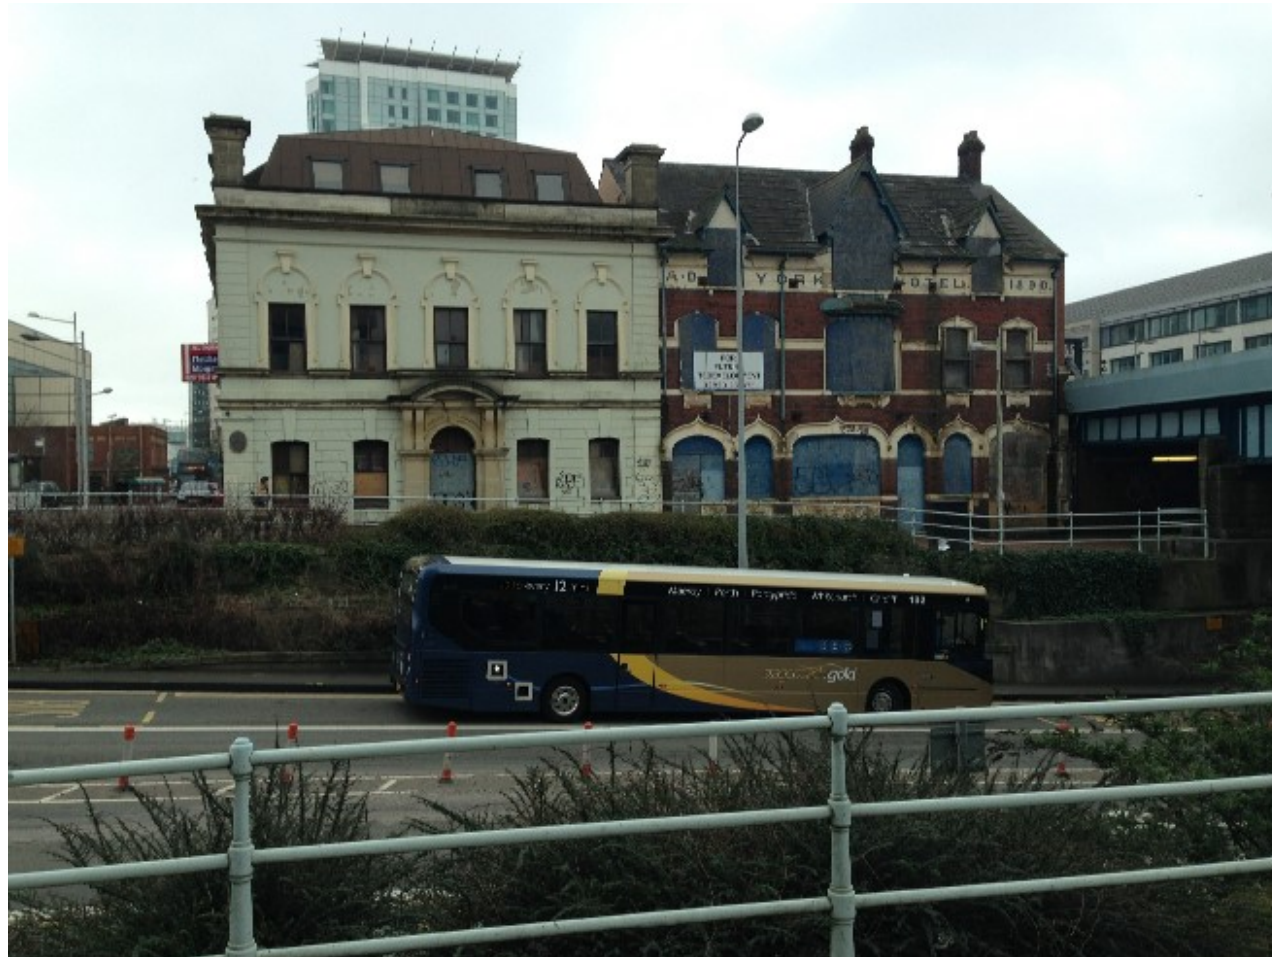
West Elevation

Photo ref	05
Photo Location	West elevation.
Details	View of the western elevation from the west. Two storeys with modern hipped Mansard roof above. Rusticated ground floor. Frontage is comprised of stucco with some bathstone dressings. The west elevation has 5 bays with ground floor central doorway. Corner chimneys, square with cornice. Stone cornice and parapet with inscription 'Custom House'. The image shows the road infrastructure close to the site.

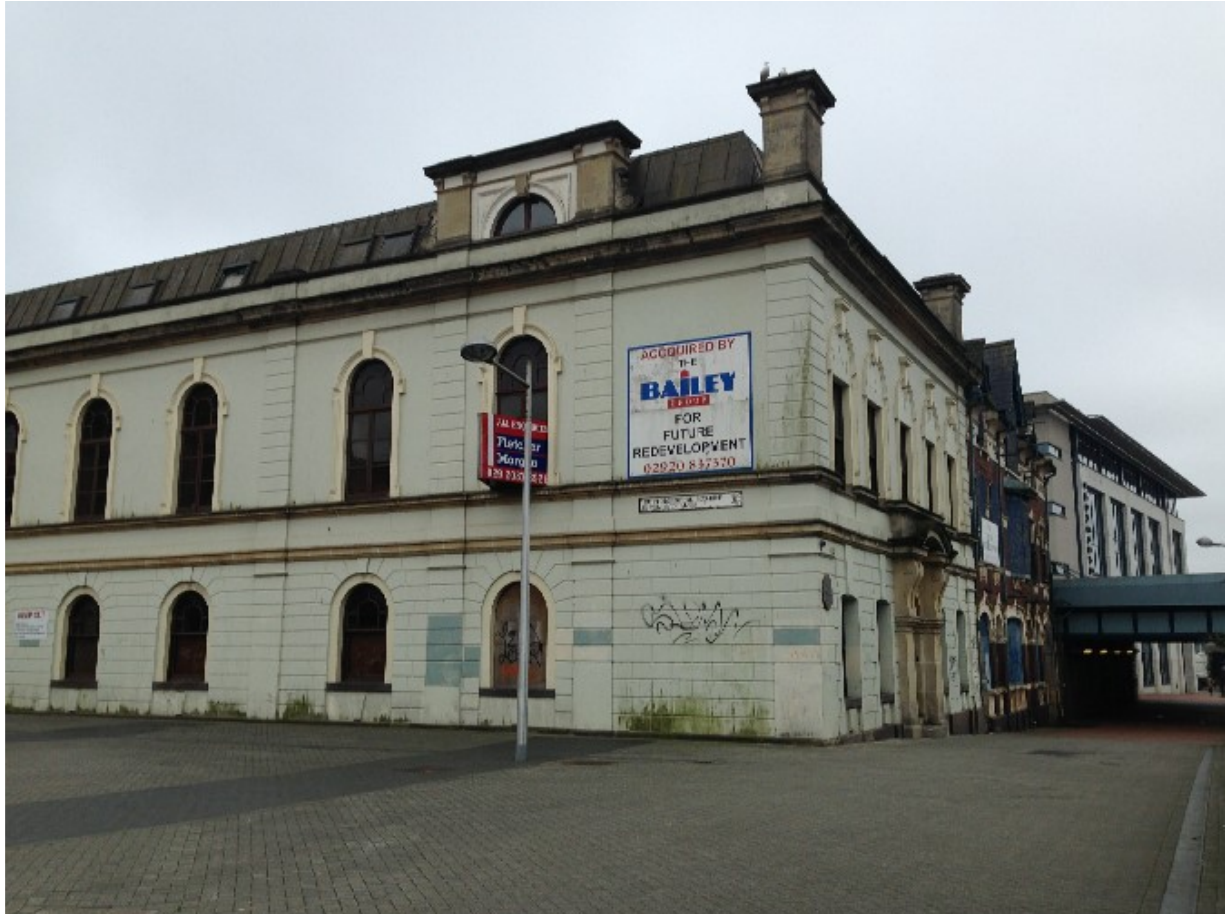
Photo ref	06
Photo Location	North and West Elevations
Details	View of the northern and western elevations, from the north west. Image includes attic lunette to North Elevation, framed by squat pilasters with scrolls, and low entablature.

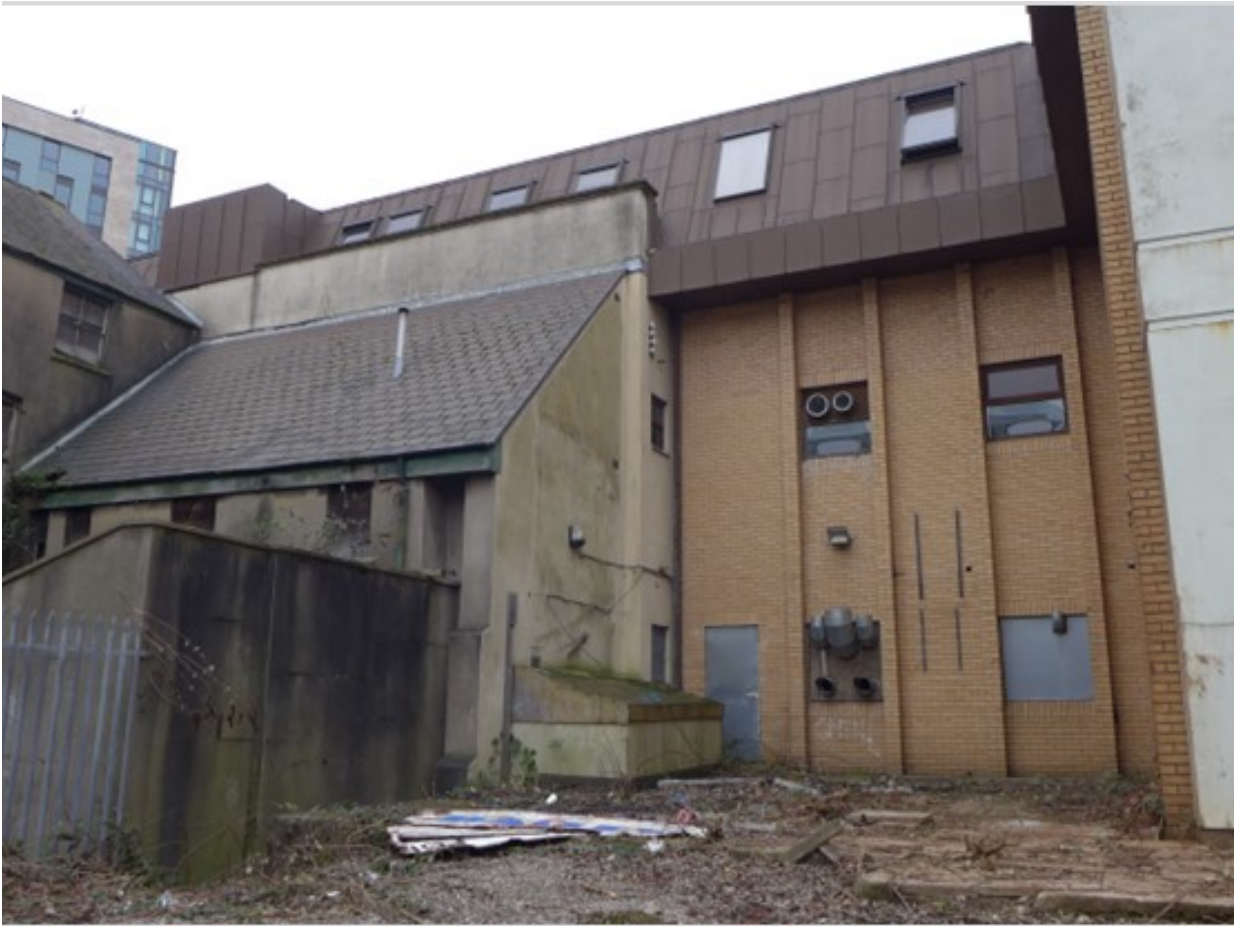
South Elevation

Photo ref	07
Photo Location	South elevation.
Details	View of the southern elevation from the south east. The southern elevation is late 20 th century in date and of a plain, utilitarian character

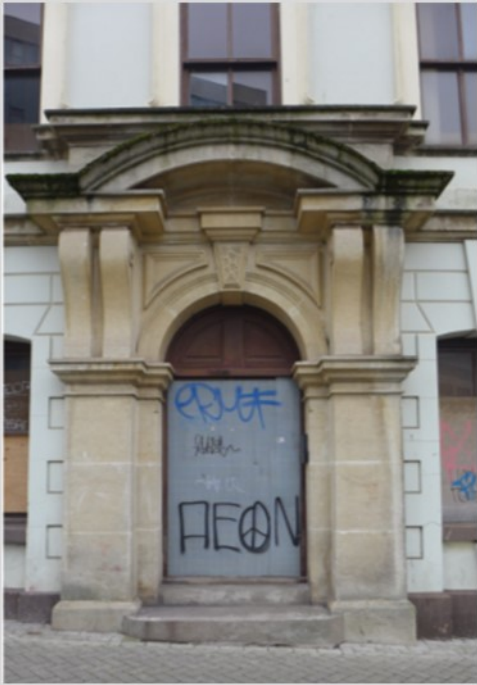
West Elevation: Central doorway

Photo ref	08
Photo Location	West Elevation: Central doorway.
Details	View of central doorway with segmental pediment supported by paired tall brackets on tall plinths; round headed entrance doorway with keystone.

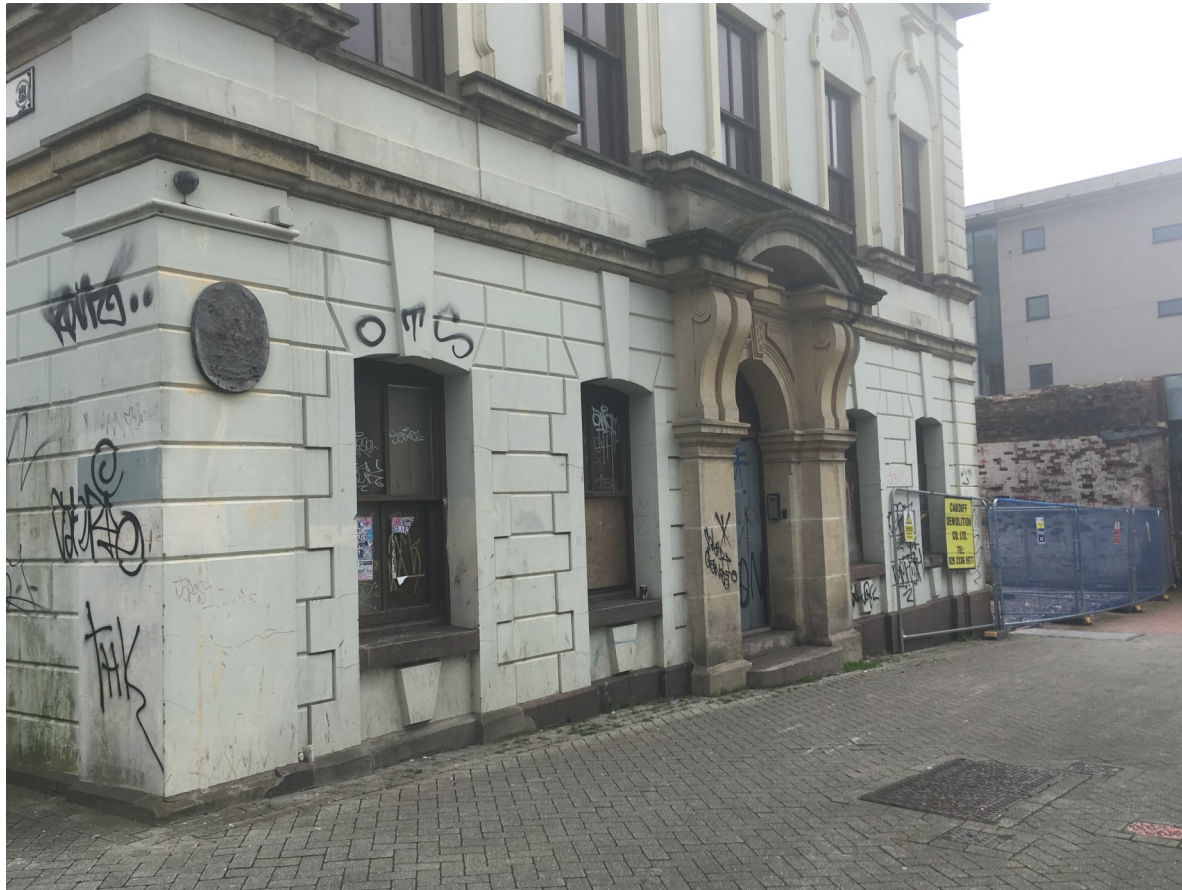
Photo ref	09
Photo Location	West Elevation: Ground floor
Details	View of ground floor windows camber-headed with tall keystones.

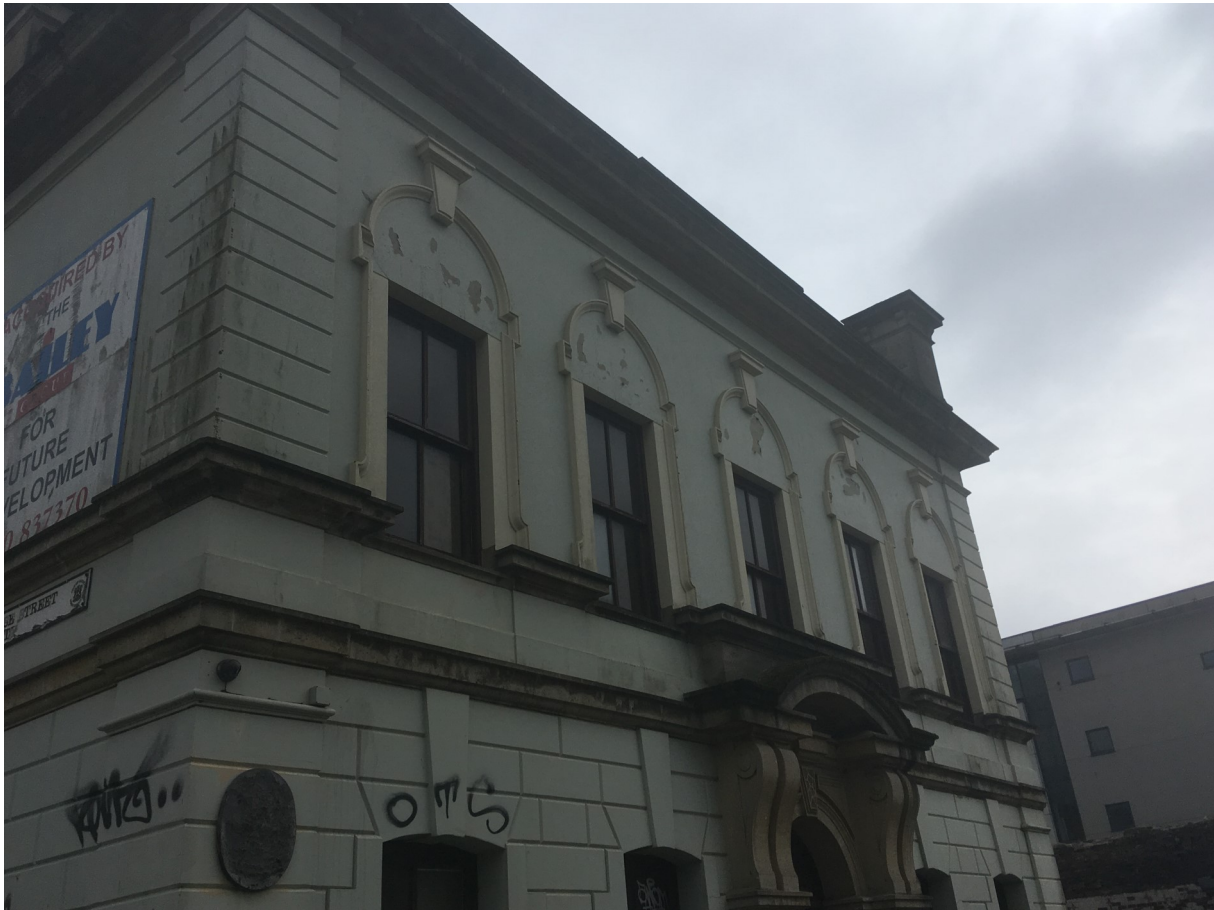
Photo ref	10
Photo Location	West Elevation: First floor
Details	View of first floor windows with square-headed sashes but round-headed shouldered surrounds with keystones.

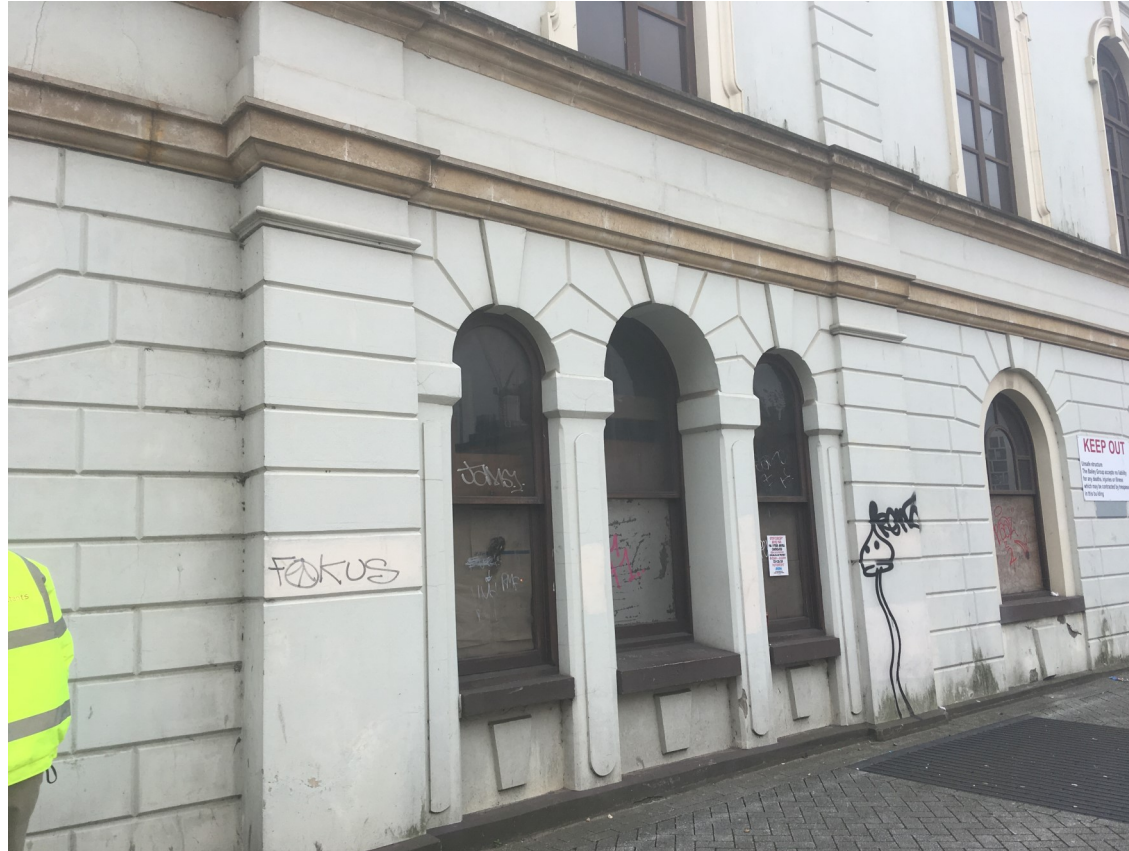
Photo ref	11
Photo Location	North Elevation: Ground floor
Details	View of ground Venetian window and, to left, example of round-headed ground floor window with keystone (present elsewhere at ground floor on North Elevation). All ground floor windows have aprons below sills with keystone-like decoration.

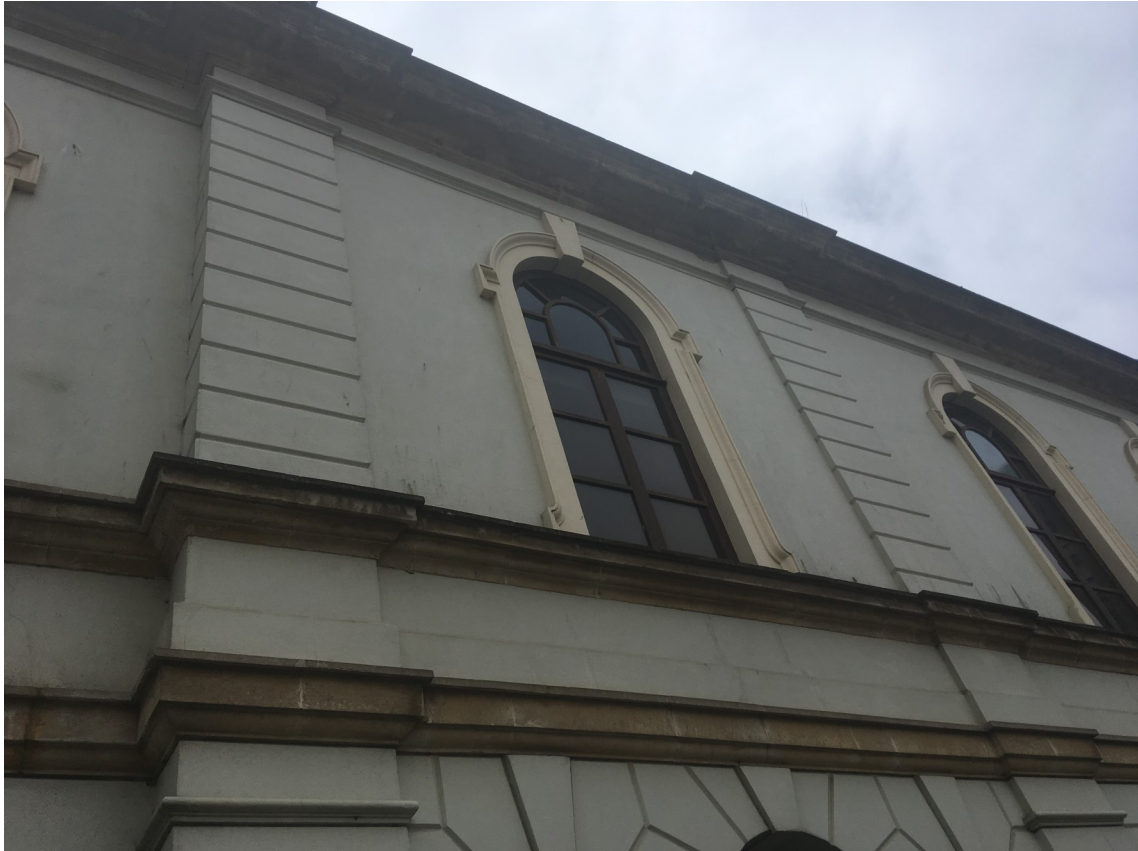
Photo ref	12
Photo Location	North Elevation: First floor
Details	View of first floor round-headed windows with horned and keystoned surrounds. Cornice at sill level.

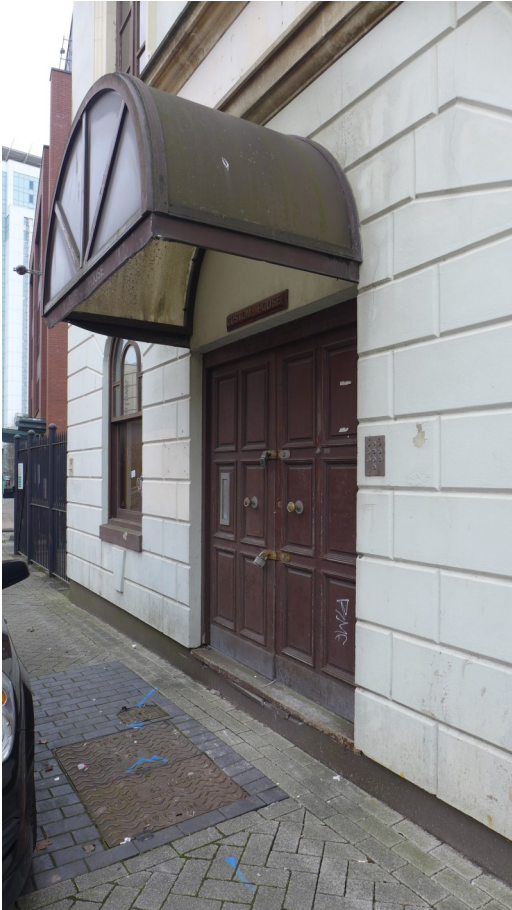
Photo ref	14
Photo Location	North Elevation (Eastern bay): Ground floor
Details	View of doorway under modern canopy to Eastern bay of North Elevation

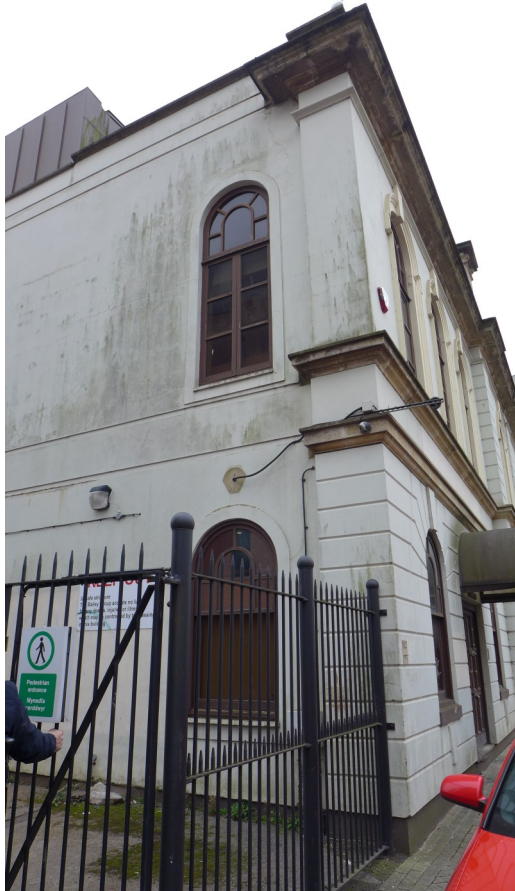
Photo ref	15
Photo Location	East and North Elevations
Details	View of corner junction between East and North Elevations

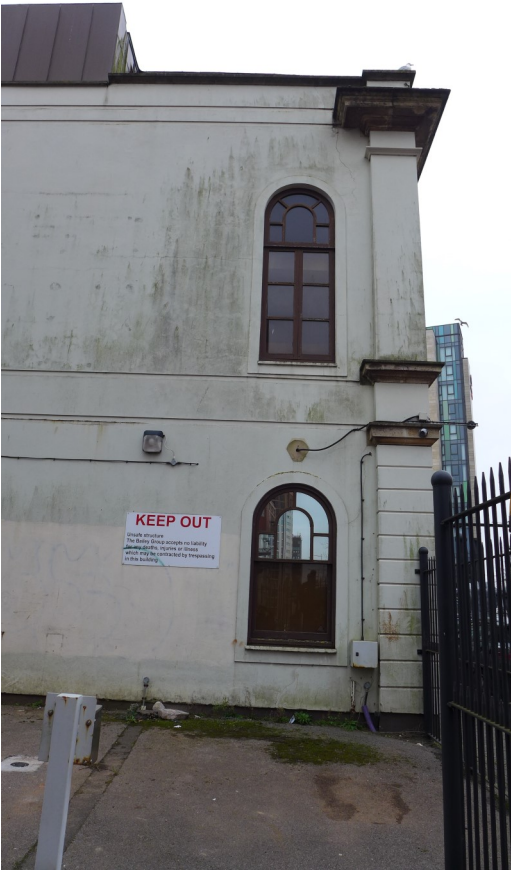
Photo ref	16
Photo Location	East and North Elevations
Details	View of corner junction between East and North Elevations
