Plas y Berllan, Llechryd, Pembrokeshire Historic Environment Appraisal

Report by: Trysor

Trysor Project No. 2014/400

RHIF YR ADRODDIAD - REPORT NUMBER: Trysor 2014/400

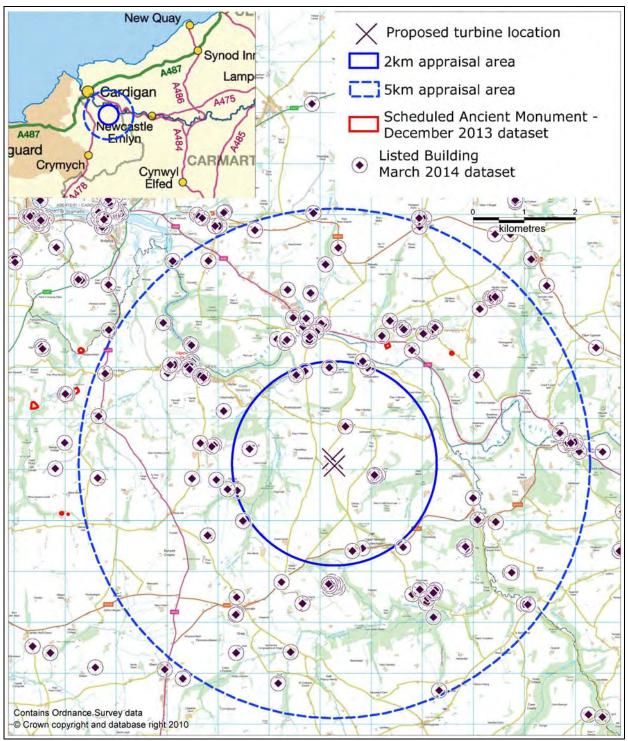
Figure 1: Location of the proposed turbine, showing the 2km radius and the 2 to 5km radius appraisal areas.

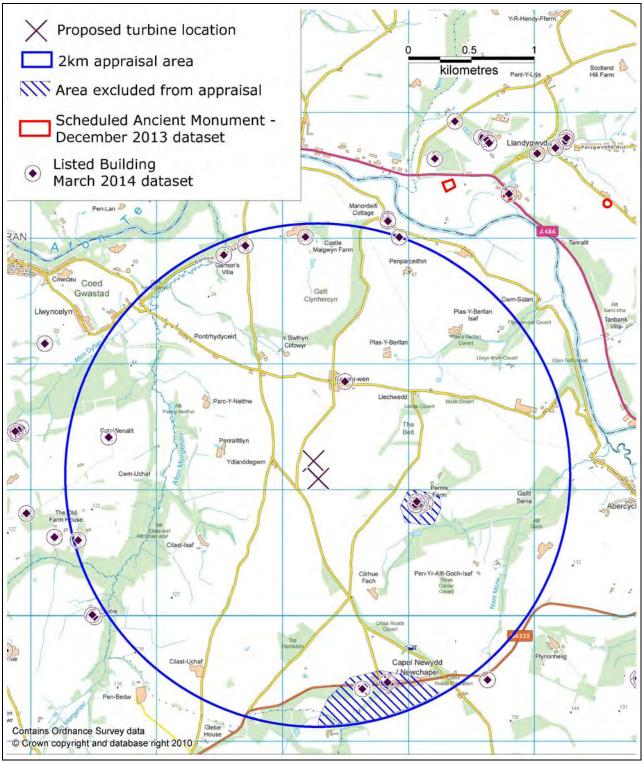
Figure 2: Areas excluded from the 2km appraisal area

- 5.1 A study area of 2km radius centred on SN2228041115, a point between the proposed two turbines, was chosen for the initial appraisal of all recorded historic assets. This area was revised to exclude two small areas which would have no intervisibility with the turbines and no impact on setting, see Figure 2.

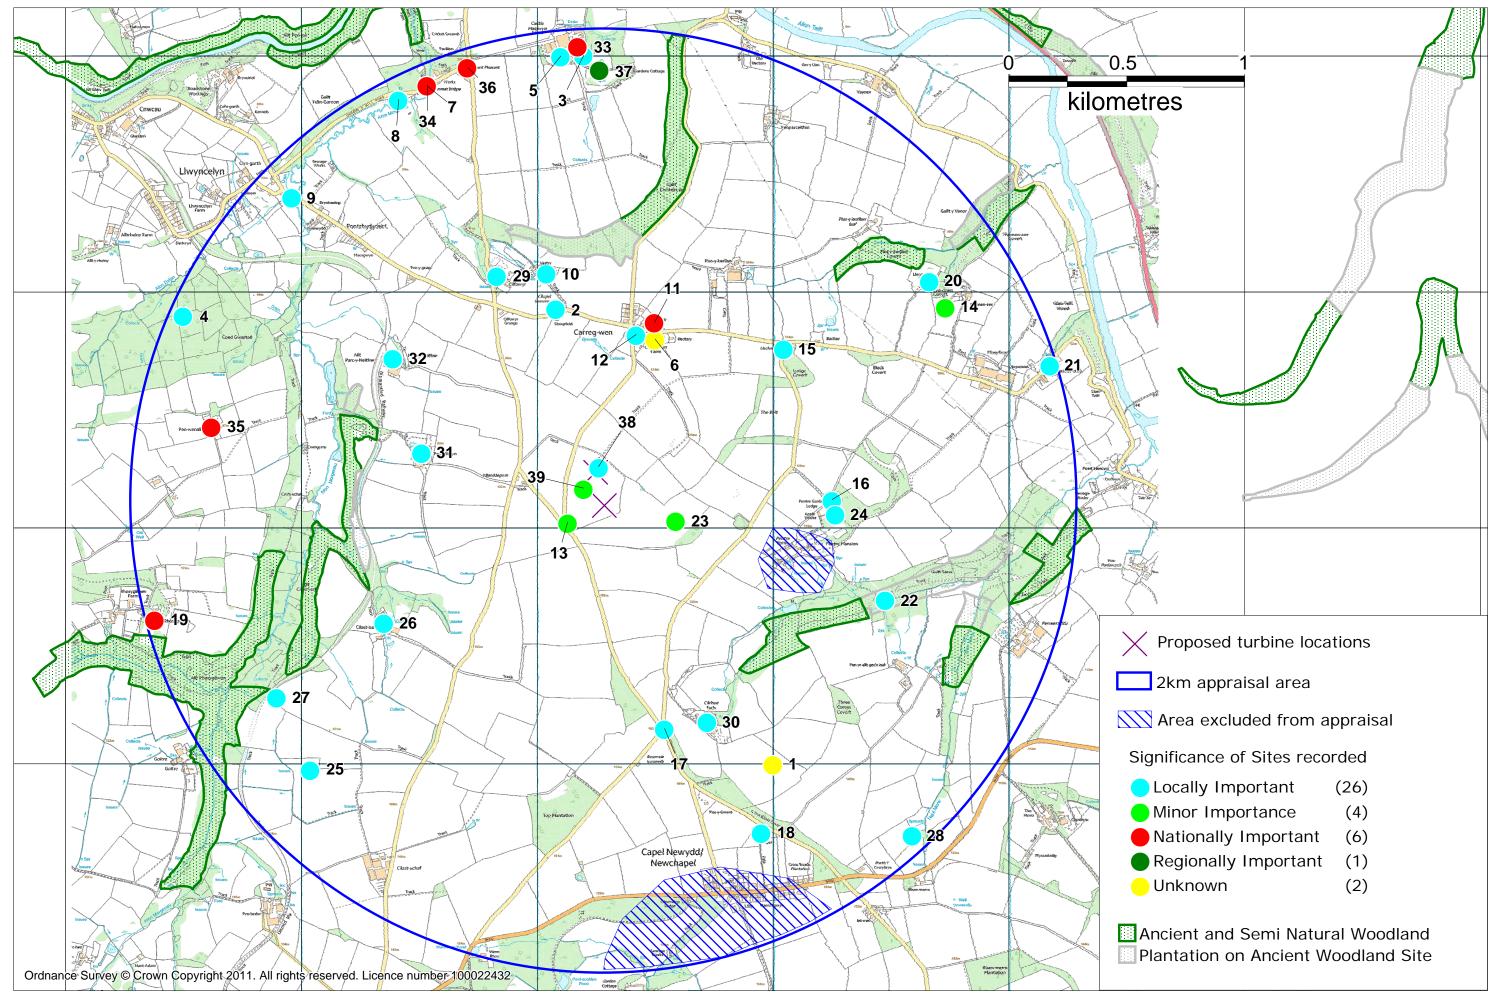
Figure 3: The 2km appraisal area showing significance of sites, labelled with Project ID number

- Locally Important, Minor and Features Needing Further Investigation (Unknown), see Figure 3. Full details of this exercise are given in Appendix D.
- 5.11 As this exercise is an appraisal of the study area, not a full desk-based historic environment assessment, no site descriptions have been included in the appraisal dataset or this printed report, apart from newly recorded features (See Appendix C).

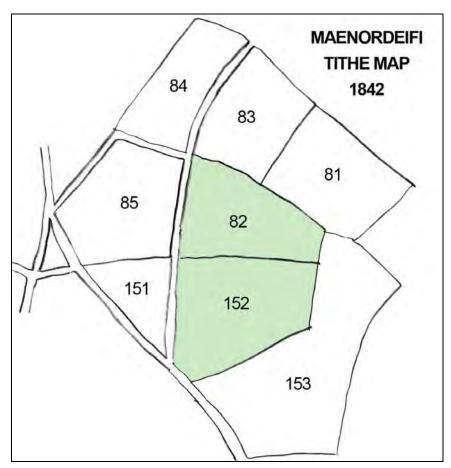
Figure 4: Proposed turbine site as shown on parish tithe map of 1842. Fields shaded in green are now the single field where the turbines would stand.

- 7.1.3 The first detailed map of the field system of the area is the Maenordeifi parish tithe map of 1842, see Figure 4. This shows that the field system at the proposed turbine site was already established. The field boundaries which define the development site today were already in place, although this map shows that the parcel was in fact two fields, not one. To the north was field parcel number 82, which belonged to Parcyneithwr farm and to the south was field parcel number 152, which belonged to Penalltyn farm. Both farms were owned by a Miss Jane Jones, who lived at Penalltyn. The field names are not given on the accompanying tithe schedule.

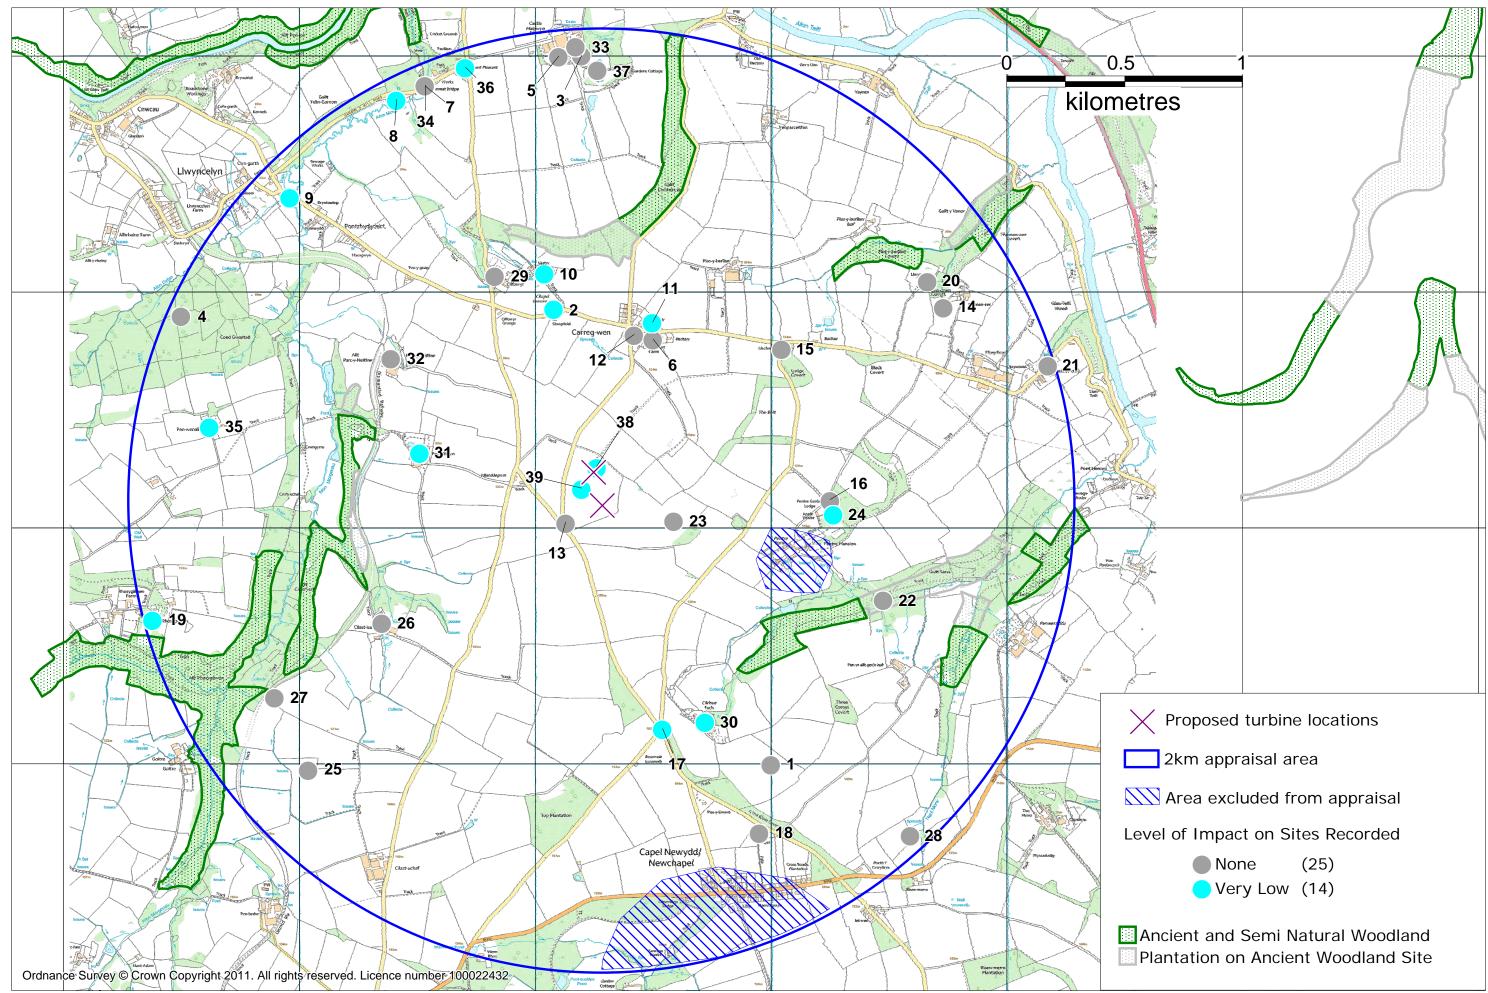
Figure 5: The 2km appraisal area showing level of impact on sites recorded, labelled with Project ID number

- 8.7 The Direct and Indirect impact on each site was assessed taking into account both physical and non-physical impacts. Each impact was assessed within the scale Very Low, Low, Moderate, High and Very High, taken into account the significance of the site and the nature of the impact. A full table is found in Appendix B but a summary is tabulated in Table 1 below and illustrated in Figure 5.

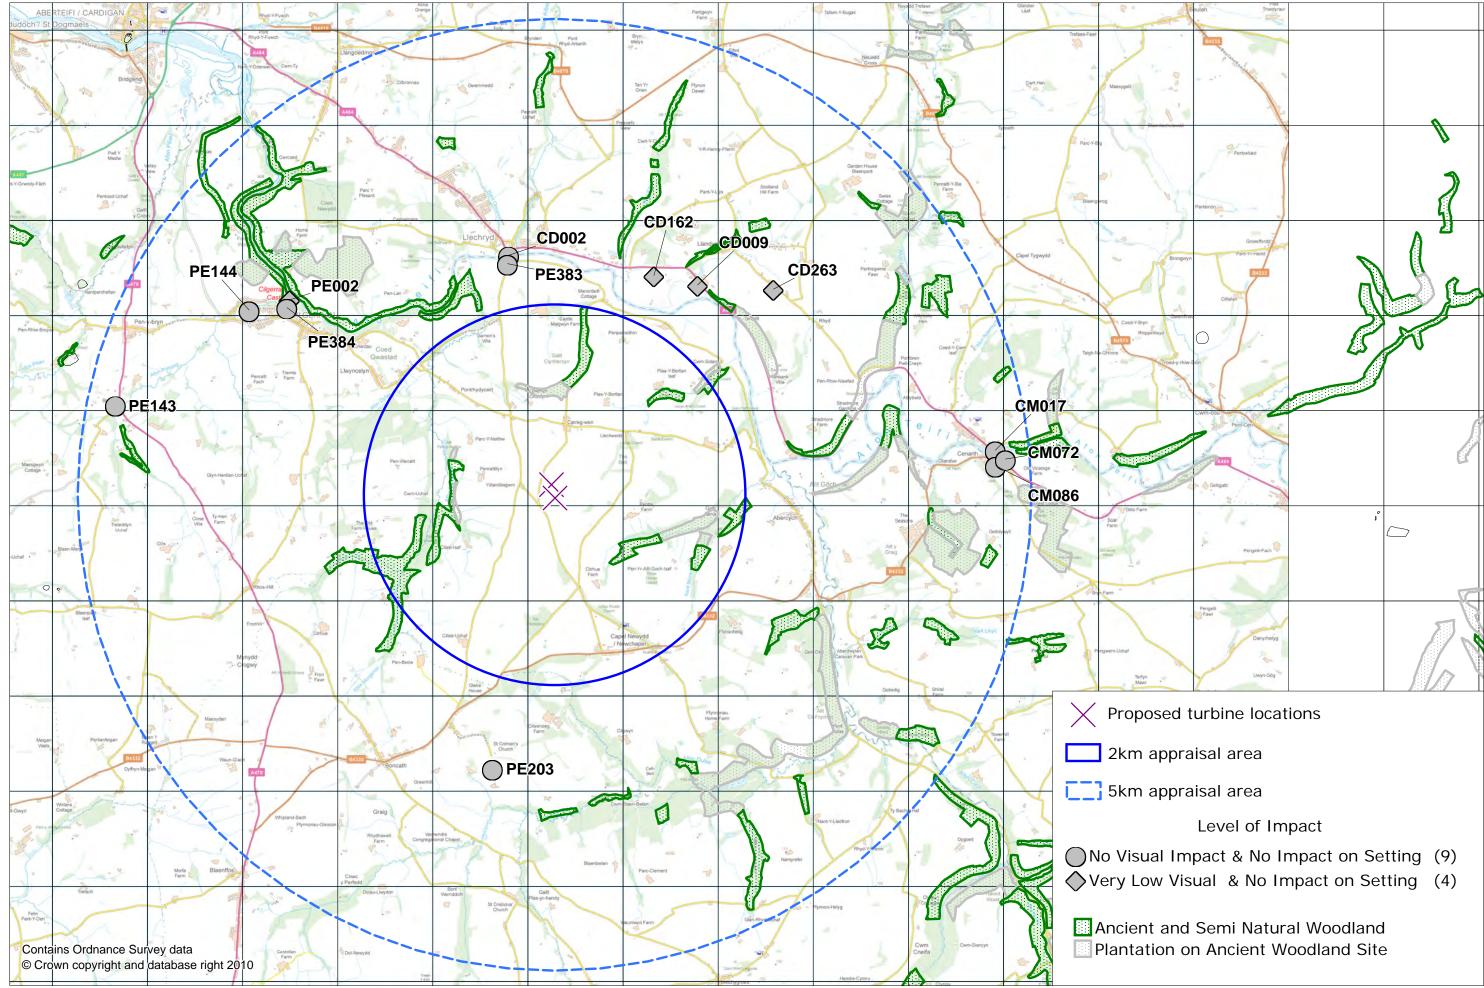
Figure 6: The 5km appraisal area showing level of impact on SAMs in the 2 to 5km area, labelled with SAM number

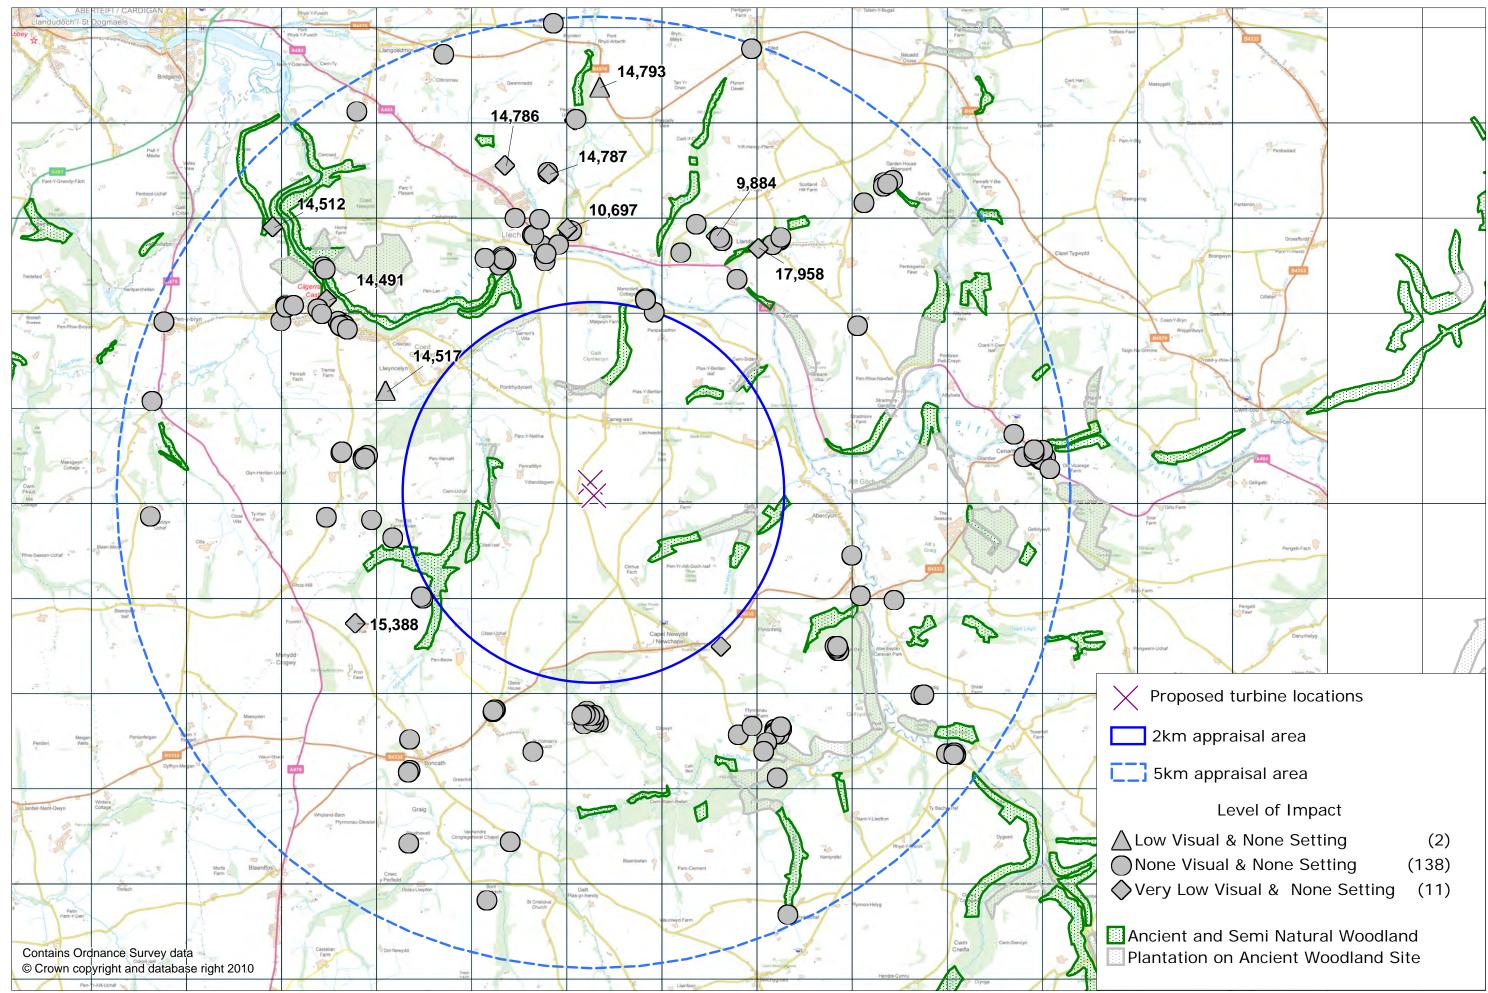
Figure 7: The 5km appraisal area showing level of impact on Listed Buildings in the 2 to 5km area, labelled with Listed Building number where any form of impact

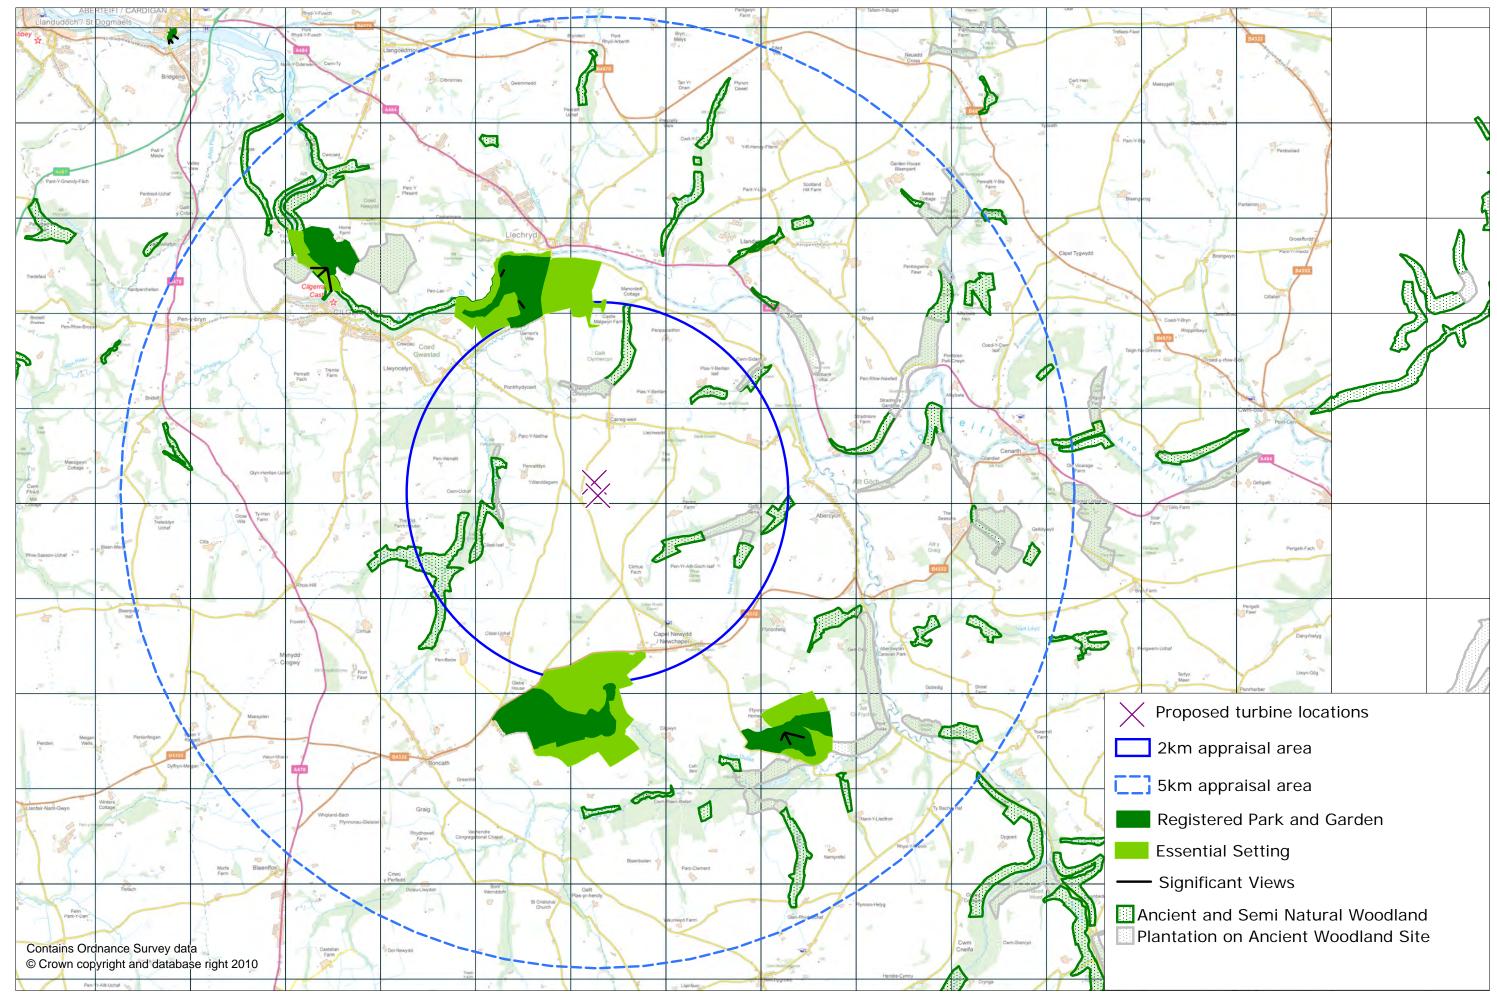
Figure 8: The 5km appraisal area showing registered Parks and Gardens in the 2 to 5km area, labelled with Parks and Gardens number

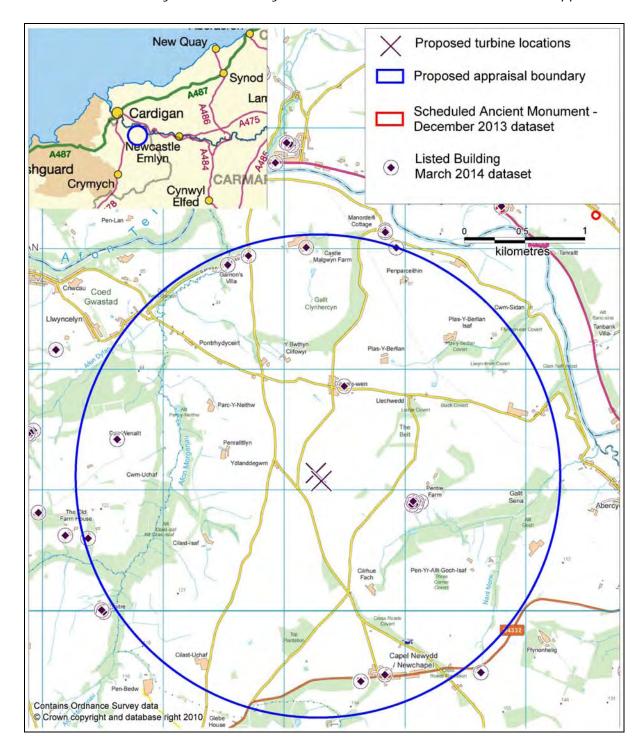
Figure 1: The proposed location of the turbine and the proposed area of the appraisal.
