Impact on Setting and Significance relating to a Proposed Agricultural Building and Access Track Bryn Derwen Mound and Bailey, Abermule, SY15 6JP Planning Application 24/0468/FUL

Trysor Project No. 2024/945 HER Event Record PRN – Heneb - CPA 218165

RHIF YR ADRODDIAD - REPORT NUMBER: Trysor 2024/945

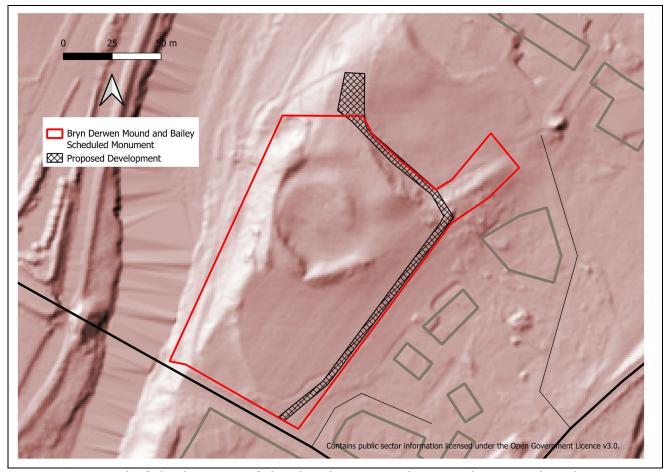
Figure 2: Detail of the location of the development, showing the agricultural building as well as the access track/hardstanding, and the scheduled Bryn Derwen Mound and Bailey Castle.

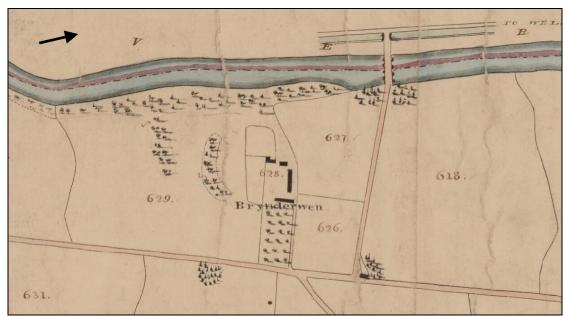
Figure 2: The 1839 Llandysul parish tithe map shows Brynderwen Farm but does not map the castle, which occupies the area of the curved woodland parcels to the left of Brynderwen in the image. Field Parcels 626, 627 and 629 are simply called "Piece by the House" (Llyfrgell Genedlaethol Cymru – The National Library of Wales).

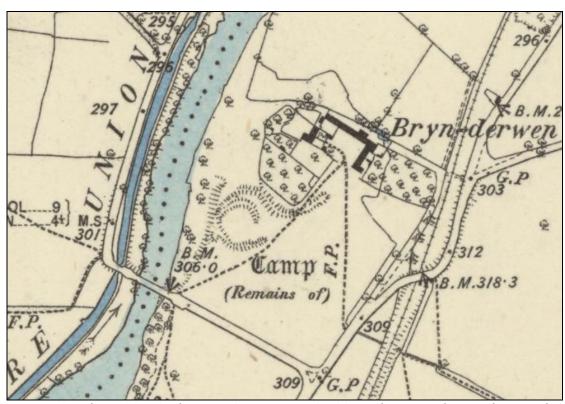
Figure 3: The 1885 Ordnance Survey 1:10560 scale map shows the castle relatively well. It shows the upstanding earthworks which can still be seen today, but does not map the whole of the monument, which may extend further northeast and southwest as buried archaeological features. (Reproduced with the permission of the National Library of Scotland).

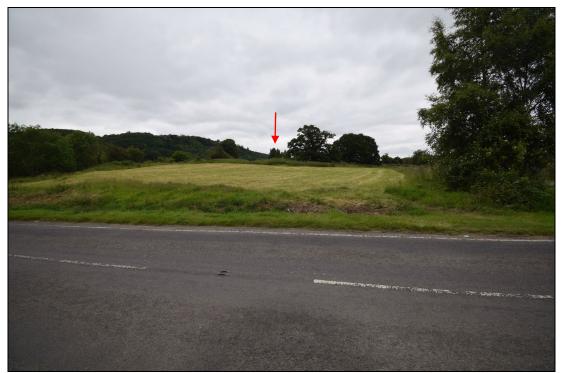
Plate 1: BDR2024_001. A view towards Bryn Derwen Mound & Bailey from the road to the south. A new entrance for the access track would be created right of centre in this image. The roof of the proposed building would be visible in front of the trees arrowed in red. Looking north.

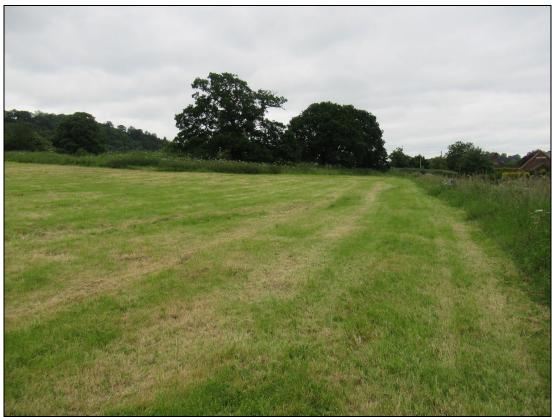
Plate 2: BDR2024_002. A view along the route of the proposed new access track, which would run inside the field boundary to the right. Looking north-northeast.

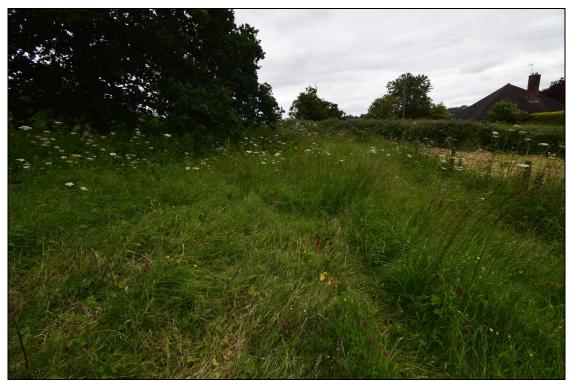
Plate 3: BDR2024_003. A view along the route of the proposed new access track, which would run to the hedge at the centre of the image and turn left. Looking north-northeast.

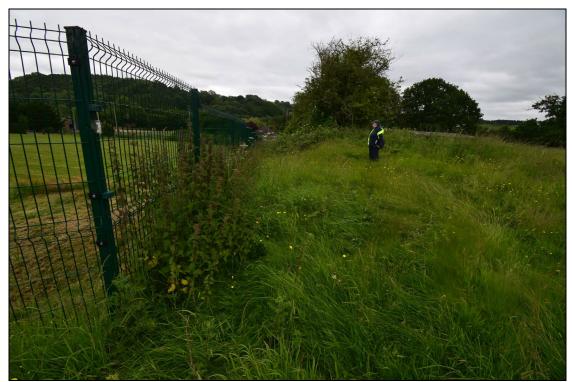
Plate 4: BDR2024_004. A view along the route of the proposed new access track, which would run to the right of the fence seen here, along the outside of the earthwork representing the north rampart of the castle. Looking east-southeast.

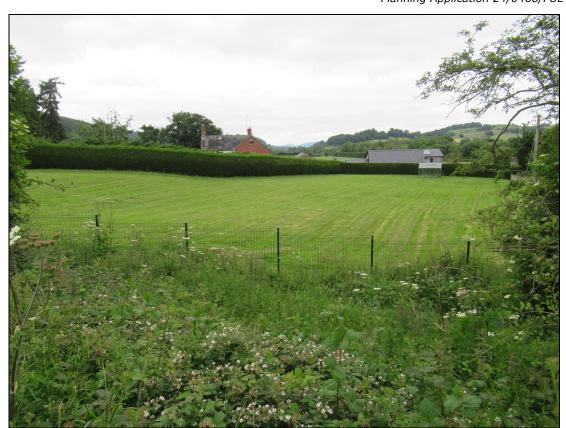
Plate 5: BDR2024_005. A view from the northern rampart of the castle, looking towards Bryn Derwen farm. The proposed access trackway would run in front of the line of the fence in the foreground. Looking north-northeast.

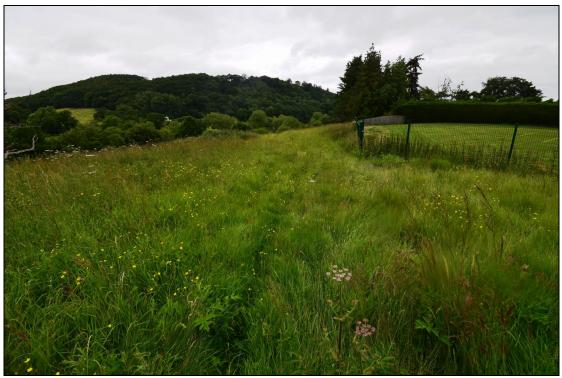
Plate 6: BDR2024_006. A view towards the proposed site of the new building, which would stand to the left of the fence on the level area at the centre of the image. Looking north.

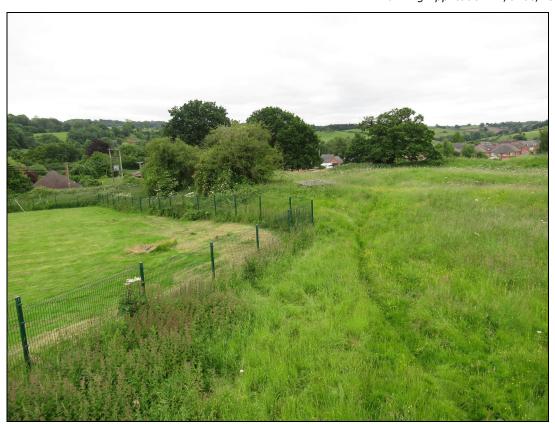
Plate 7: BDR2024_007. A view from 4 metres above ground, taken using a camera pole. The proposed new building would stand in the foreground and the access track would run along the fence to the left. Note the modern housing in Abermule which has appeared close to the monument in modern times. Looking south-southeast.

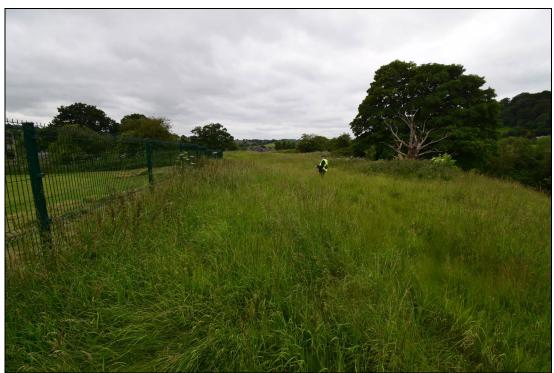
Plate 8: BDR2024_008. A view across the site of the proposed new building, with the castle site beyond and the roofs of modern houses in Abermule in the distance. Looking south-southwest.

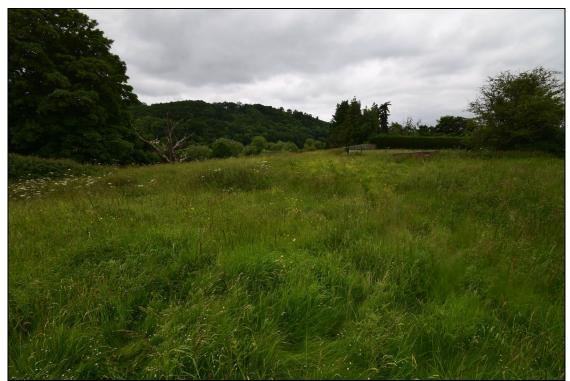
Plate 9: BDR2024_009. A view towards the site of the proposed new building at the centre of the image, looking from the centre of the castle site. Looking north-northeast.

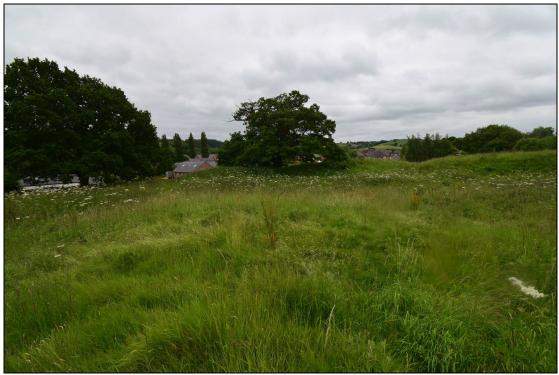
Plate 10: BDR2024_010. A view towards Abermule village, looking from the centre of the castle site. Note the well-preserved ramparts defining the southern edge of the monument. Looking south-southeast.

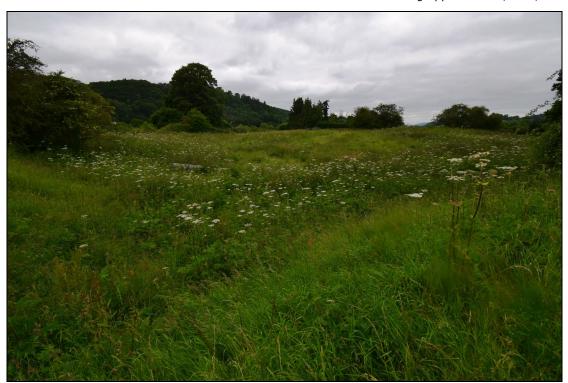
Plate 11: BDR2024_011. A view towards the site of the proposed new building at the centre of the image, looking from the rampart defining the southern edge of the castle site. Looking north.

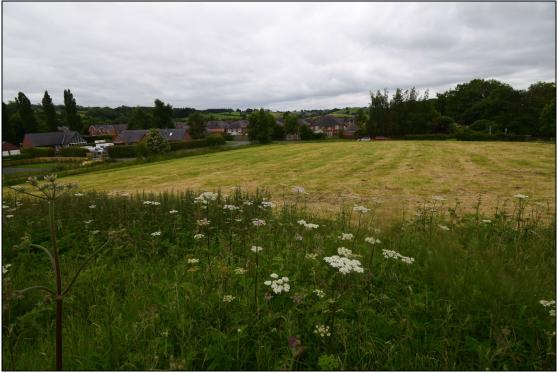
Plate 12: BDR2024_012. A view towards Abermule village, looking from the rampart defining the southern edge of the monument. Looking south-southwest.

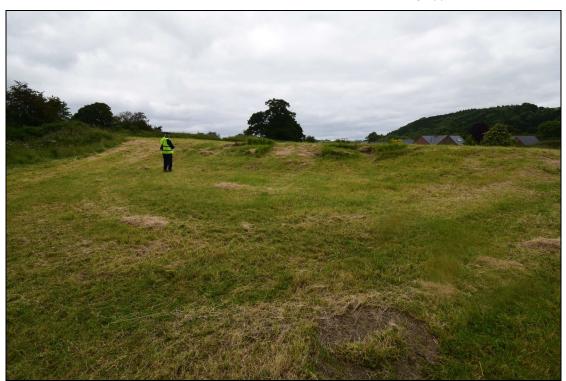
Plate 13: BDR2024_013. A view towards the castle site from the field to the south of the monument, near the road bridge over the River Severn. The proposed new building would not be visible from this position. Modern houses are in view to the right. The break of slope across the middle of the image appears to be an outwork of the castle. Looking northeast.

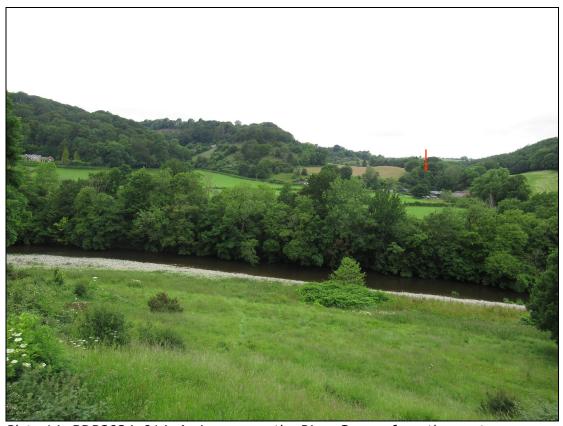
Plate 14: BDR2024_014. A view across the River Severn from the western rampart of the castle. Looking west-southwest.
