Name: Ty-asch (Tir-bach)

OS grid ref: SO 299 035

Parish / Location: Mamhilad

Ty Asch

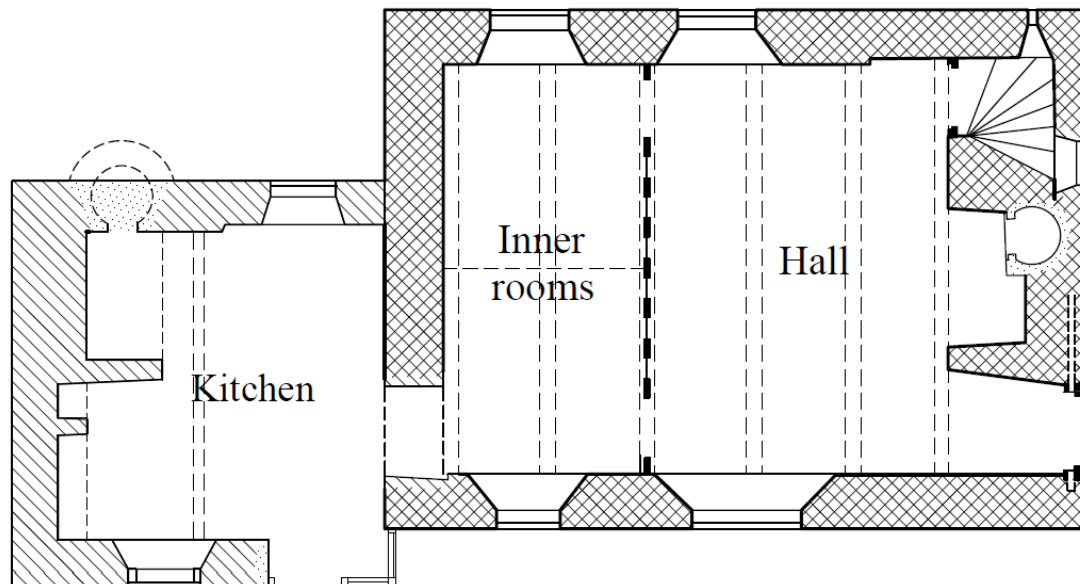
Revised from earlier RCAHMW plans

Phase 1 (c.1600)
-

Phase 2 (later 17 C)
-

Later & modern

The site consists of three buildings; an original dwelling house of hearth-passage plan, a small kitchen or bakehouse added to the upper end and, on the south side of the yard, a small square outbuilding, presumably a stable. The 1839 tithe map (extract right) shows an additional building to the east, and a northwards extension to the house; both had been removed by the time of the 1904 OS map.

Development. Clearly the house is the oldest part here, the shape and size of the door suggesting a late-sixteenth century date, but the thin ceiling beams and squared (rather than rounded) stairwell point to a slightly later period. Therefore a date around c.1600 would be a reasonable inference. The kitchen is clearly an addition, probably of the later-seventeenth century, while the detached stable appears to have been added in the eighteenth century.

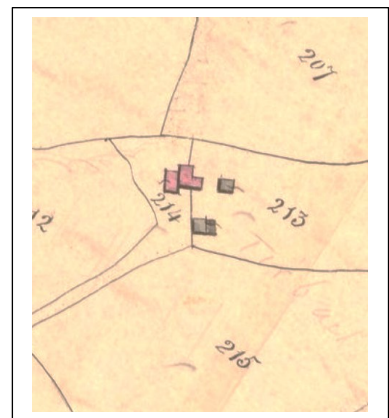
The original house consists of a stone rubble range with restored stone tiled roofs, aligned downhill, with an east-facing doorway in the gable wall. This has a fine Tudor-arch wooden frame with chamfered edges and plain stops (the door itself is a modern replica). The frame retains the holes for a drawbar. The passage leads into the **hall**, with its impressive post-&-panel partition at the upper

end. It is modern, but has been recreated from surviving fragments, and each post has chamfered edges with diagonal stops at the bottom. Twin doorways (with restored boarded heads) lead into paired **inner rooms**. Both rooms have splayed windows in the side walls, now with restored unglazed timber mullions. At some point the southern room was given a plaster ceiling, and was probably used as a small parlour (later a doorway was cut through into the added kitchen). The north-facing room was, as usual in these upland houses, a dairy.

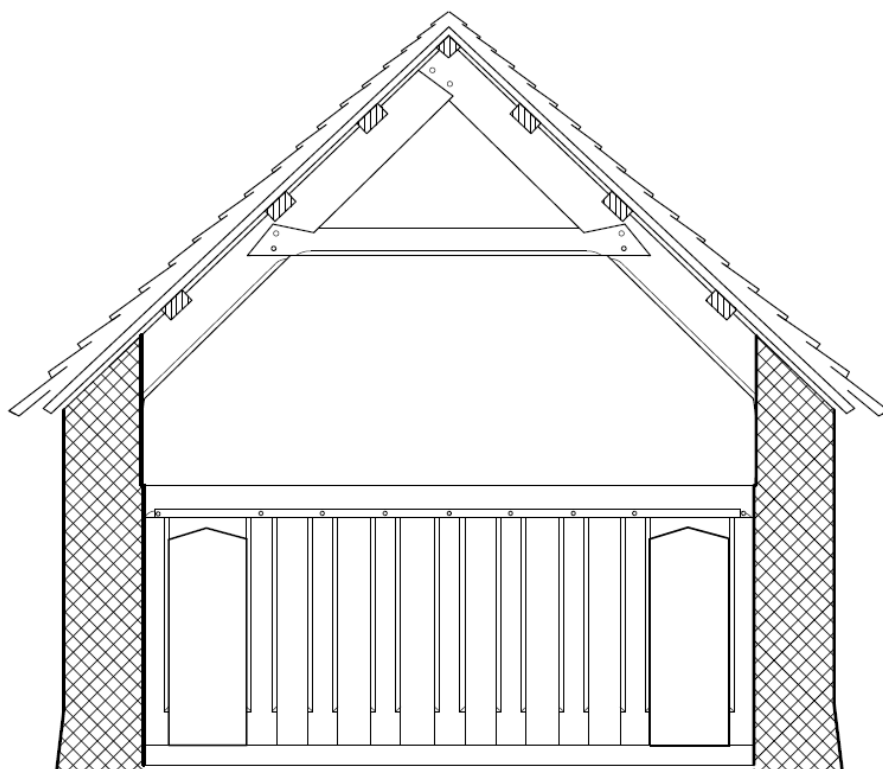
Cross section of hall

in the Gwent uplands). The roof is supported on two upper crucks with angled feet and dovetail-jointed collars, both chamfered and stopped on the undersides, and there are three rows of trenched purlins.

Back in the hall, there is a large gable fireplace with a huge timber bressummer stopped dead against the jambs. Into the LH side has been cut a pentagonal salt niche, while a brick and stone oven has been inserted into the back of the hearth. The ceiling is formed of joist-beams with medium chamfers and the common hollow-&-fillet stop. The two windows have been filled with replica mullioned frames and wooden shutters. Interestingly, the main south-facing window has a much wider splayed opening than all the others, plus a chamfered timber lintel stopped dead against the jambs (were the other windows been altered at a subsequent date, or was the south window itself a later insertion?).
