# AN ARCHAEOLOGICAL MAP REGRESSION FOR FLOOD DEFENCES, AT YNYS HIR RSPB RESERVE, CEREDIGION

October 2009

Prepared by Dyfed Archaeological Trust For: The Environment Agency

RHIF YR ADRODDIAD / REPORT NO. 2009/80 RHIF Y PROSIECT / PROJECT RECORD NO. 98414

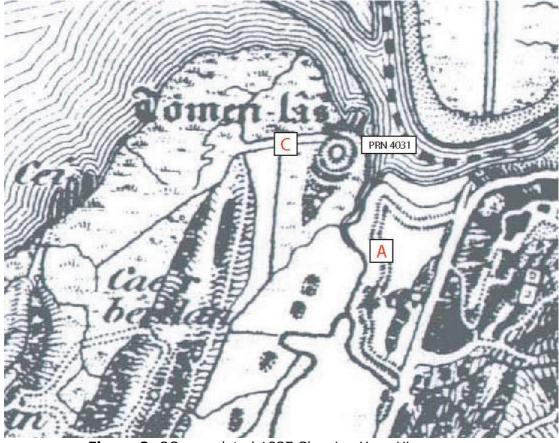
Figure 2: OS map dated 1837 Showing Ynys Hir reserve.

The 1837 OS map (Figure 2) appears to use a double line to depict what are probably flood defences (A) to the east of Afon Einion. A similar line convention is used to depict the east-west boundary (C) west of the motte. This may suggest that all the fields and flood defences in this area were established between 1834 and 1837, possibly as a result of the parliamentary enclosures Act. Later map evidence (discussed below) however, may suggest that boundary (C) is possibly of earlier origin. Flood defences B and D are not depicted.

From the available evidence it appears that the field boundaries and flood defences in the Ynys Hir RSPB reserve were constructed at different times. The flood defences on the east side of Afon Einion (A) probably date from before 1837 and may be part of a larger land reclamation scheme at the time of the parliamentary enclosures. The defences on the west side of Afon Einion (B) may have been constructed later, at some time between 1837 and 1887 (along with those further to the northwest (D).

The origins of boundary (C) are less clear. Although apparently depicted as a flood defence in 1837, it is subsequently only depicted as a field boundary. It is clear, however, from the map depictions, and the construction of flood defence (D) that boundary (C) acted as a flood defence throughout. It may be that this boundary has earlier origins than the others in the area, possibly even dating from when Tomen Las motte was constructed.

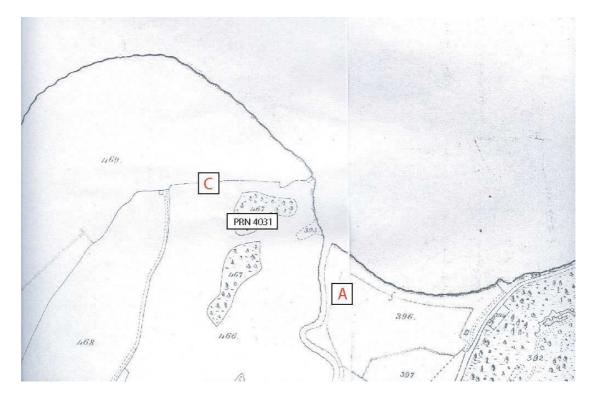
Figure 3: Tithe map dated 28<sup>th</sup> of March 1848 Showing Ynys Hir reserve.

On the tithe map of 1848 (Figure 3) the field containing the motte (field number 466) and the motte itself (labelled as field 467) are listed in the apportionment as owned by a Mr John Maurice Davies and occupied by Mr Thomas Davies. Field 466 is described as pasture. The motte is described as being a garden. The small enclosure to the immediate east of the motte named Pant Glas (field 395) is also described as pasture, but resembles a mooring inlet on the map. Field 469 situated to the north of field boundary (C) is recorded as being owned by a Mr Matthew James Williams and occupied by Mr Thomas Davies. The field is described as pasture and is named 'Cae garw' ('rough or bumpy field').

Flood defences (A) on the eastern side of the Afon Einion (in field 396) are indicated on the tithe map, but those on the western side (B) are not depicted. It is possible (although perhaps unlikely), that flood defences (B) could have been present by this time, but were not depicted since they did not represent a land ownership boundary.

The east-west boundary (C) to the west of the motte is only depicted as a field boundary. Also depicted, close to either end of this boundary are small rectangles of uncertain significance, but possibly sheepfolds. The present day flood defences (E) are not depicted. Flood defences (D) are not depicted.

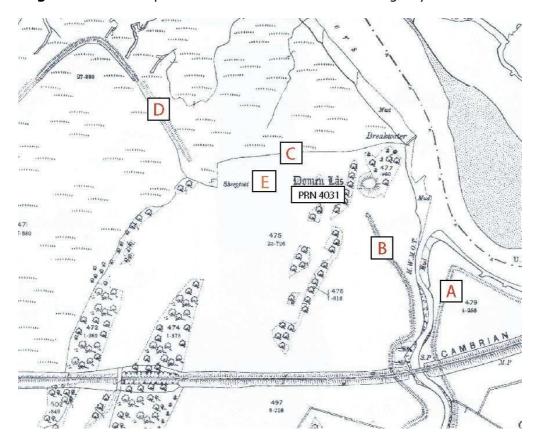
**Figure 4:** Ordnance Survey 1887 Cardiganshire Sheet II NW  $1^{st}$  edition 1:10560, extract showing Ynys Hir reserve.

The flood defences (B) running from the motte southwards along the west bank of Afon Einon, are first represented on the  $1^{st}$  and  $2^{nd}$  edition OS maps dated 1887 and 1905 respectively (Figure's 4 & 5). Although the boundary to the west

of the motte (C) is not represented as a flood defence, the maps clearly indicate a difference in land use or land management. This may suggest that the boundary was of sufficient strength, or the land to the south sufficiently elevated, to prevent inundation.

That flood defence (D) (also depicted for the first time) run northwest from boundary (C), may again suggest that boundary (C) did not need strengthening against sea inundation.

The words 'breakwater' visible to the north of the motte refer to the groyne on the shore immediately to the east.

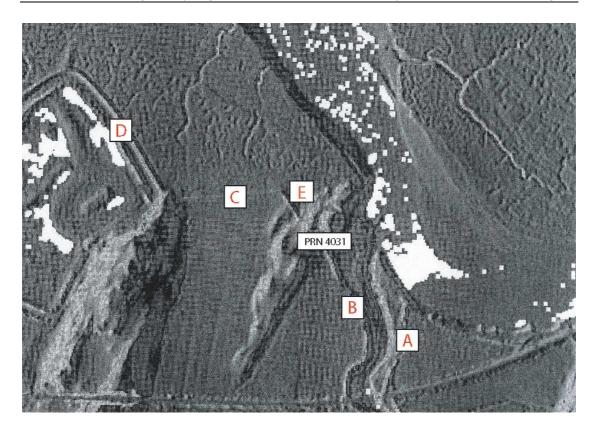
Plate 2: Detail from Lidar image provided by the Environment Agency

A Lidar image (Plate 2) shows that flood defence (E) turns southeast at its eastern end, whereas boundary (C) is mapped as continuing eastwards. The difference in the appearance of boundary (C) and flood defence (E) suggests that flood defence (E) may incorporate boundary (C).

Flood defence (E) appears to have been constructed between 1953 and 1955. It appears to incorporate, or possibly to have re-modelled or replaced, boundary (C). At its east end (E) turns southeast, diverting from the original course of boundary (C).
