# Denbigh County Hall

Hall Square  
Denbigh

## Drawing of the surviving Phase I roof truss

NPRN: 23423  
Grid ref: S105294 6611  
Surveyed: SF/LB/DJP August & September 2005  
Print Scale: 1:100 at A4

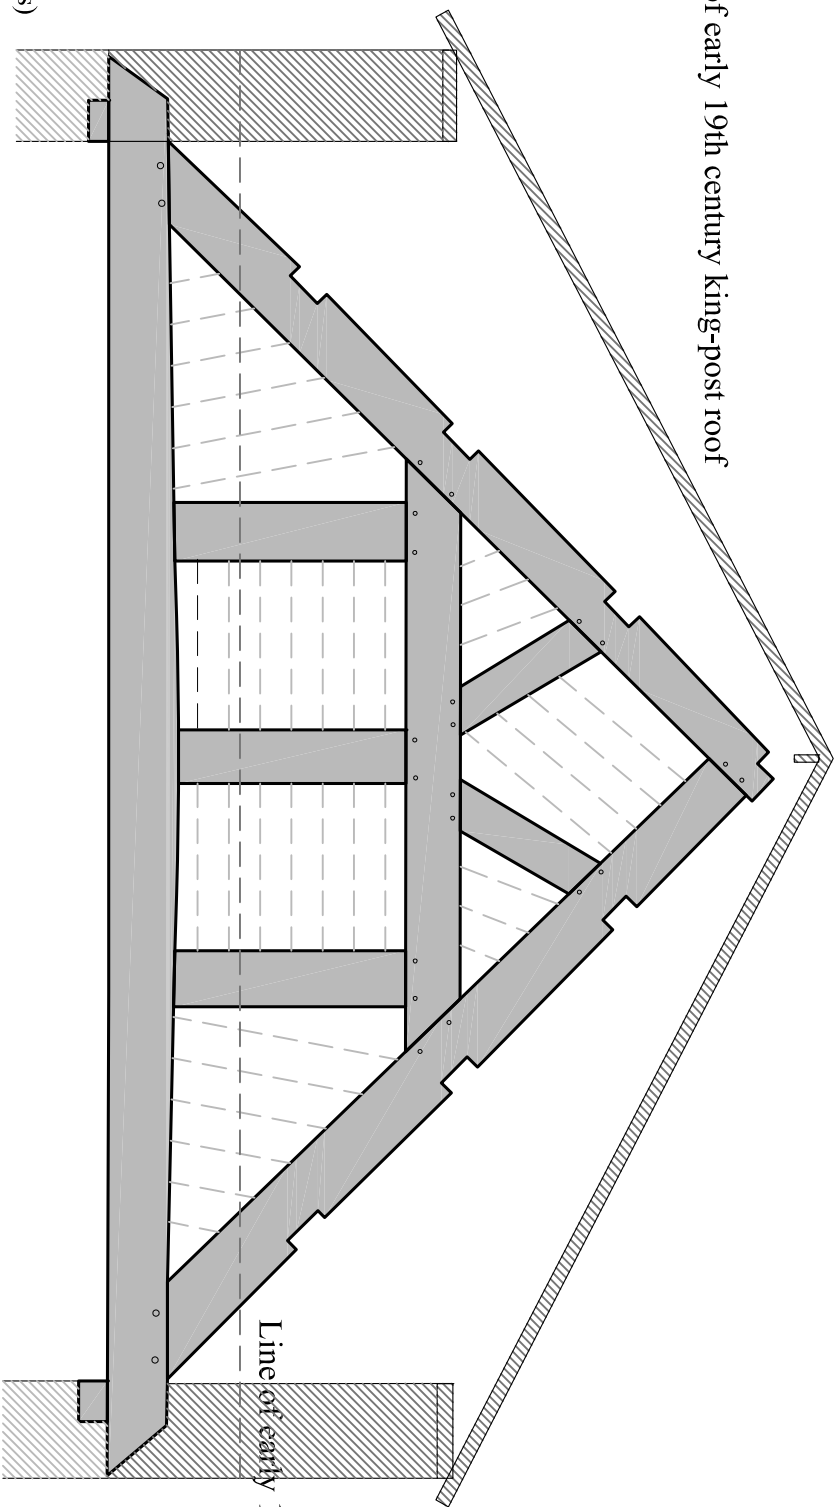
Roofline of early 19th century king-post roof

- Phase I (1580's)
- Phase II (1780's)
- Phase III (19th C)
- Phase IV (20th C)
- Phase V (Late 20th C)
