# Gelli Cefn y Rhos, Cwmdu, Carmarthenshire

## Level 3 Historic Buildings Record

Project #: AD100

Date: May 2021

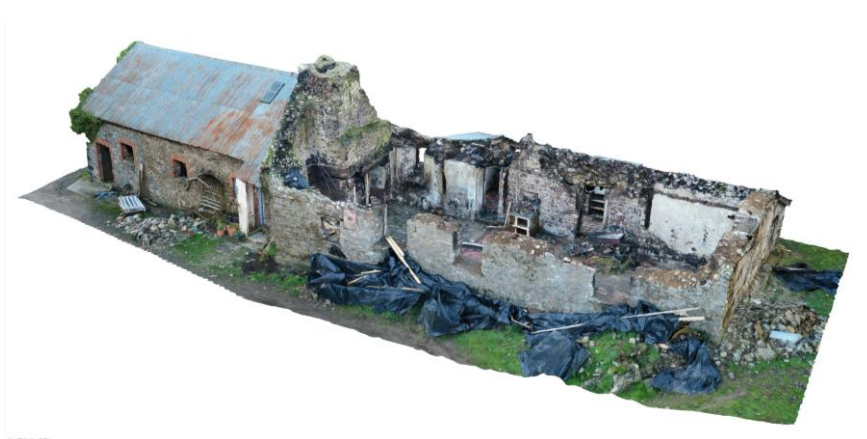
*Fig. 1 – Gelli Cefn y Rho post-fires, photogrammetric model.*

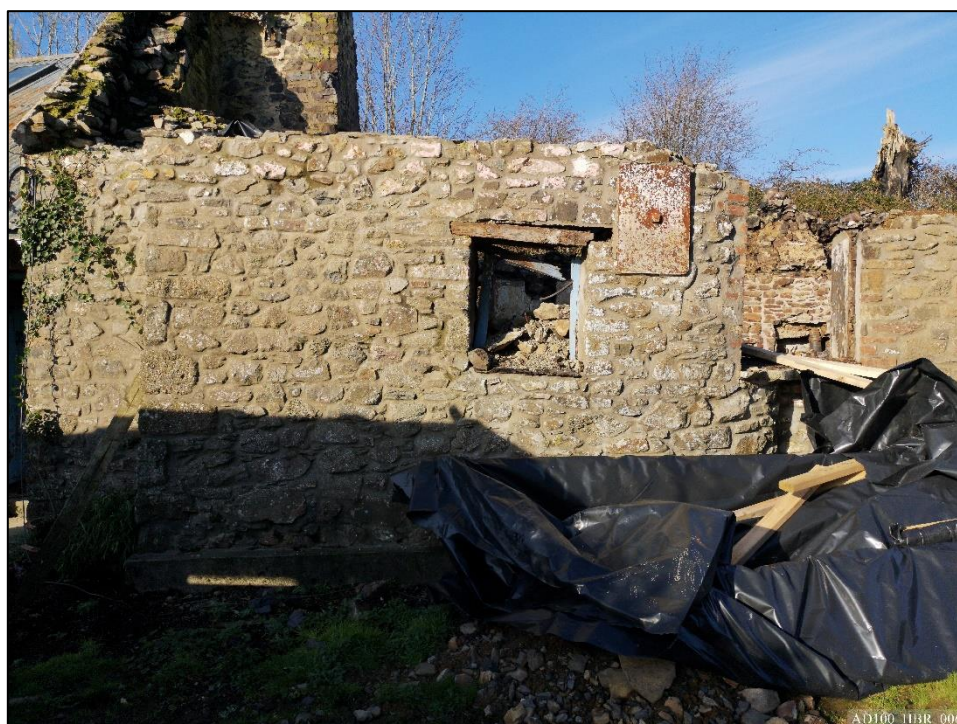
Plate 6 – East elevation, showing stair projection.

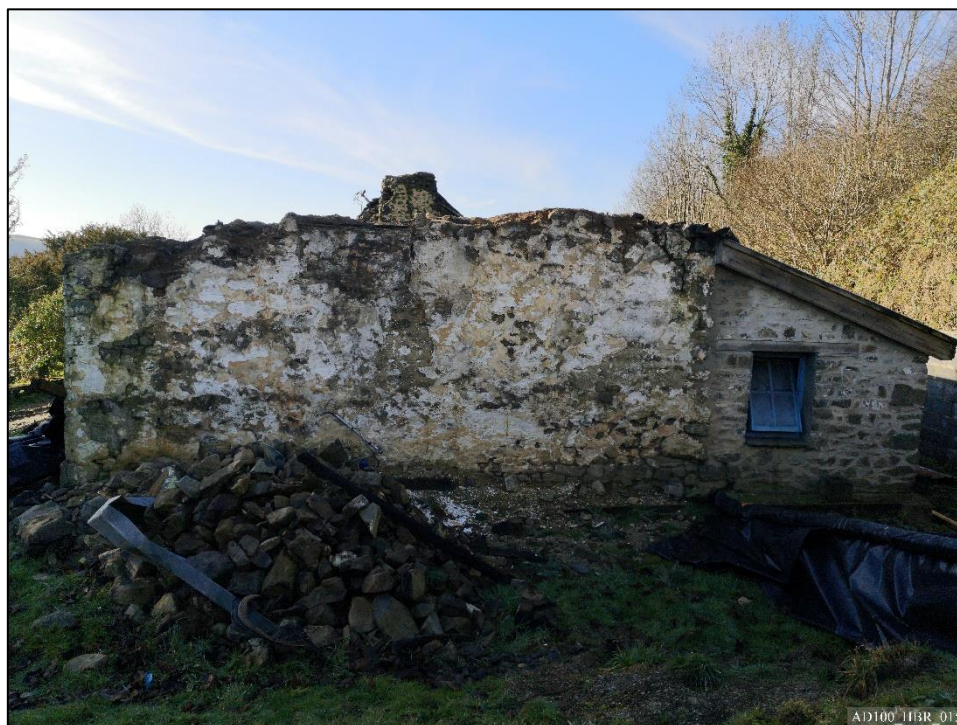
- 7.6.2 A single storey extension is added to the north end of the west elevation, probably constructed as a pantry and scullery (Plates 15 & 18). Only three walls survive for this addition, with the internal wall having been replaced with brick and stud.

Plate 15 – North elevation of house and pantry.

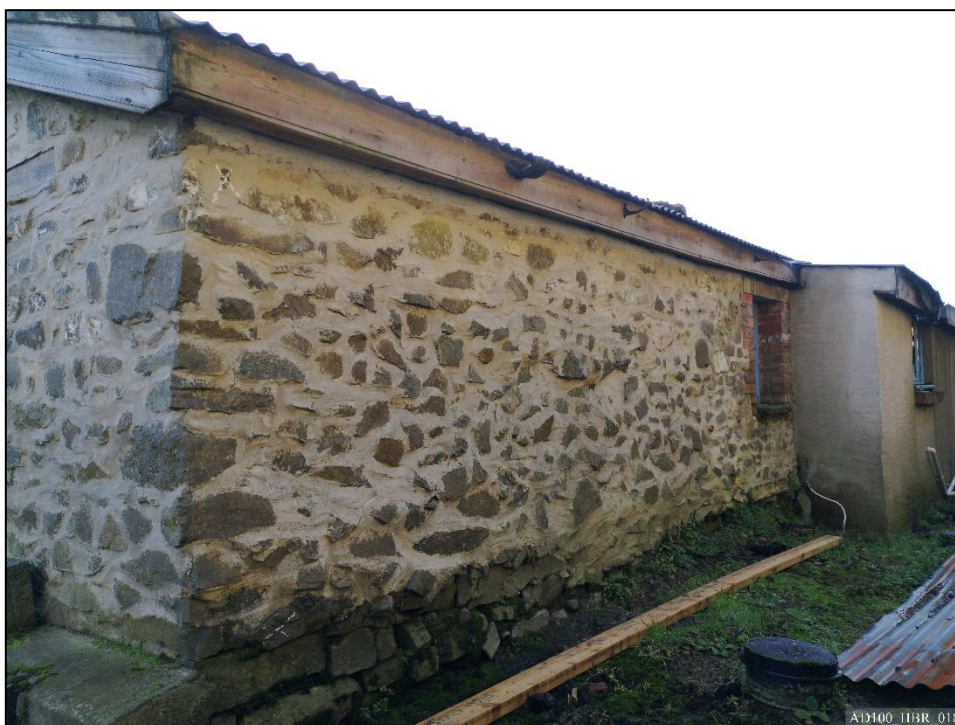
Plate 18 – West elevation of pantry, showing later window with red brick reveals.
