LLWYN CELYN  
Stanton  
Crucorney Fawr  
Gwent  
19/17995/DISCON

PHOTOGRAPHIC  
RECORD  
DURING WORKS  
2016-2018

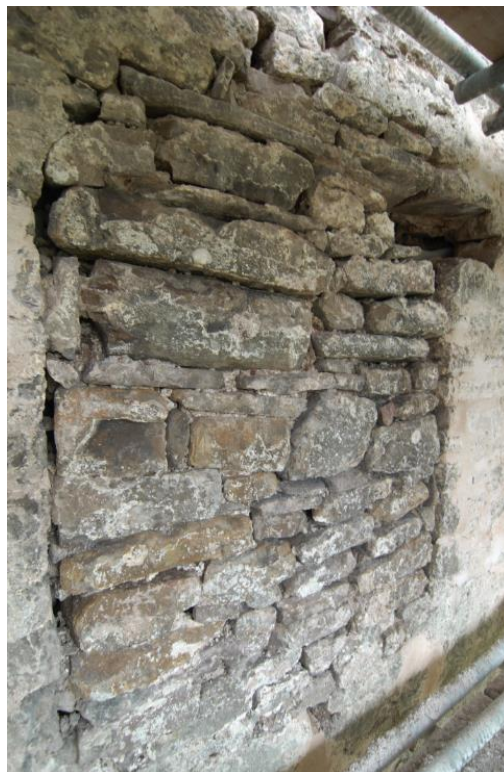
Pl.2: Blocked first-floor window opening discovered in south gable of Solar, now opened.

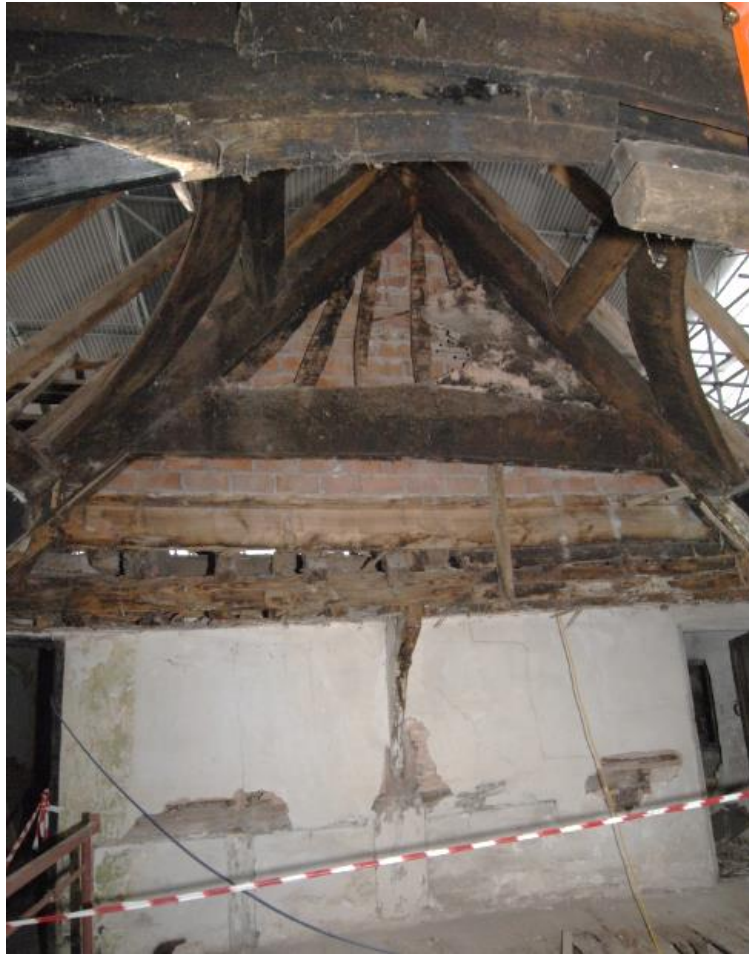
Pl.9: West end of Hall roof, with possible dais canopy traces.

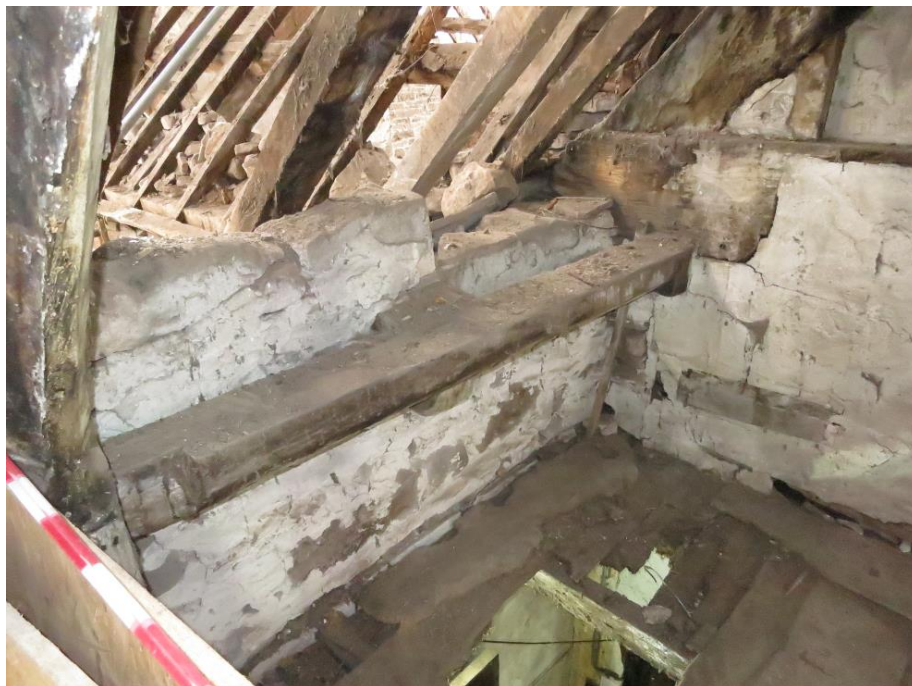
Pl.10: Surviving section on inner wall-plate of Hall roof, north of main stack.

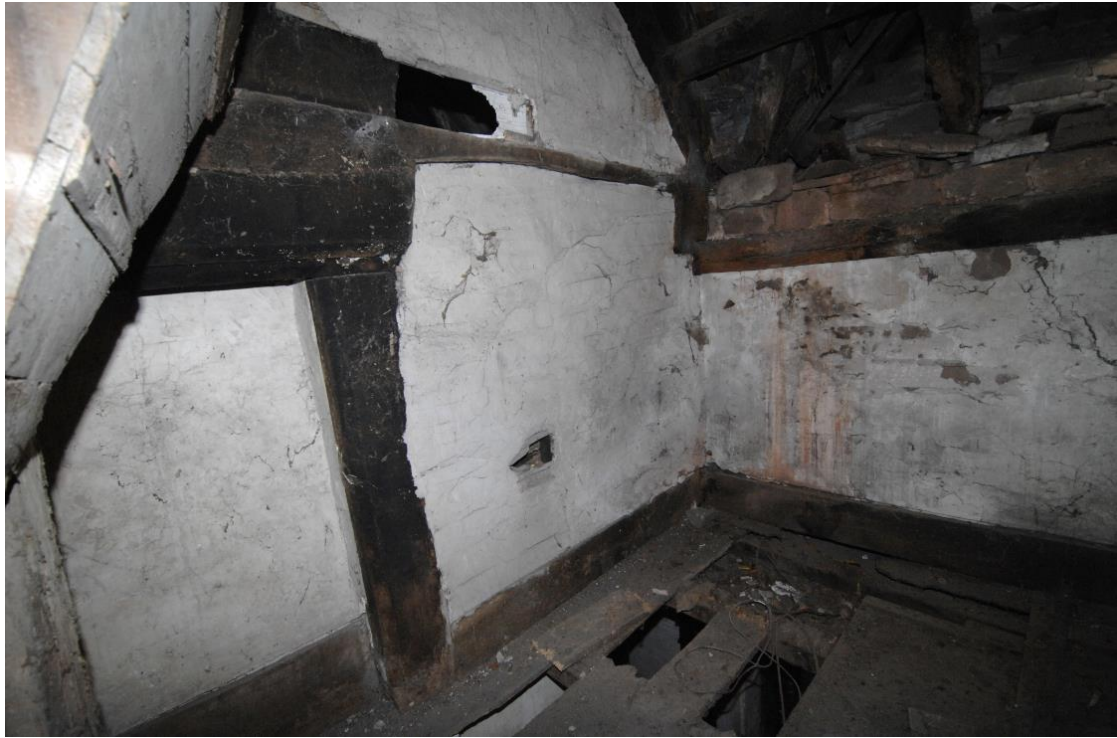
Pl.11: Top of spere truss and blocked inserted doorway through it, north of stack.

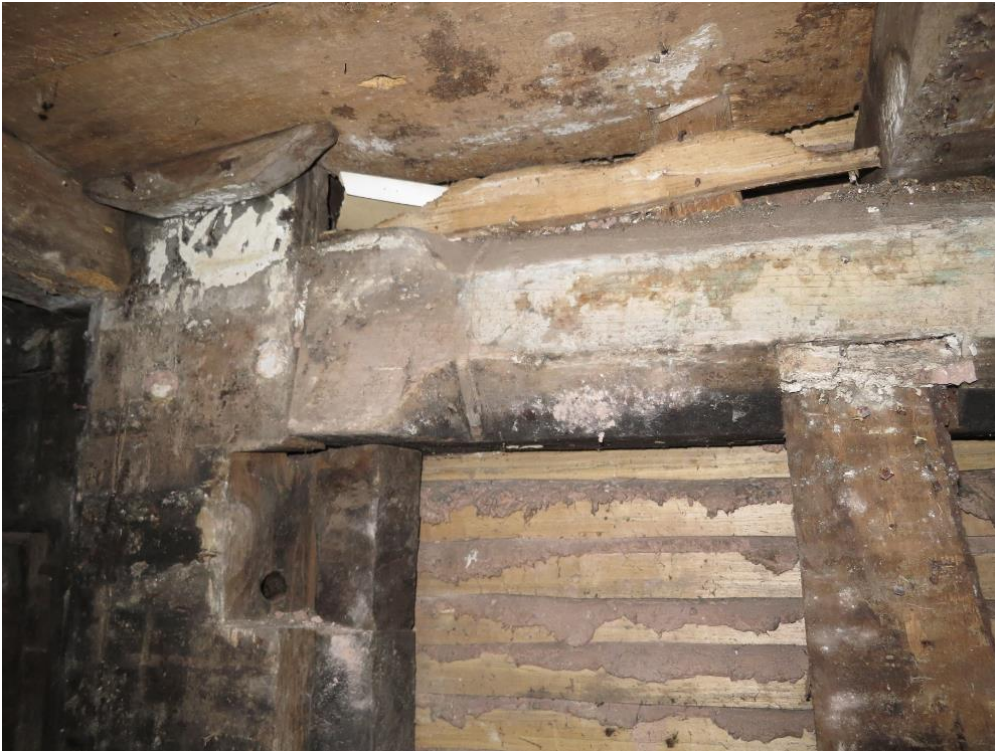
Pl.18: Detail of re-used moulded beam/mullion infilling the spere truss.

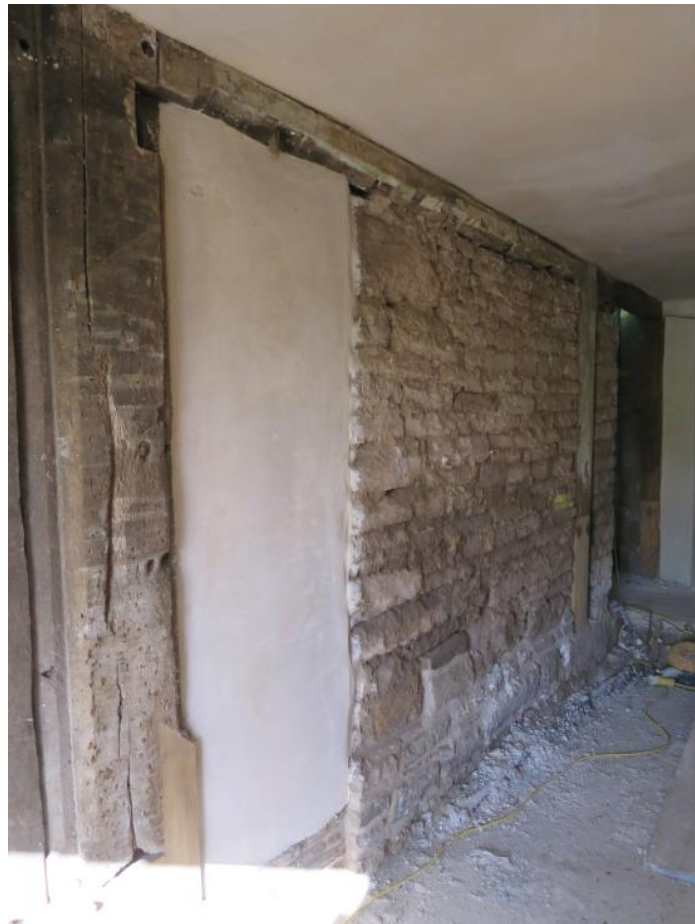
Pl.19: Rear of inserted stack between the spere truss posts.

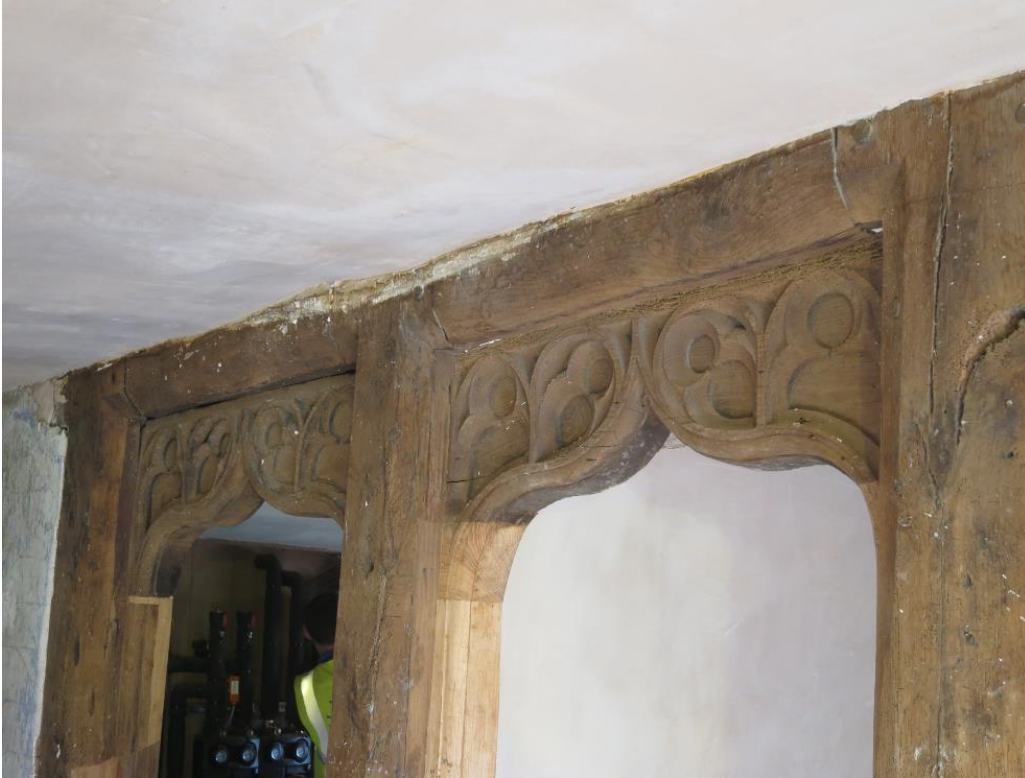
Pl.20: Restored heads of paired doorways to the services, 2017.

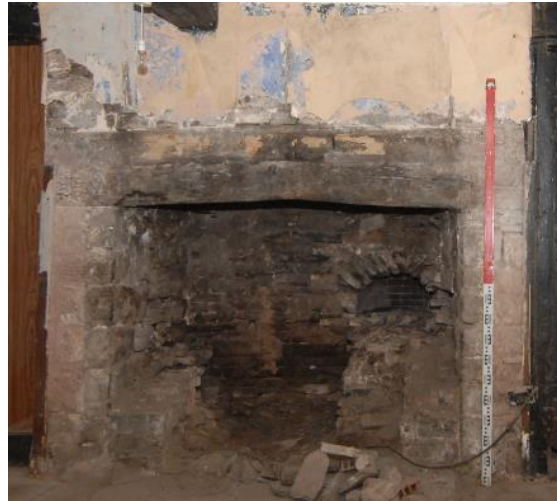
Pl.26: Evolution of the hall fireplace – phases I and II, the original open fireplace of the 17<sup>th</sup> century with the inserted bread oven to the right; other remnants belong to Phase III.

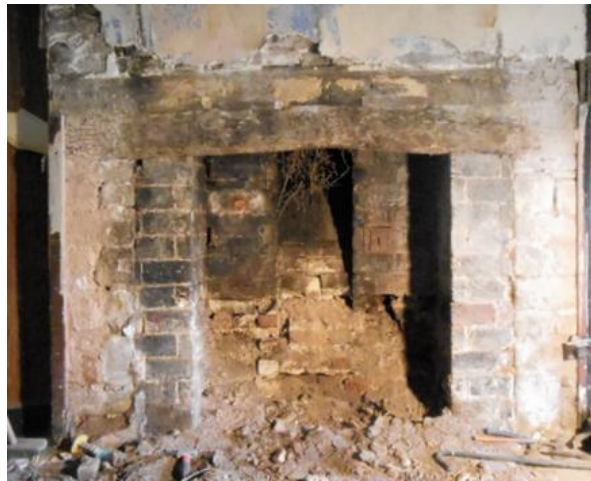
Pl.27: The Phase III arrangements, probably of the later-19<sup>th</sup> century.

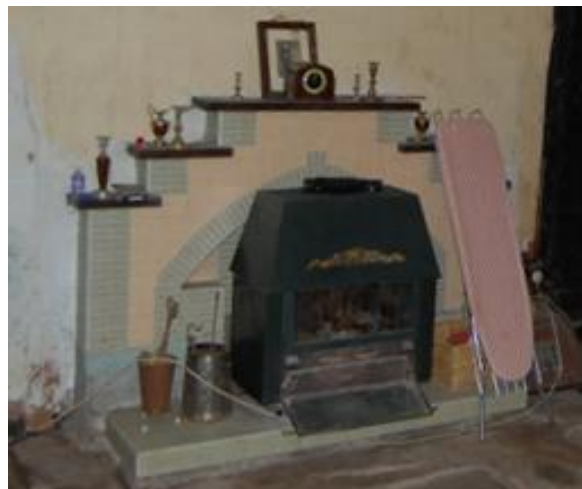
Pl.28: The Phase IV mid-20<sup>th</sup> century chimneypiece and later-20<sup>th</sup> century stove of Phase V.

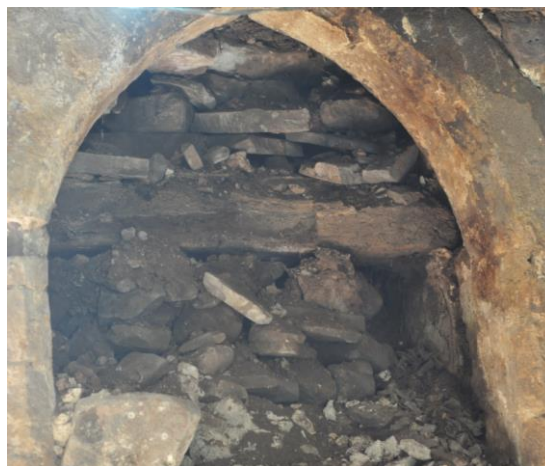
Pl.31: Detail of blocking of the top of the doorway.

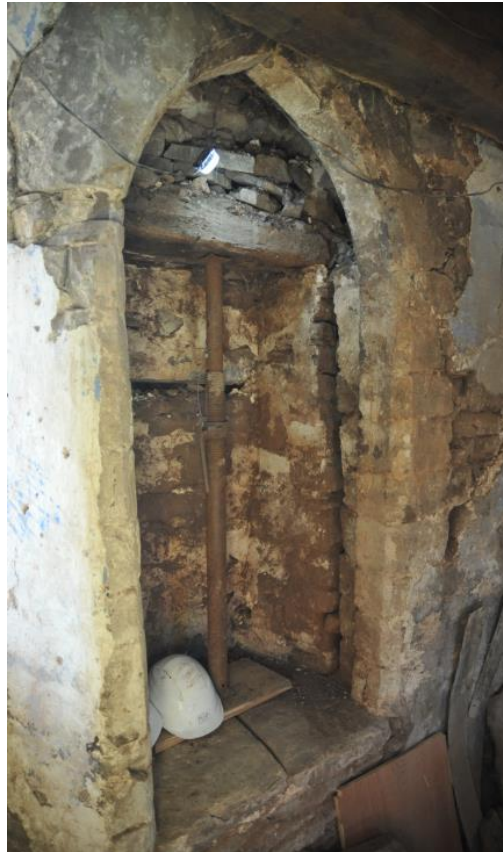
Pl.32: The doorway once the main infill had been removed.

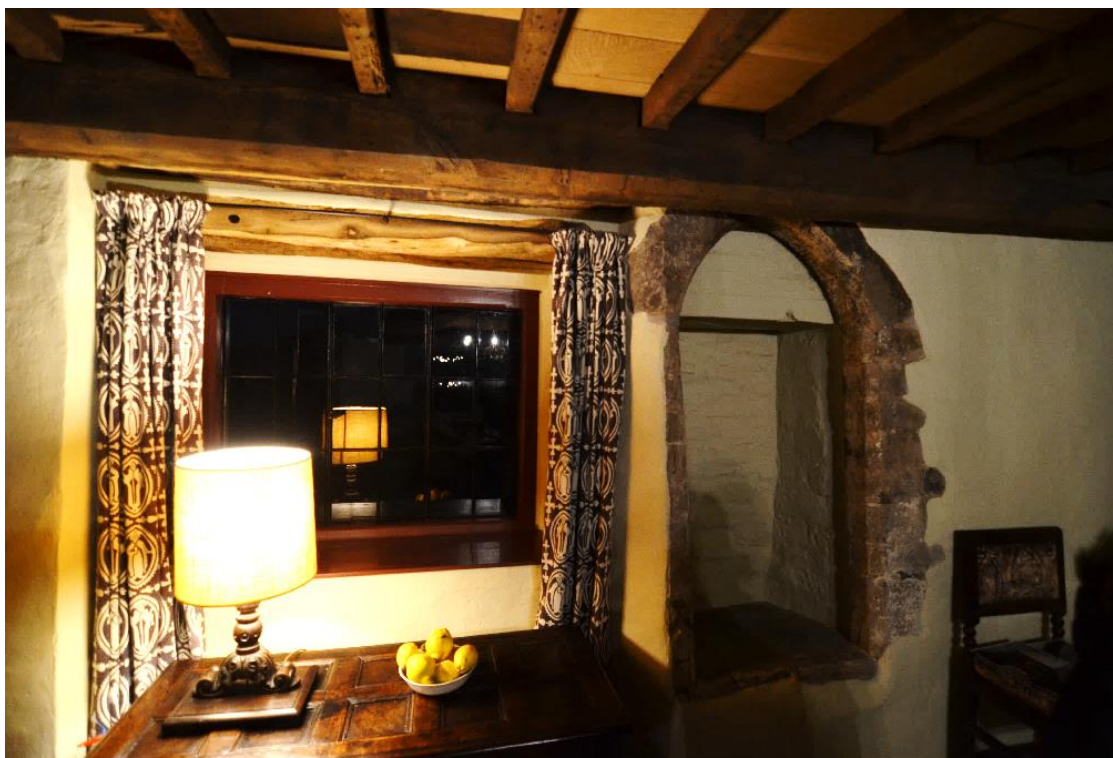
Pl.33: The doorway as restored and expressed, 2018.

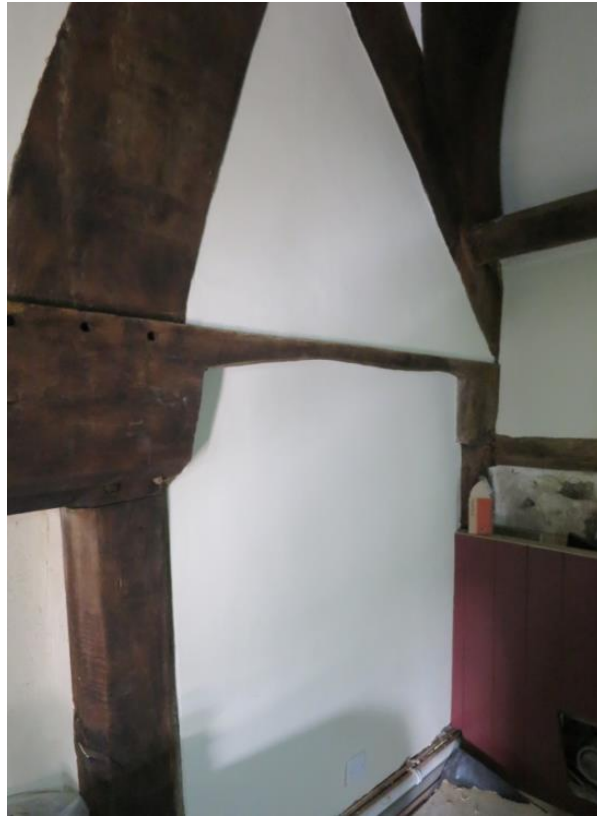
Pl.34: Remains of inserted blocked doorway for stairs through north side of spere truss.

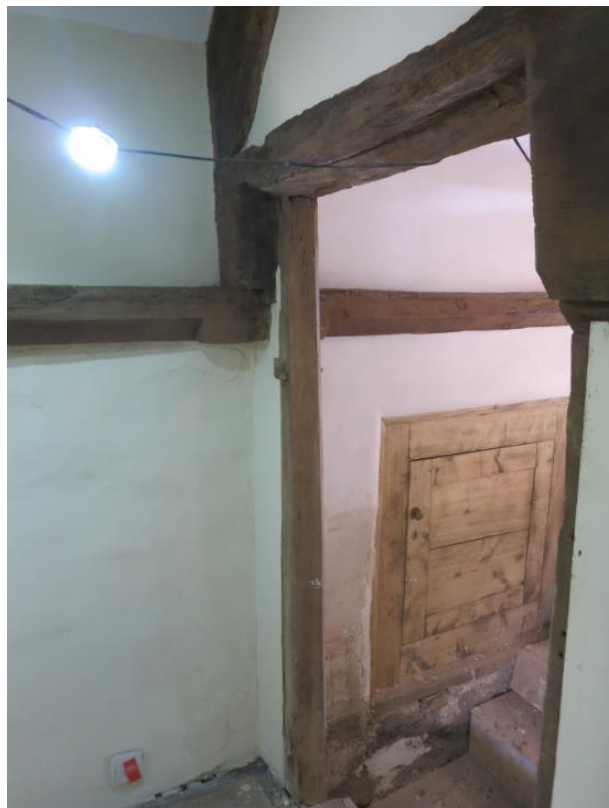
Pl.35: Present almost identical doorway for the present stair landing through south side.

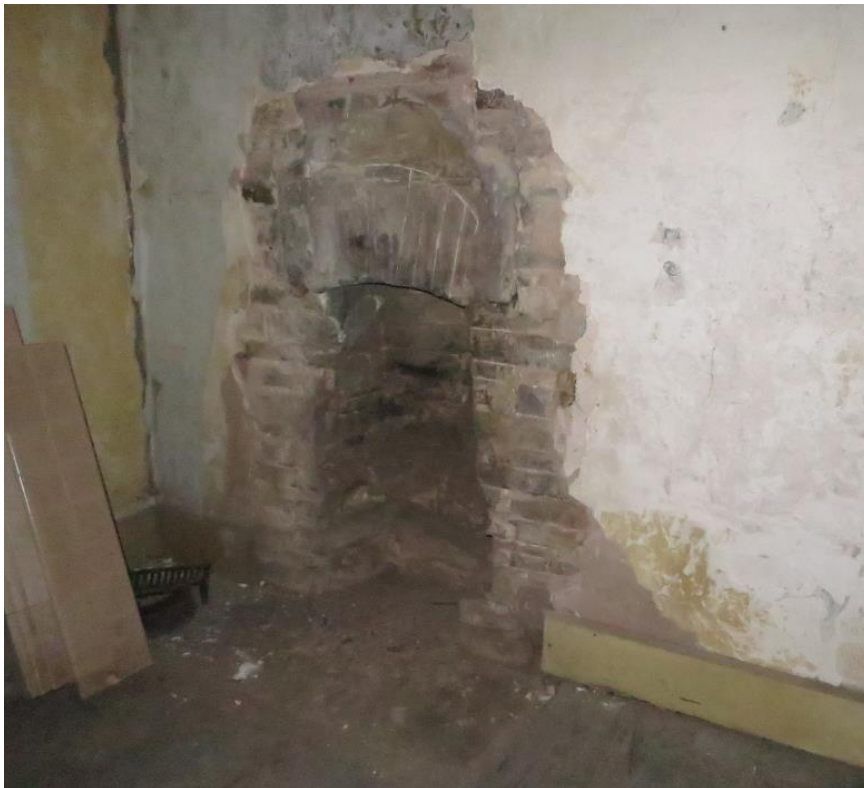
Pl.51: Exposed early inserted fireplace in the west wall of the solar at first-floor level with incised head.

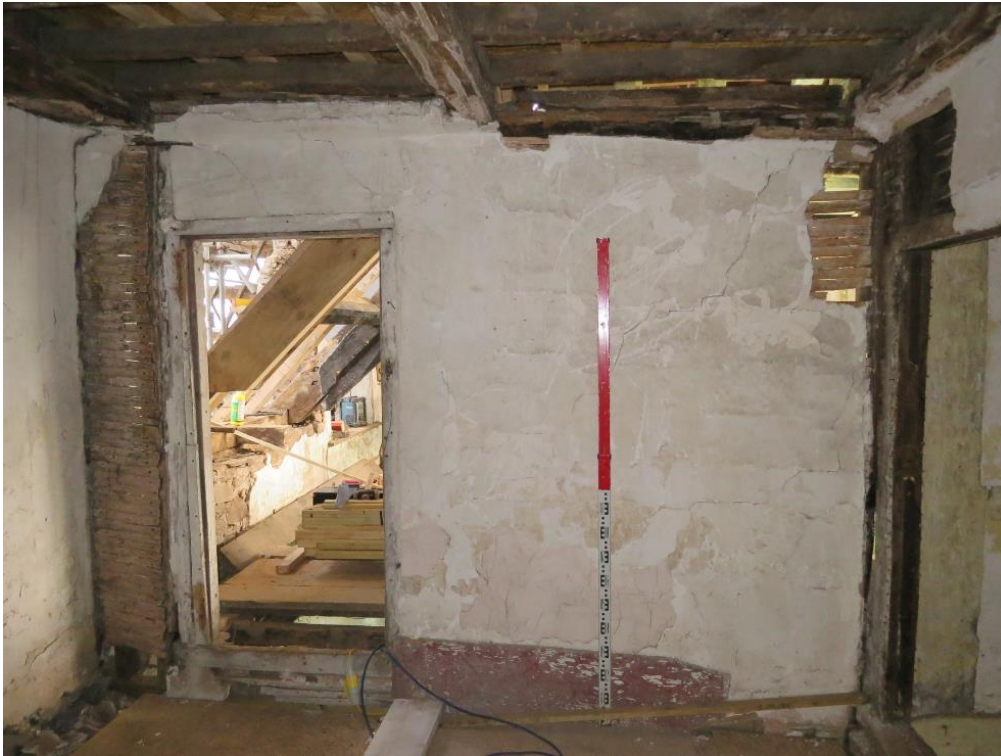
Pl.52: Norther first-floor room in solar, looking east into the hall range, 2017.

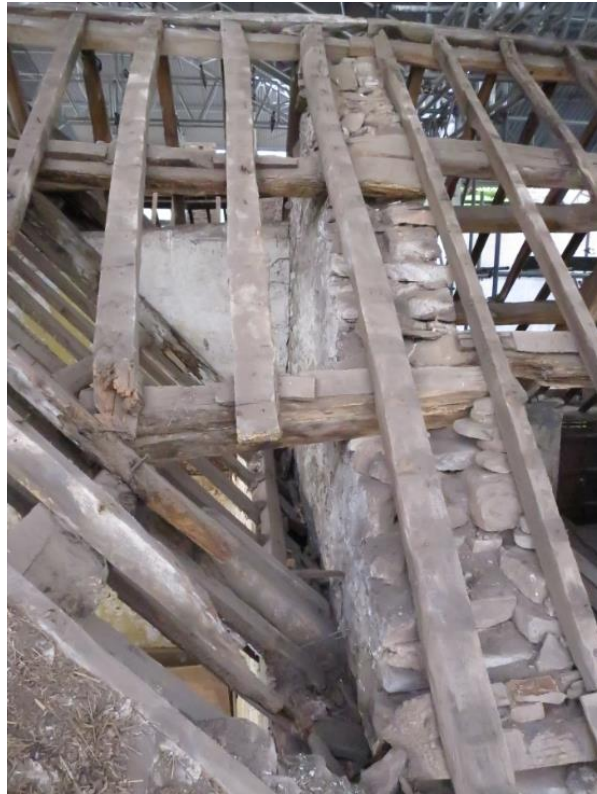
Pl.58: South gable of Rear Wing roof, built up from north wall of the original house.

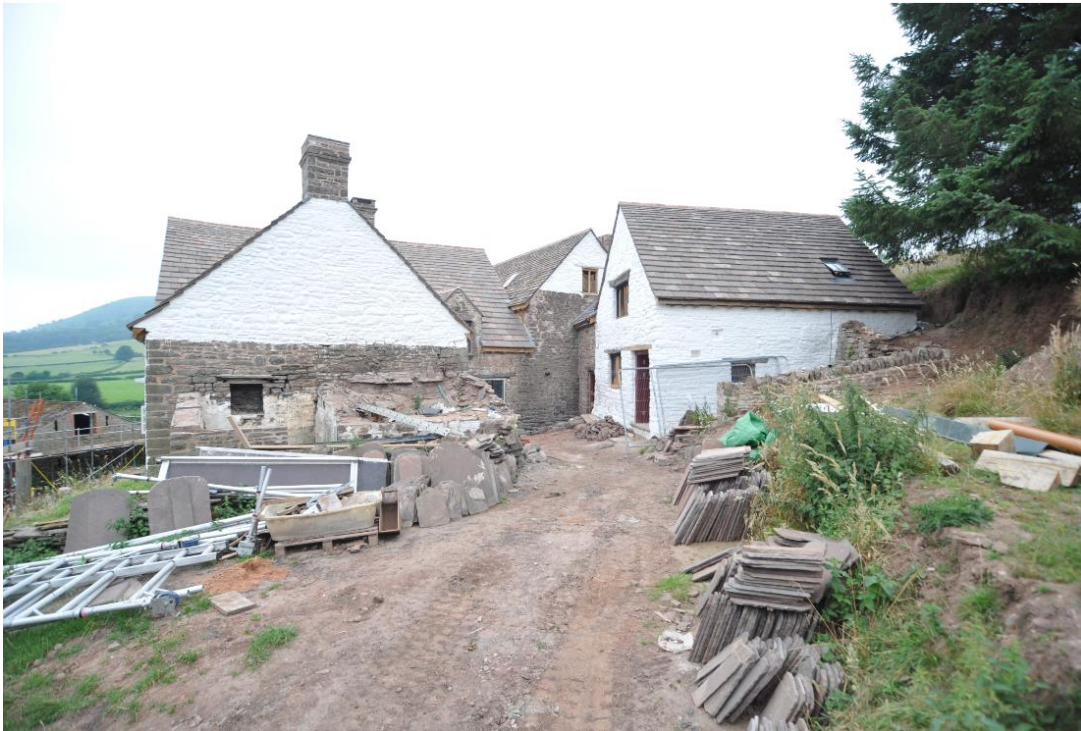
Pl.65: Rear of farmhouse in 2017, with Apple Store (Building C) to right.

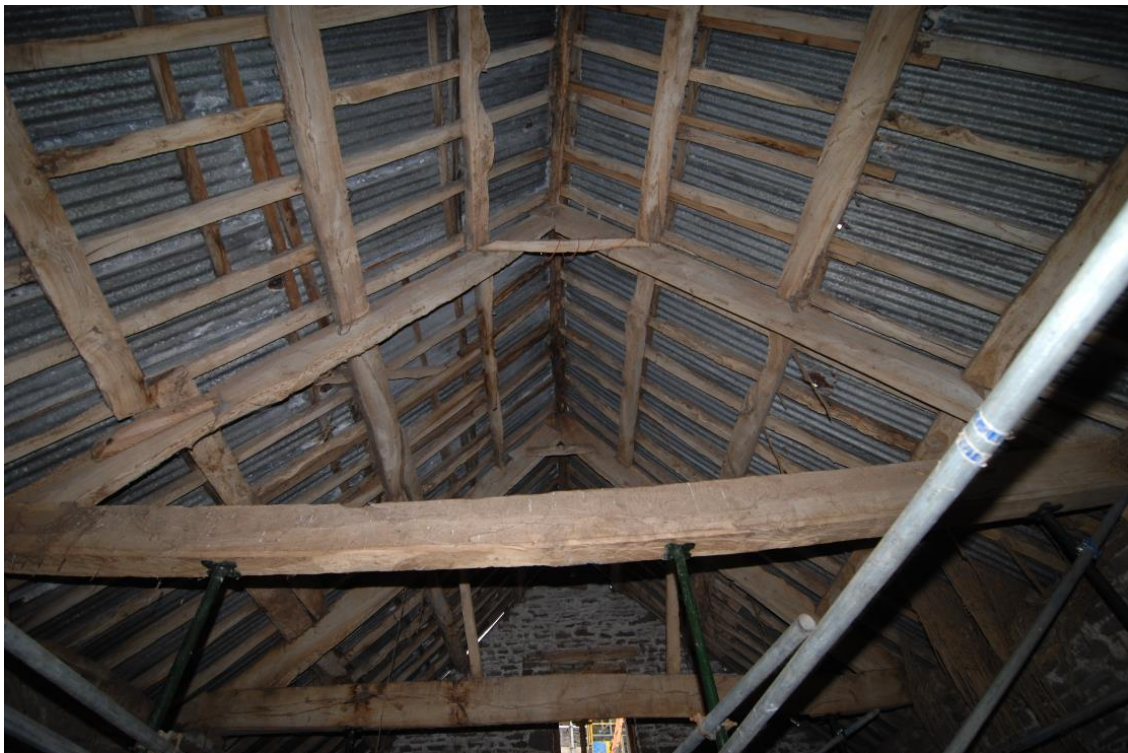
Pl.72: Beast House roof, internal view prior to removal of covering.
